2019 Dundas SCIA Compaction Event

Winchester, Ontario

August 29th, 2019

Dundas SCIA Compaction Event

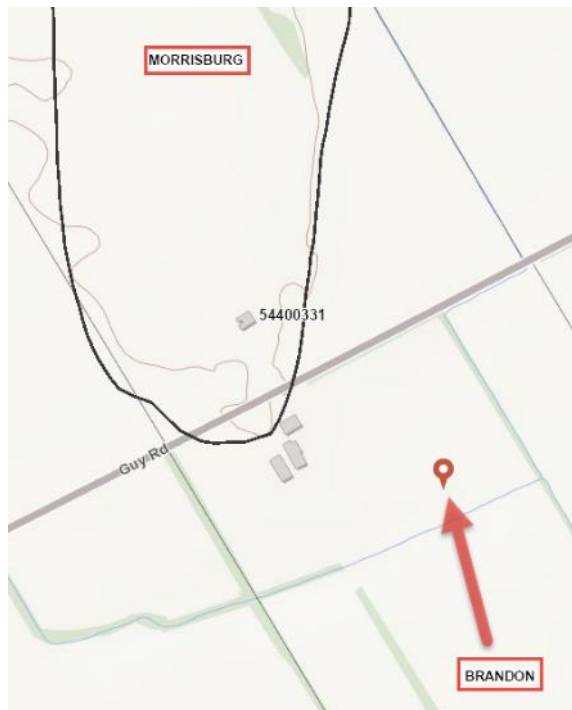
Site Layout

- The soil at the site was a primarily Brandon soil with a Clay Loam surface and Silty Clay B Horizon according to the county soil map.

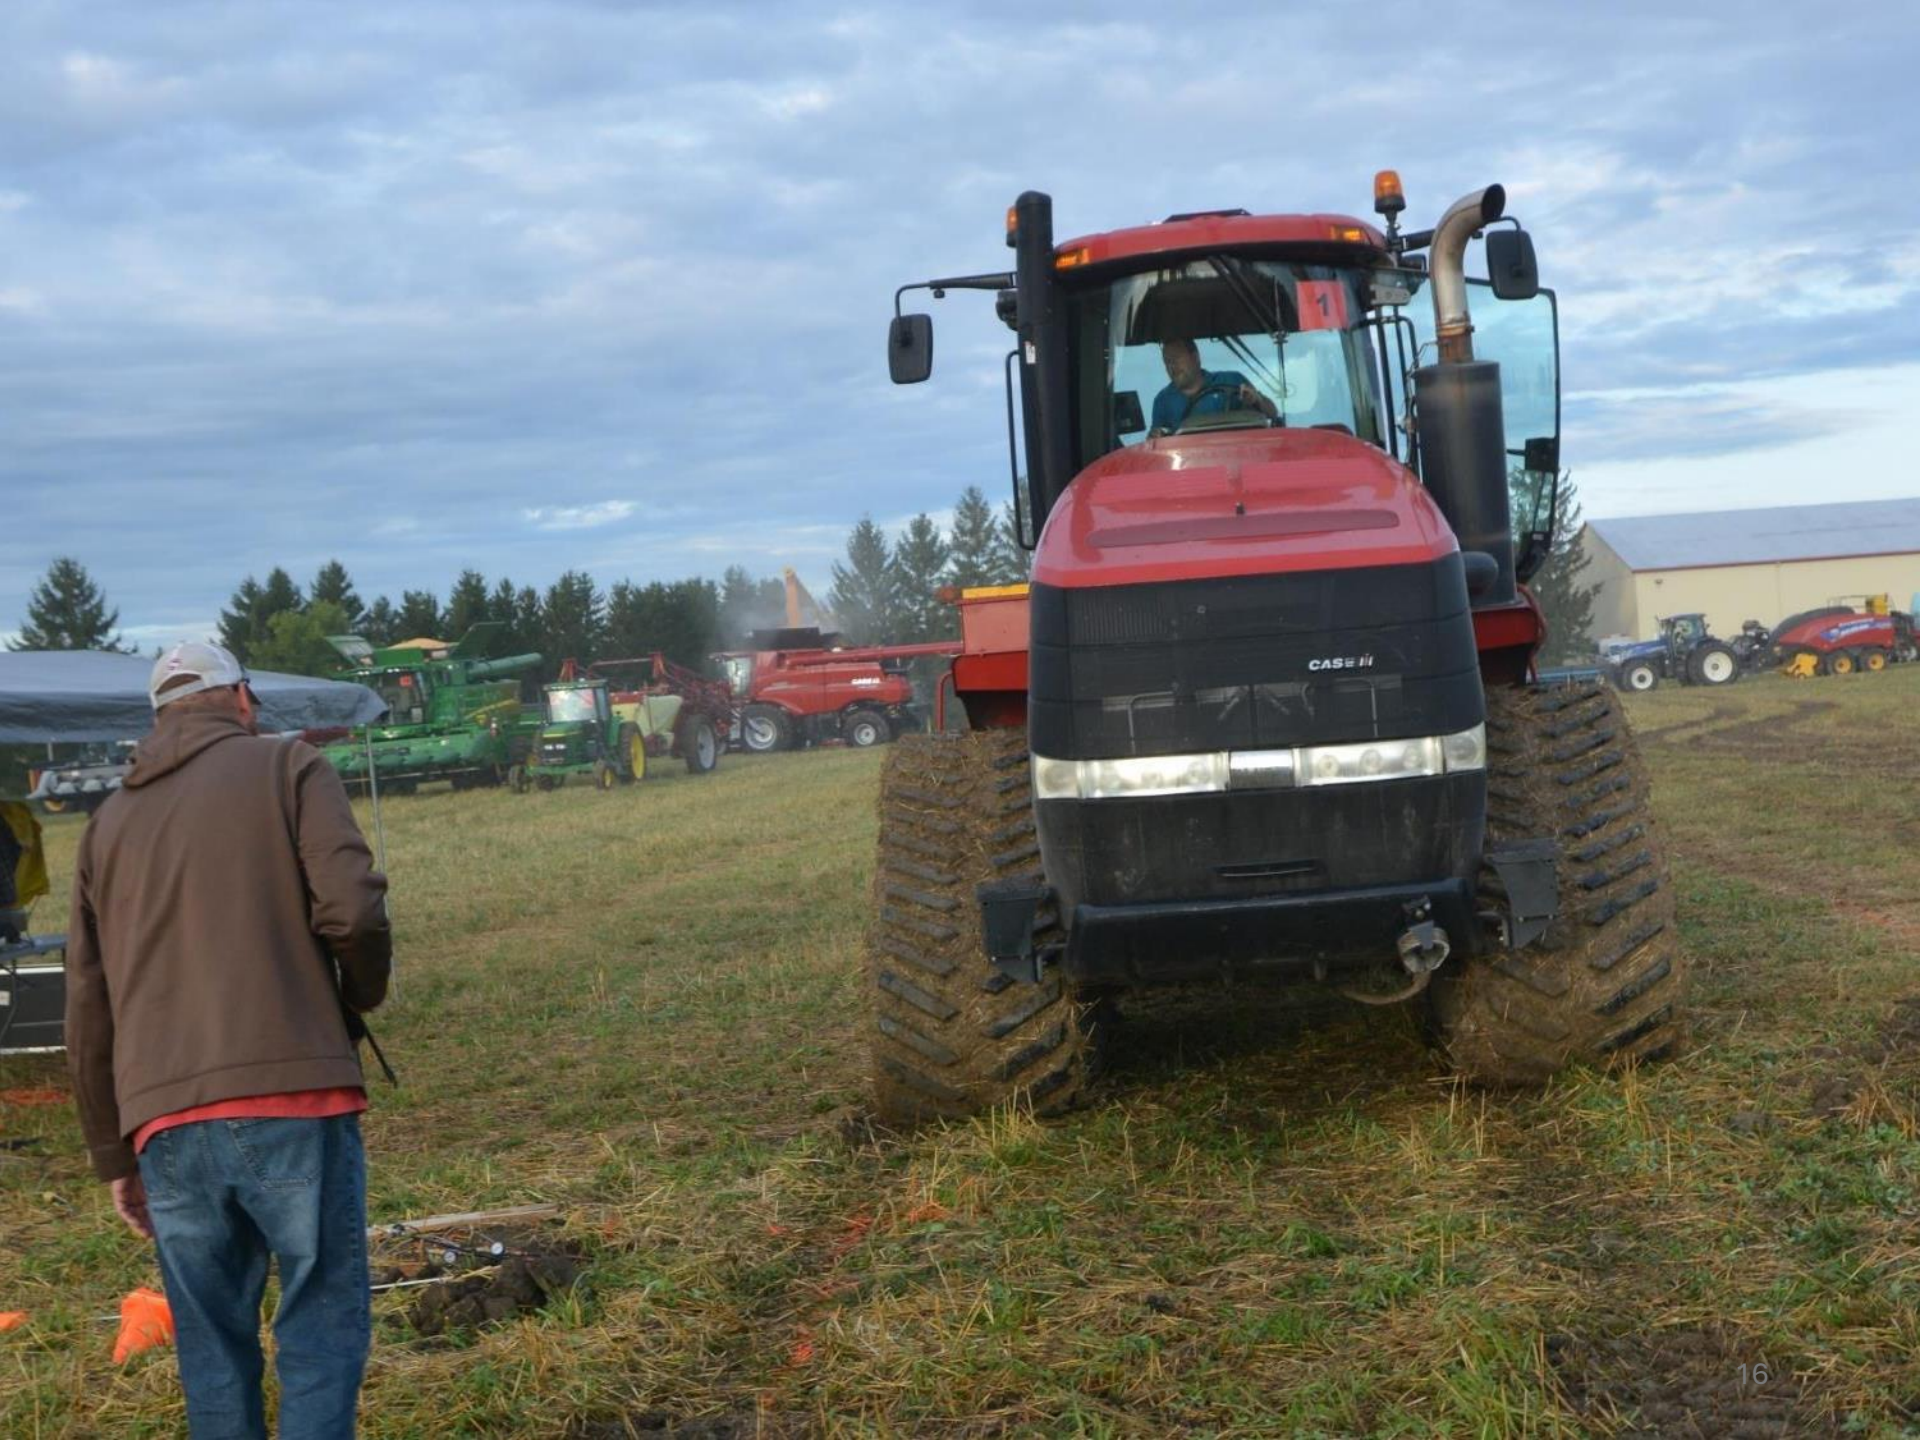
Exhibit: D1

**CaseIH Quadtrak STX500
Tracked Articulated Tractor**

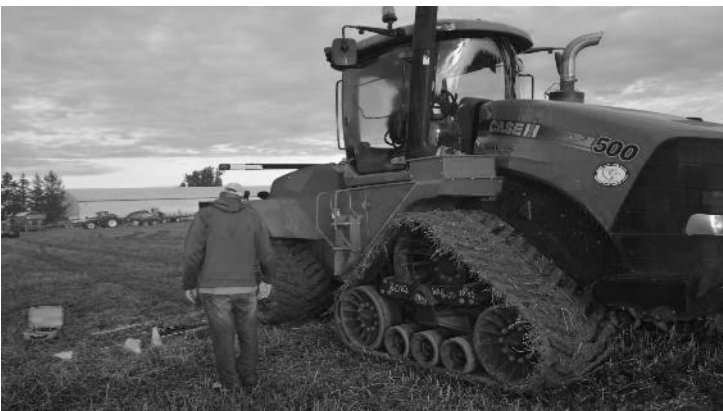
D1_right_3

Jans Farm Equip Tractor - Articulated CIH STX500 Tracks

- This is a curved bottom track
 - Notice how there are only 3 peaks on each curve, corresponding to the small rollers on each track unit.
 - The hard ground conditions meant the track was not bearing on the entire surface.
- The deeper pressures are a concern with this amount of weight.
- But in this situation the stress transferred into the soil was suitable for the soil in terms of avoiding compaction under these conditions.

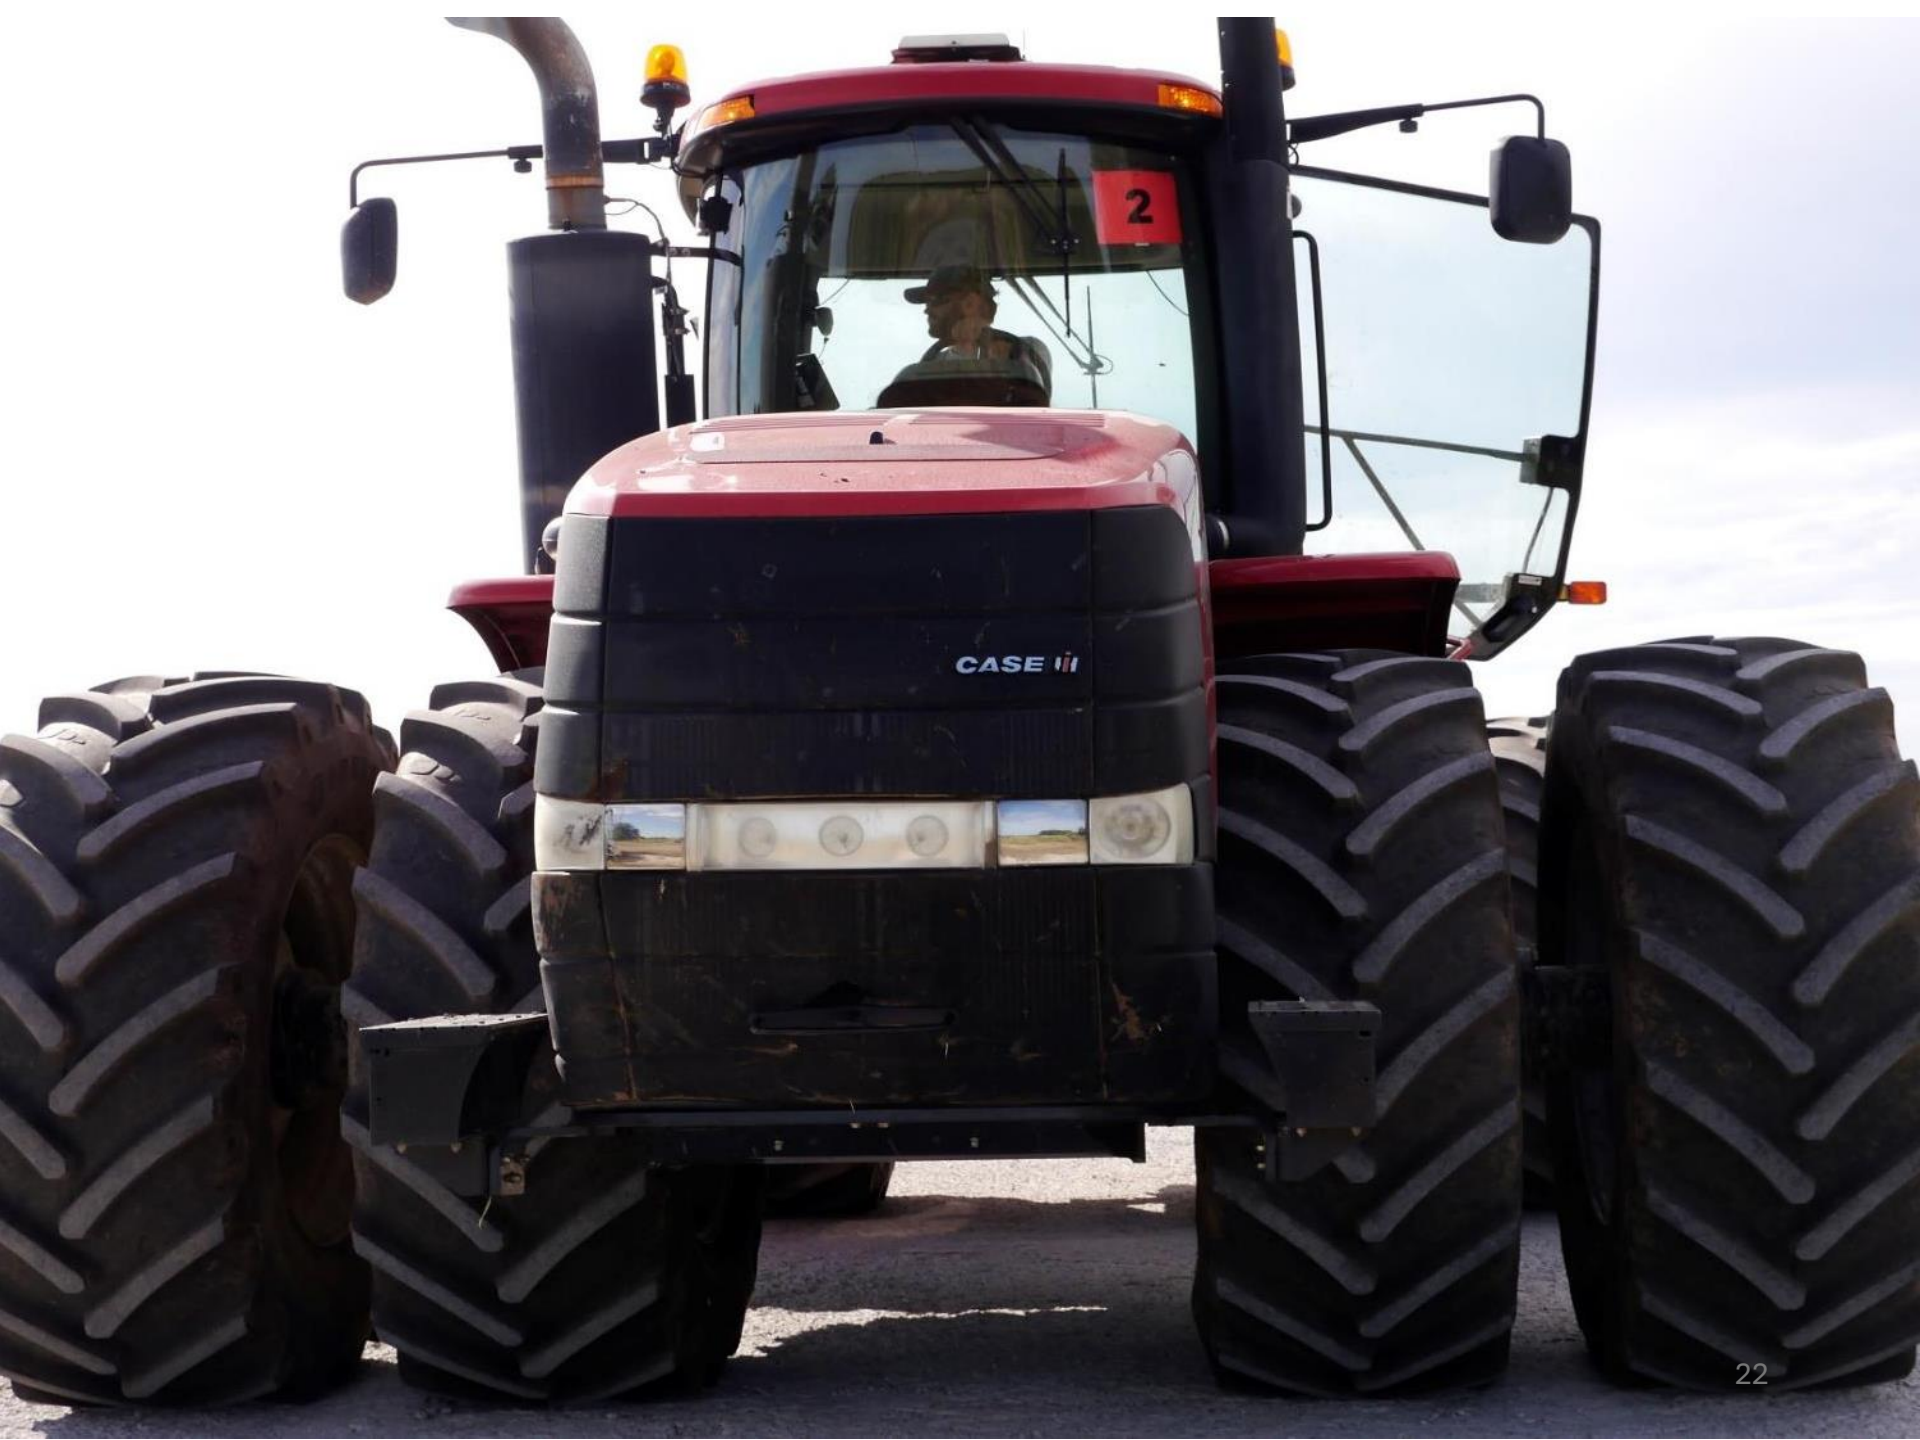
Exhibit: D2

**CaseIH Steiger 400HD
Dualled Articulated Tractor
w710s**

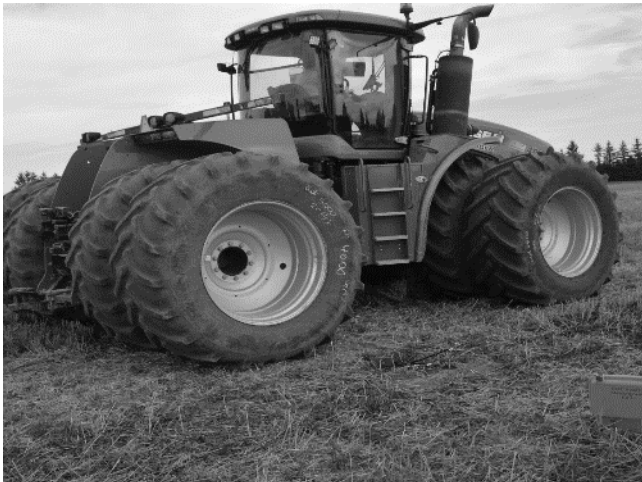
D2

Reis Tractor - Articulated CIH STX420 Duals - Wi

- This Unit was tested at the _3 installation.
- This is a wheel tractor, comparable stress at depth effect compared to D1 (tracked articulated Steiger) as even accounting for lighter axle weight

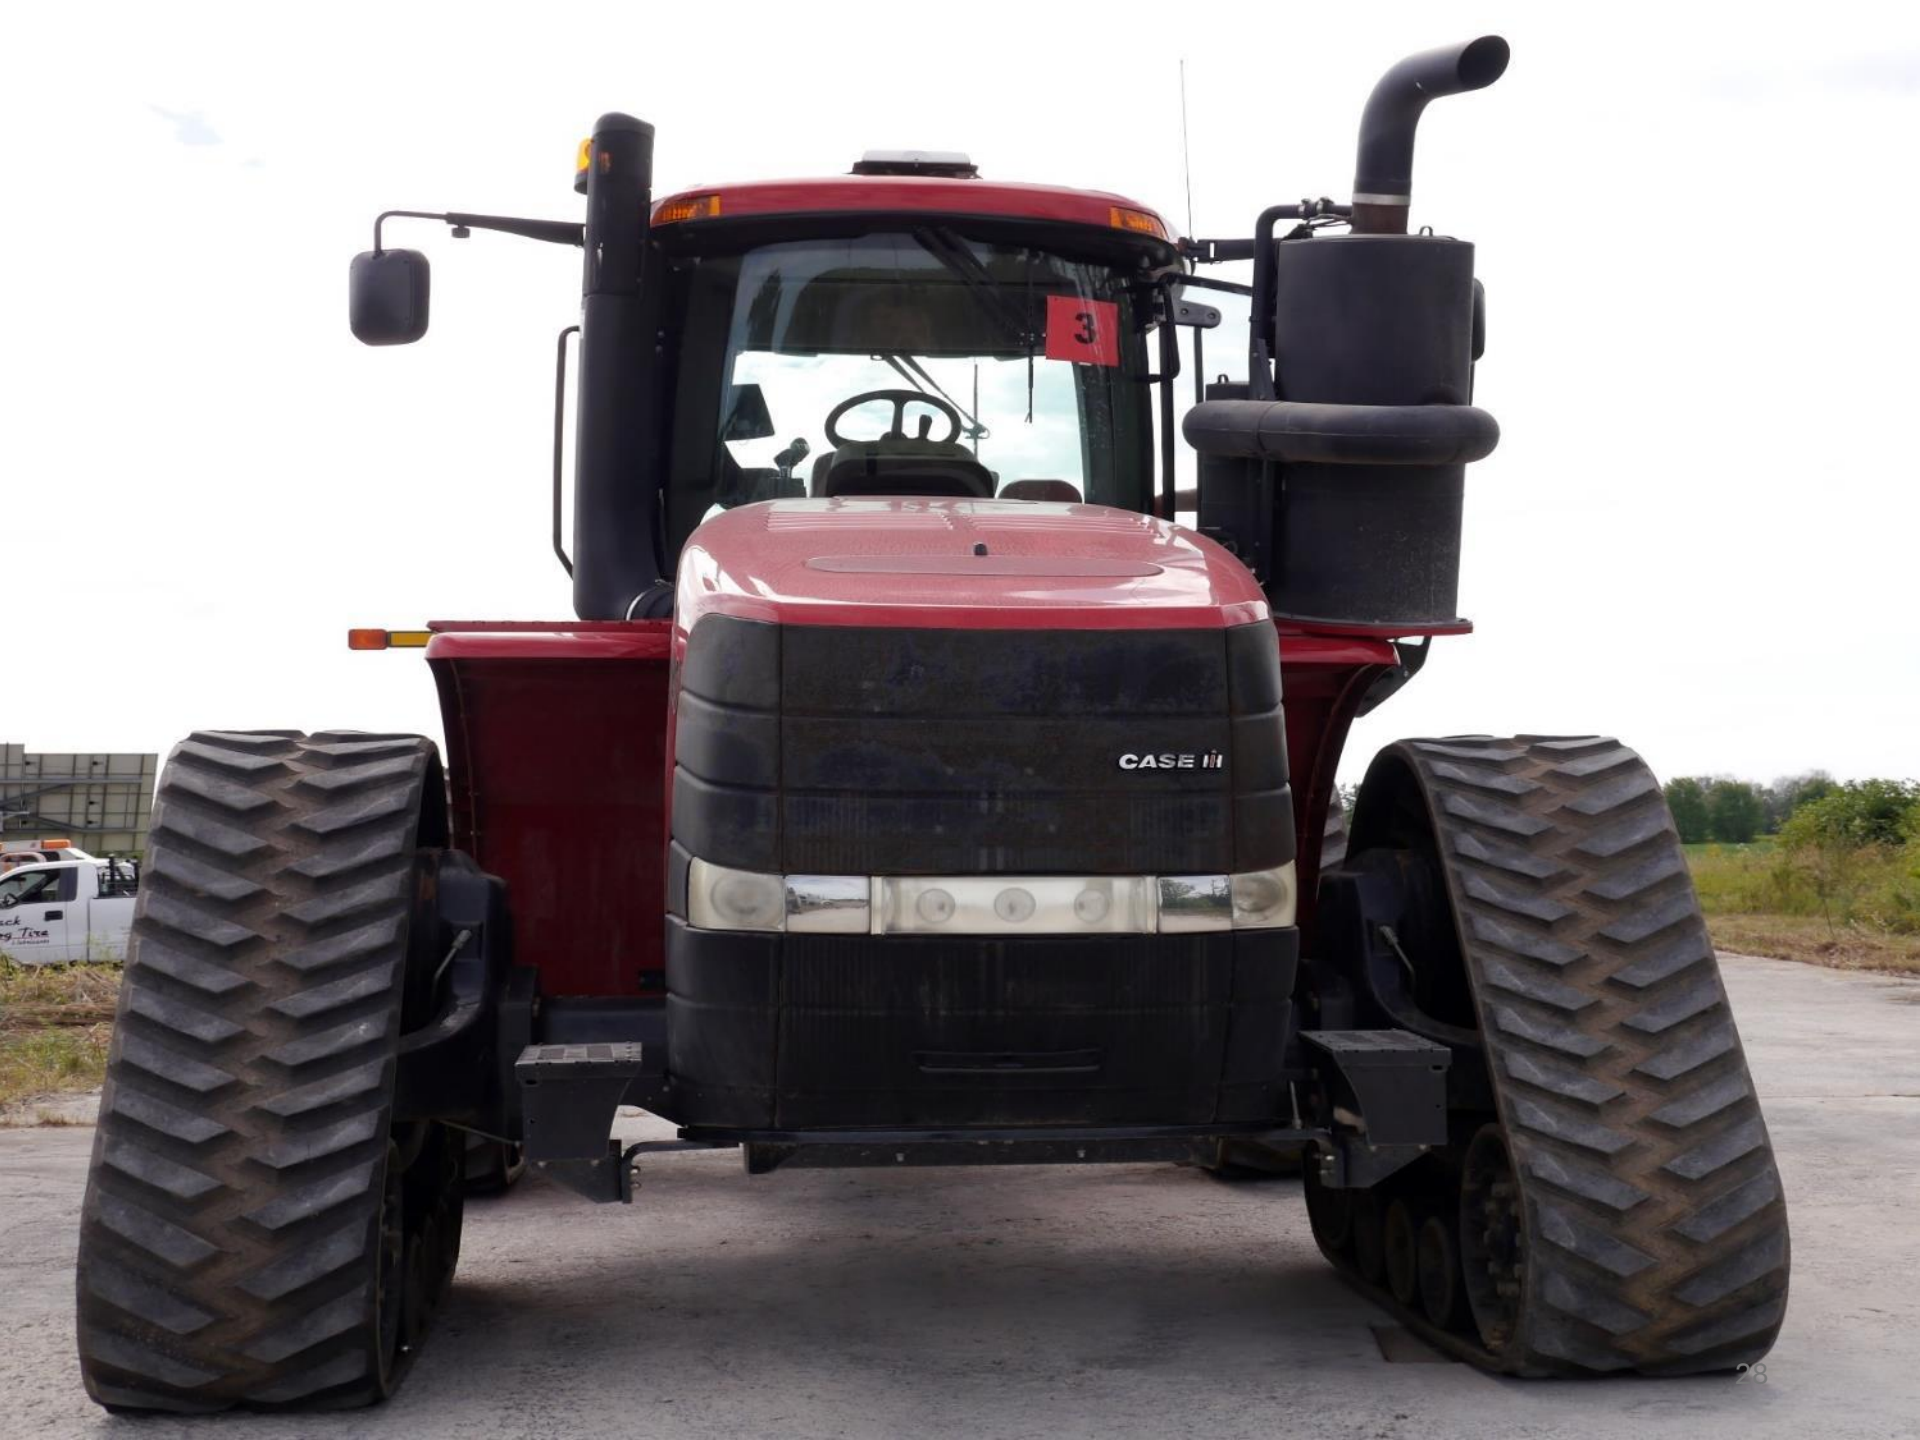
**Exhibit: D3
CaseIH Steiger 420 Tracked
Articulated Tractor**

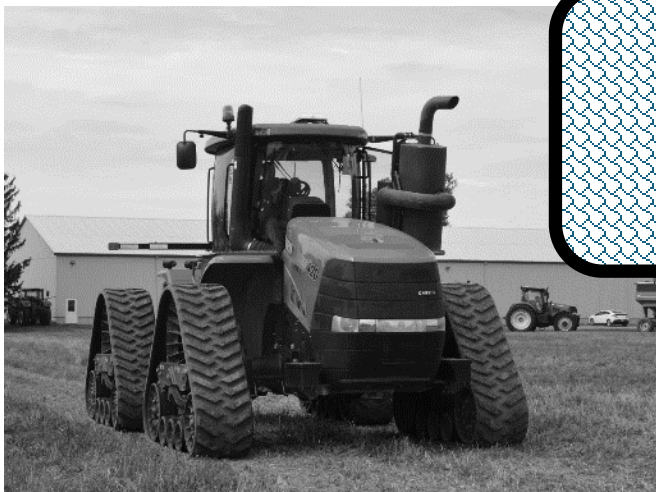
D3_OuterLug_1

Reis Tractor - Articulated CIH STX420 Tracks Narrow

- This is a good configuration for compaction avoidance.
- Similar results to D1 and D2, this unit we tested the distribution underneath the track.
- The sensor was aligned under the outer lug, inner lug and down the center of the track.
- The center of the track had slightly lower stress since there was no direct contact to the rollers.
- Also notice how only the mid rollers carried the weight of the machine.
- The grain buggy was a tracked unit. Notice the higher stress at all depths which is a concern with very heavy implements.

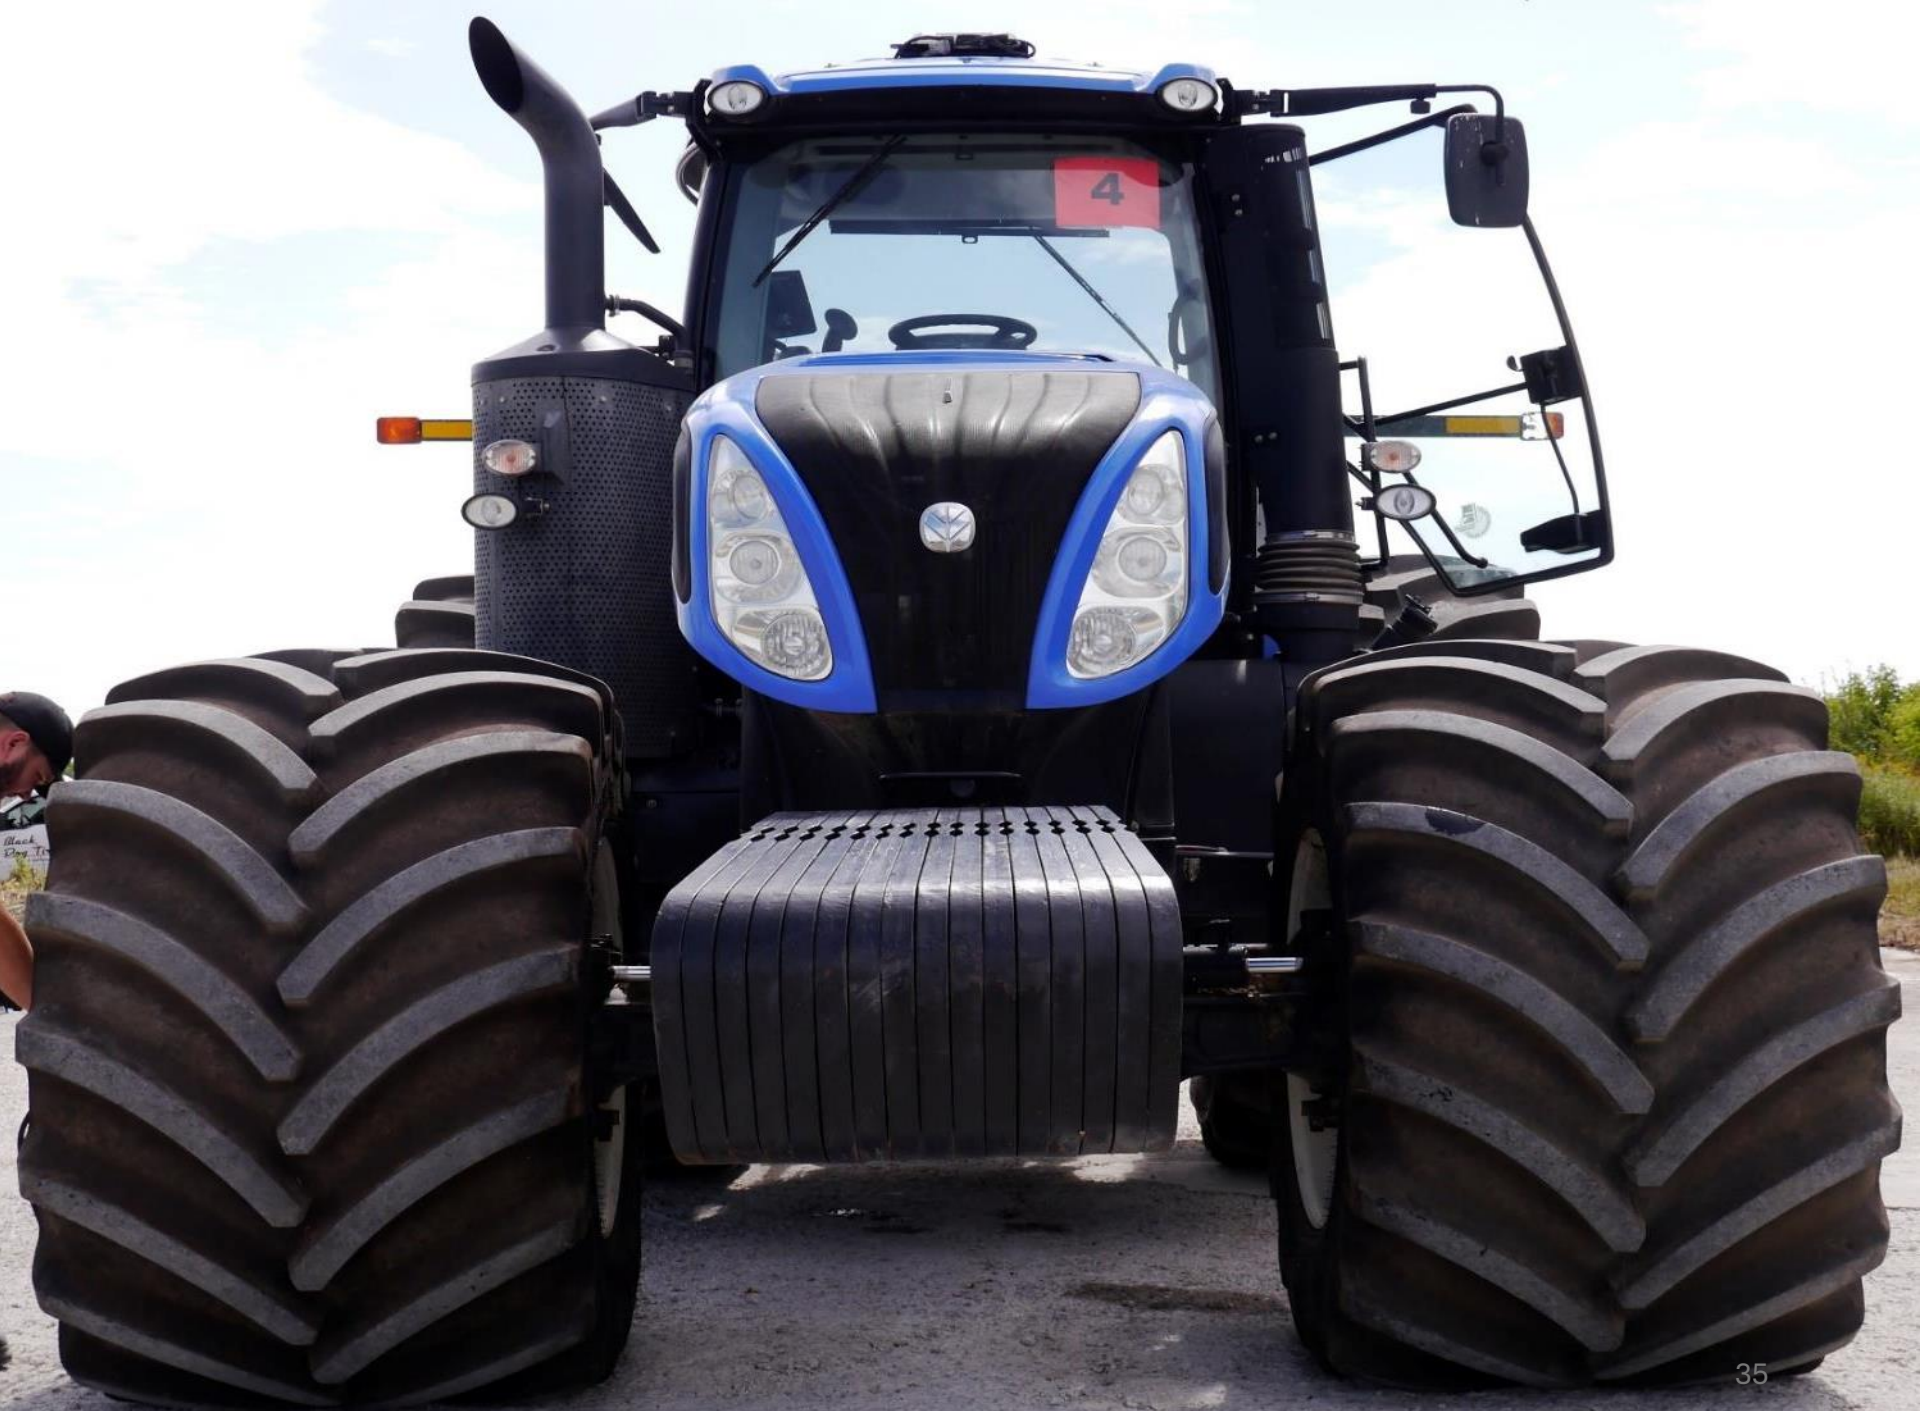
**Exhibit: D4
New Holland T8.380
w 1100 LSWs**

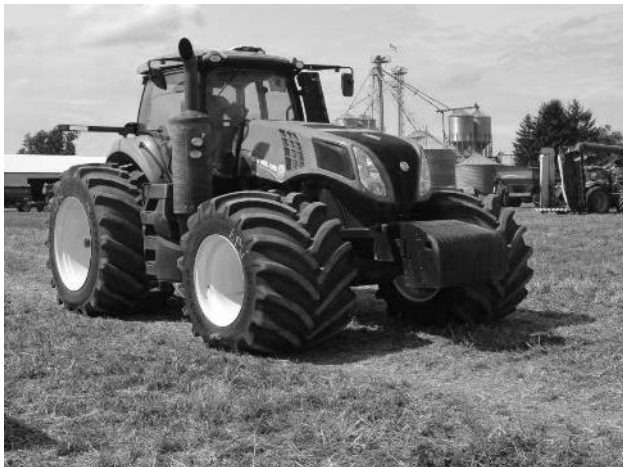
D4_1

Andy Corput Tractor - Row Crop NH T8.380 Singles - LSV

- Even with the large tires on this tractor, the total weight is still causing stress at depth.
- Stress at the surface is significantly lower than would be expected with a narrower tire at higher pressure.

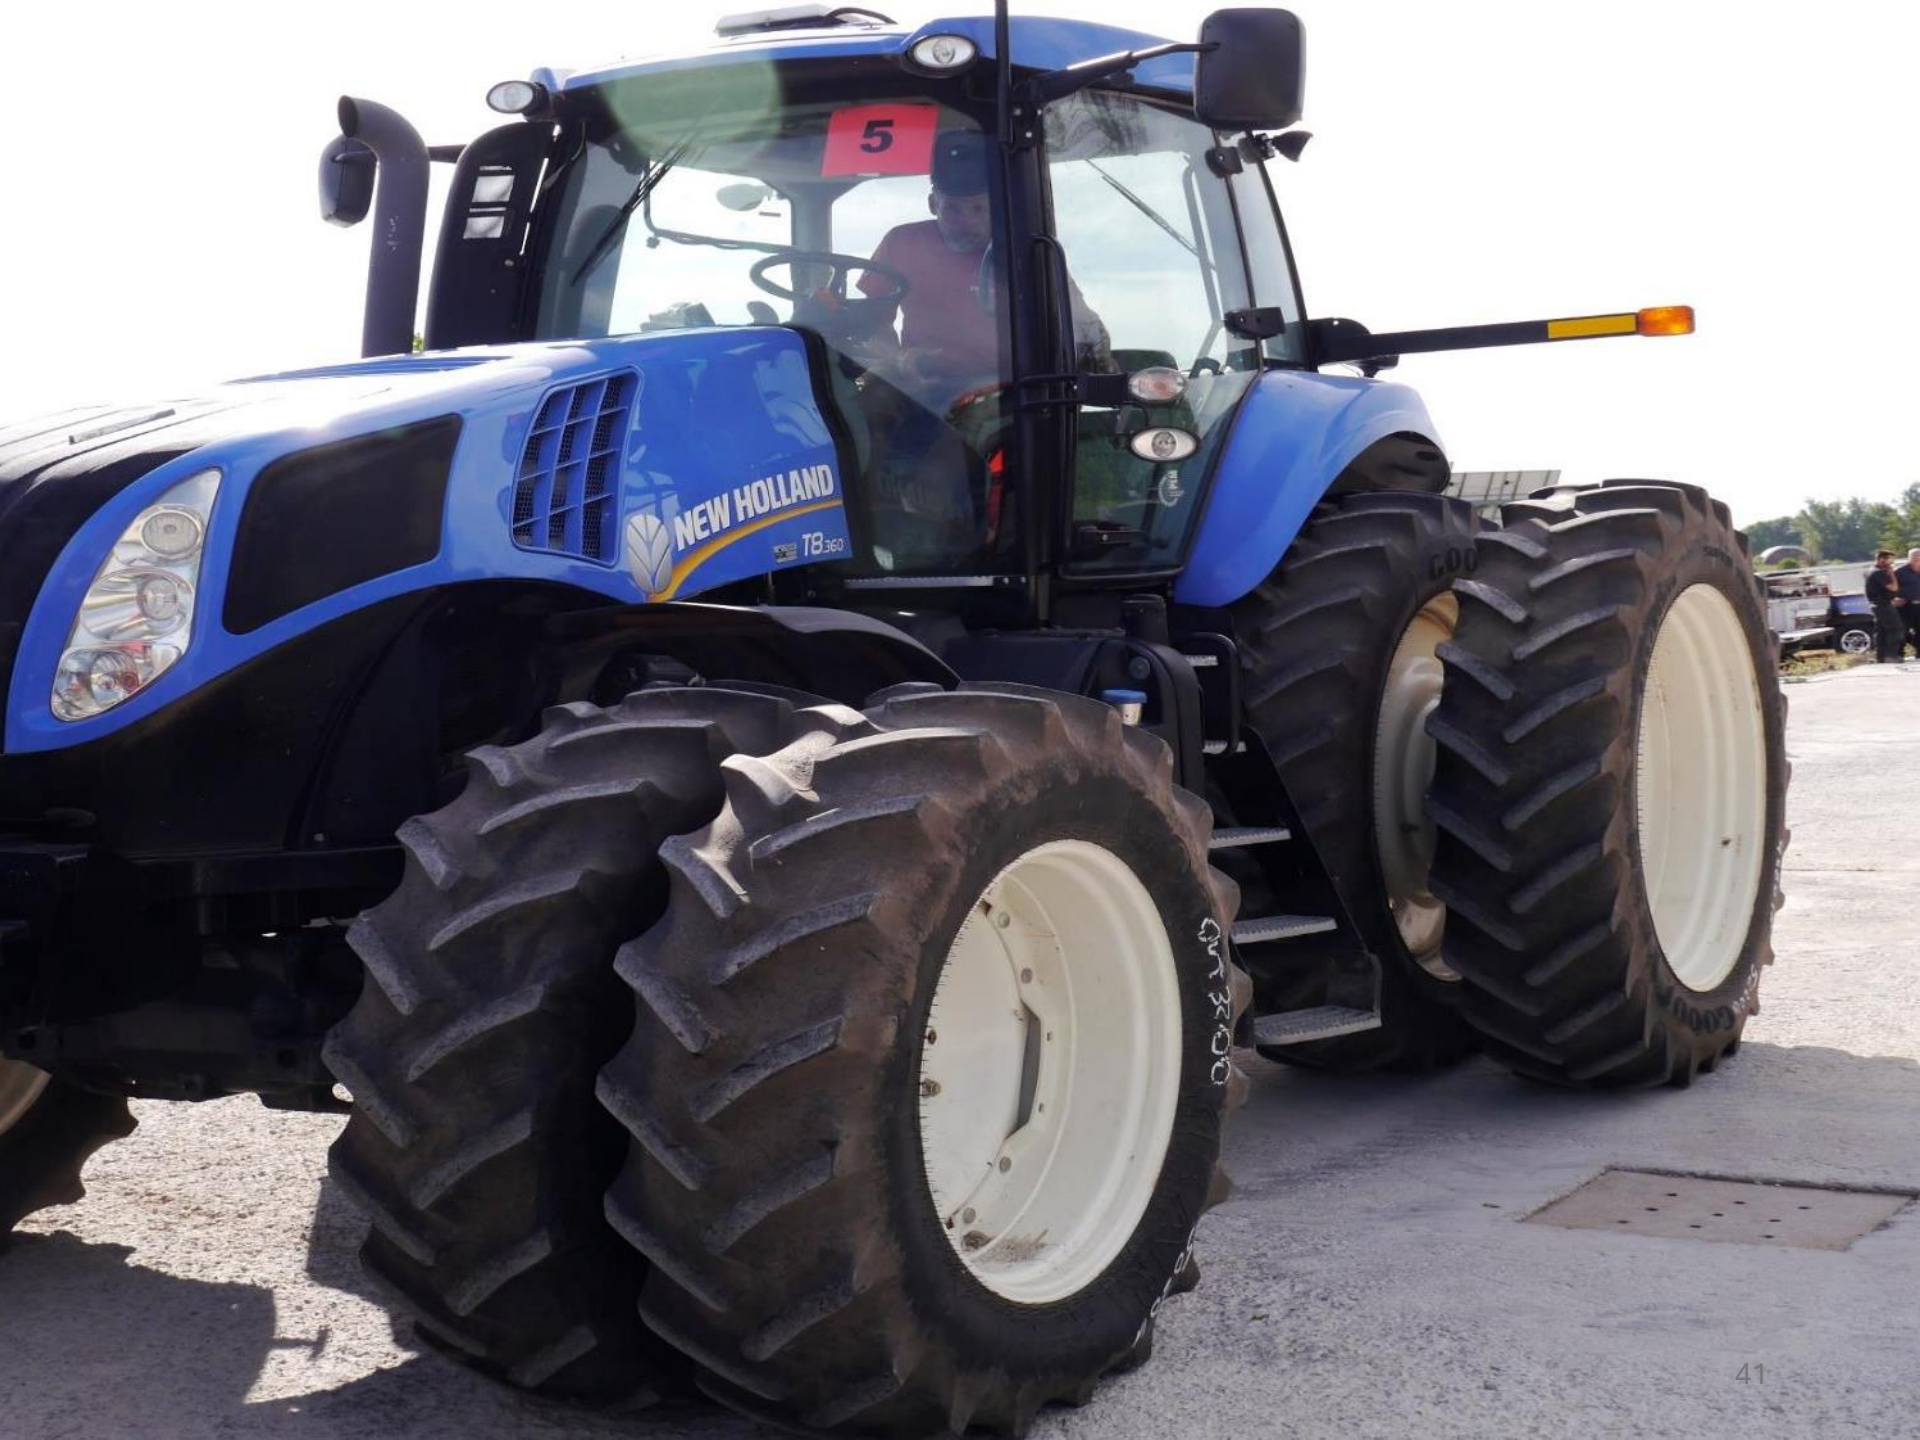
Exhibit: D5

**New Holland T8.360 Dualled
Row Crop Tractor w 480s**

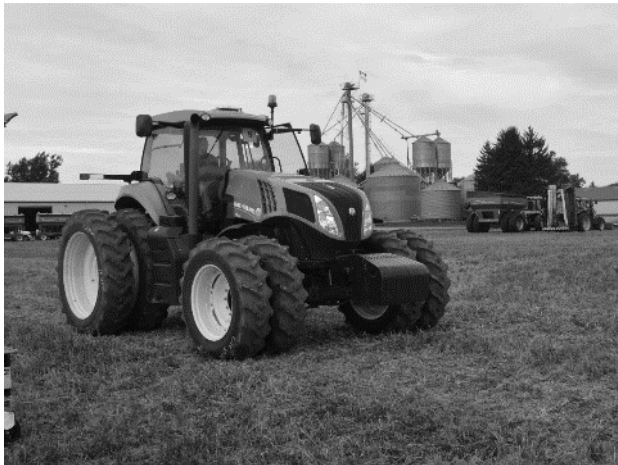
D5_R_1

Tyler Hoy Tractor - Row Crop NH T8.360 Duals - 480 x R5

- Similar stress at depth compared to D4 with LSW,
- The higher pressure tires compared to D4 mean a higher stress at 6 inch depth.
- This was the stress under the outer dual. It would be expected that stress under the inner duals would be higher as they have higher pressure and would carry more of the weight. Our equipment cant accommodate inside duals, which is why outside was tested.
- The two top graphs are from Pit 1 and he bottom Pit 4+5. Note how different pits can show different responses or response levels.

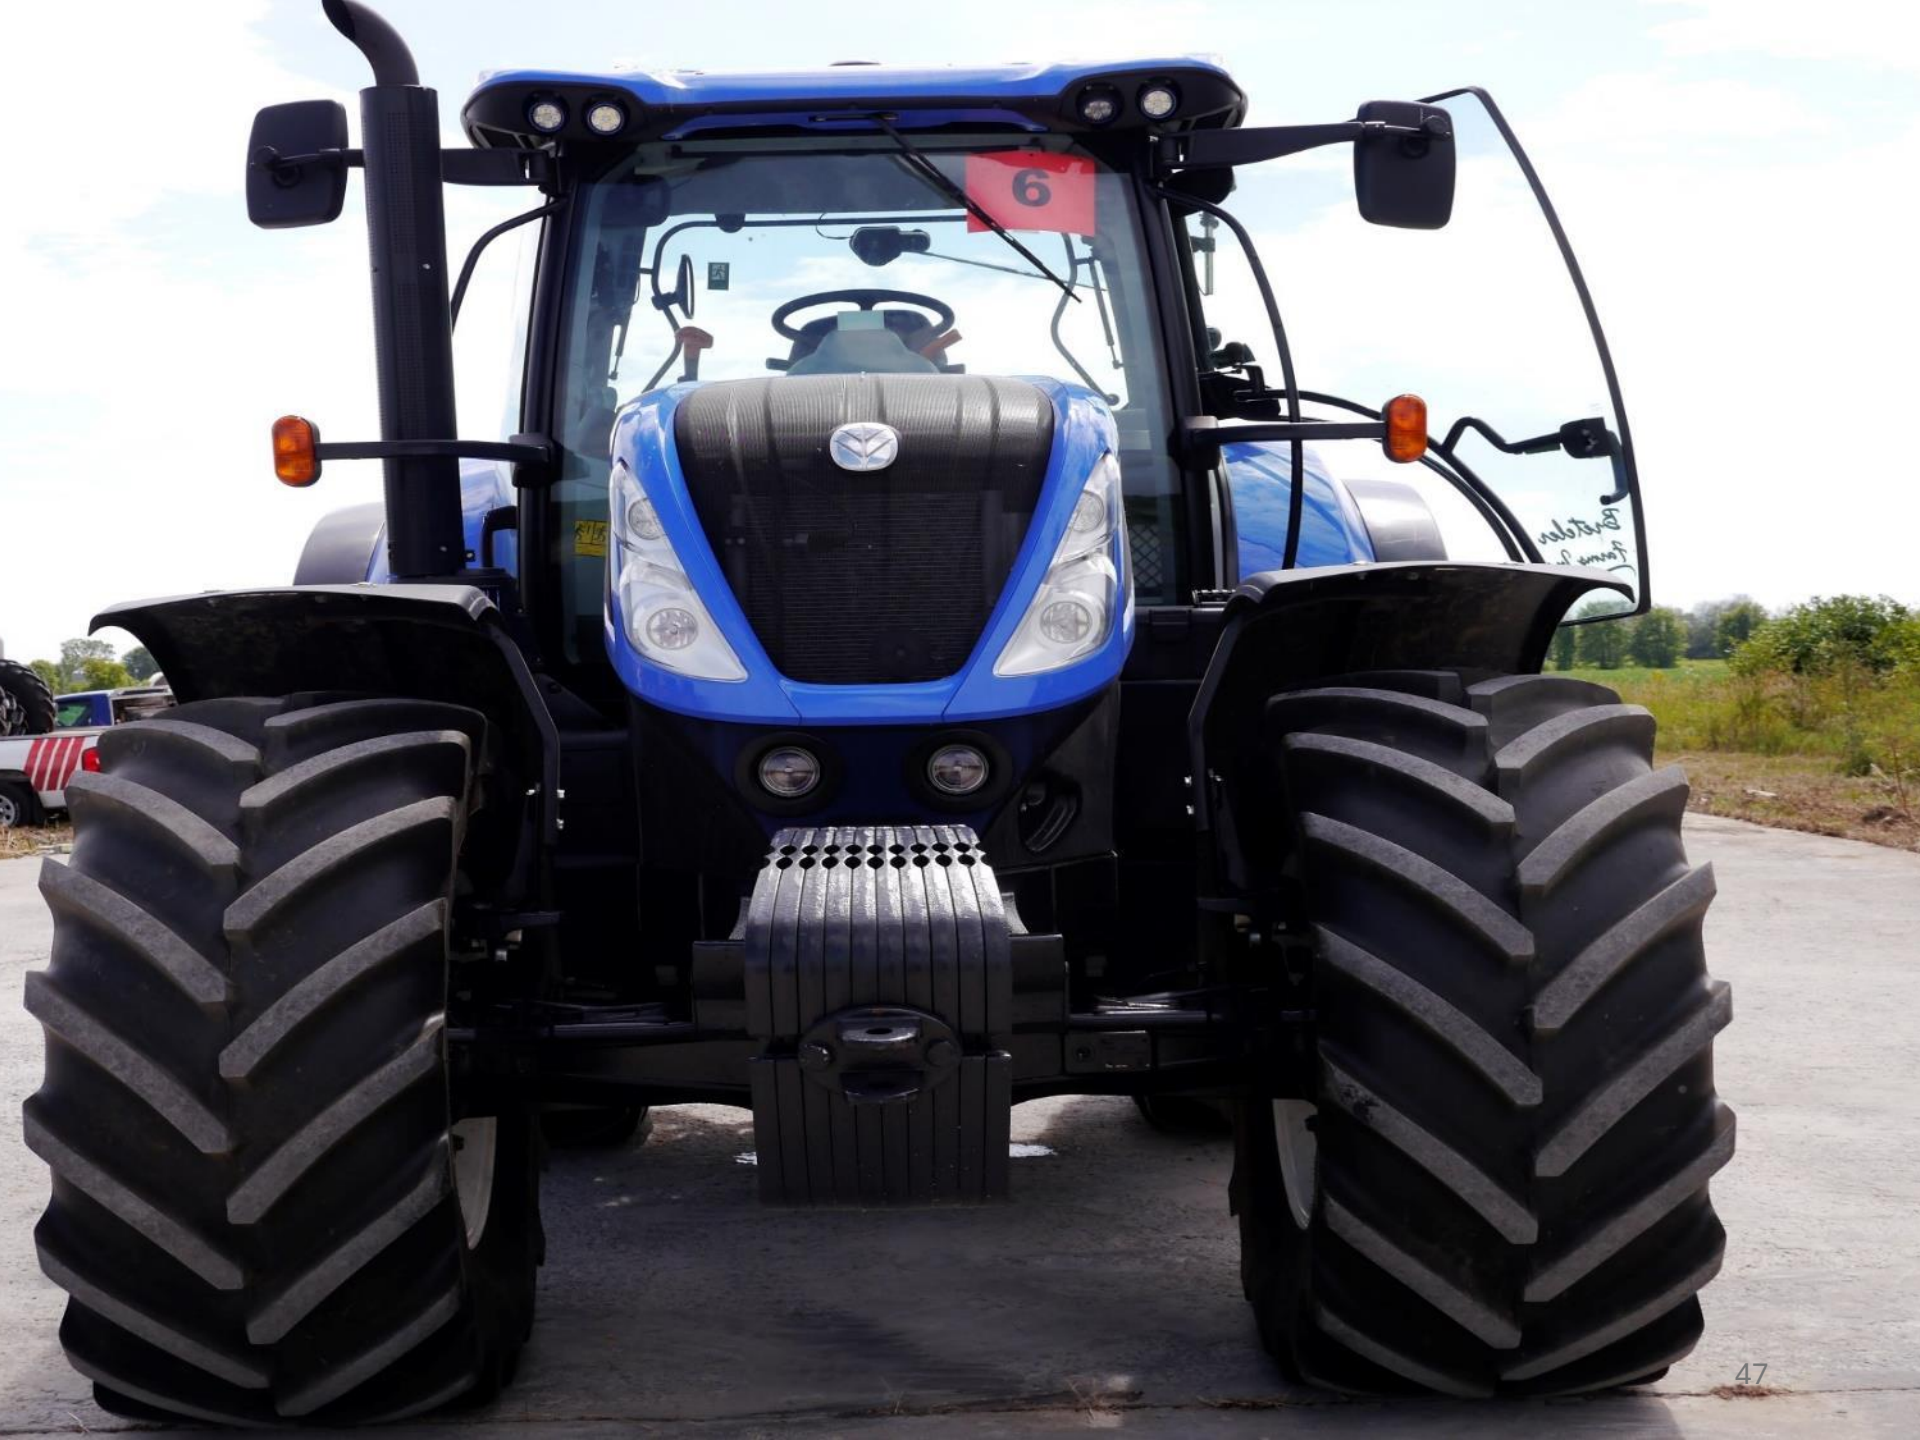
Exhibit: D6

**New Holland T7.230 Big
Singles Row Crop Tractor w
710s**

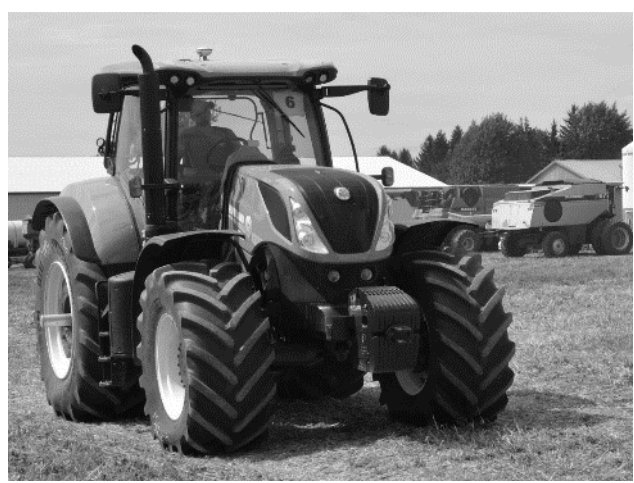
D6_1

Paul Bretler Tractor - Row Crop NH T7.230 Singles - 710 x

- This is a lighter tractor than the others tested. Slightly lower stress even with narrower tires.
- D6_D28_4 only the left two peaks are the tractor.
- The _4 sensor location had significantly more moisture in the top 12 inches which would explain the higher stresses in the top two sensors at this location.
- This speaks to the variability of soil even in close proximity that makes the responses from individual exhibits problematic in interpretation.

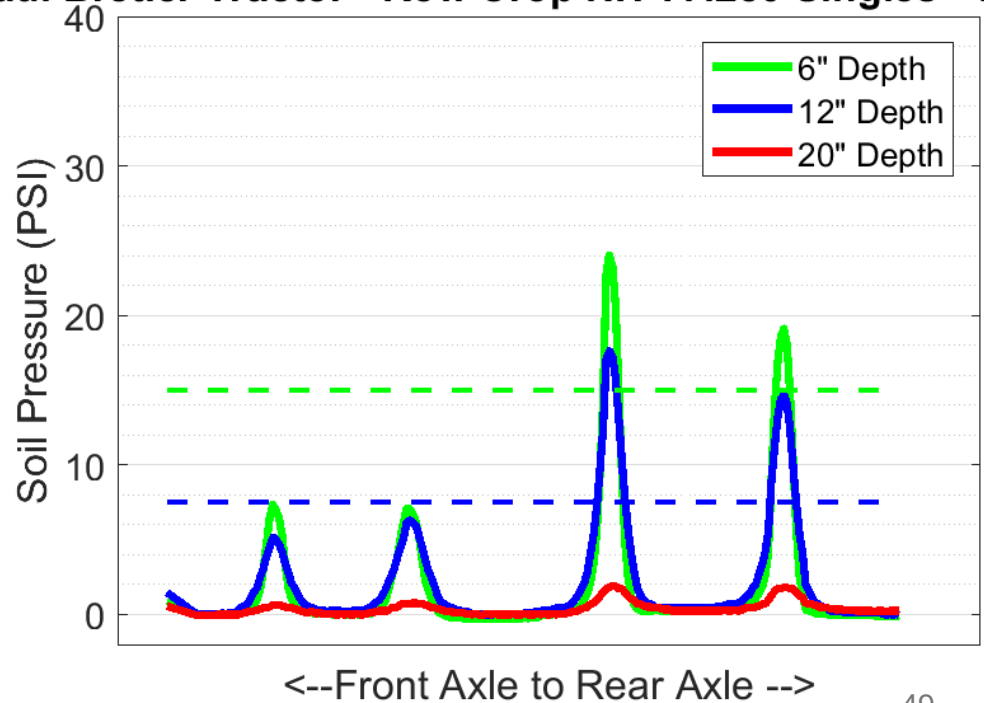
D6_D28_4

Paul Bretler Tractor - Row Crop NH T7.230 Singles - 710 x

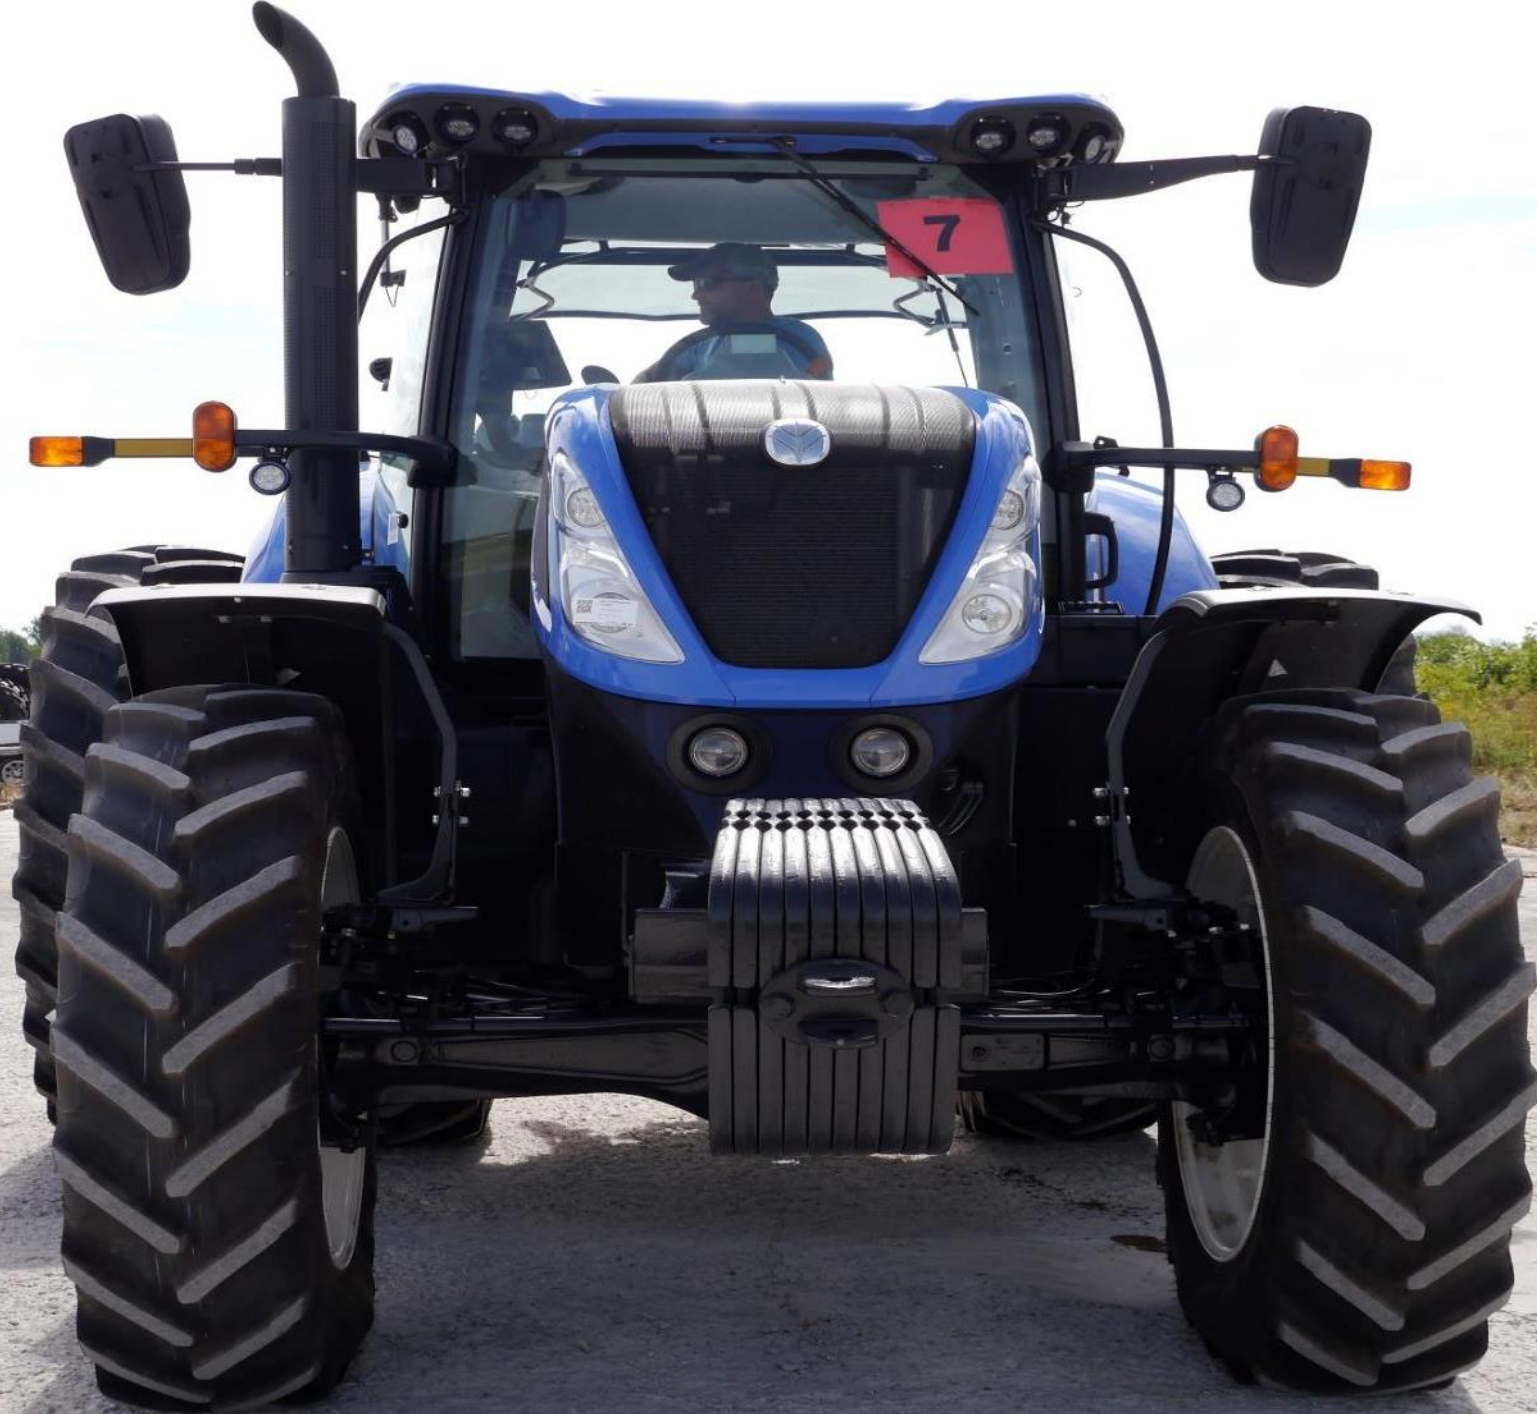
Exhibit: D7

**New Holland T7.260
Dualled Rear Row Crop
Tractor w 480s**

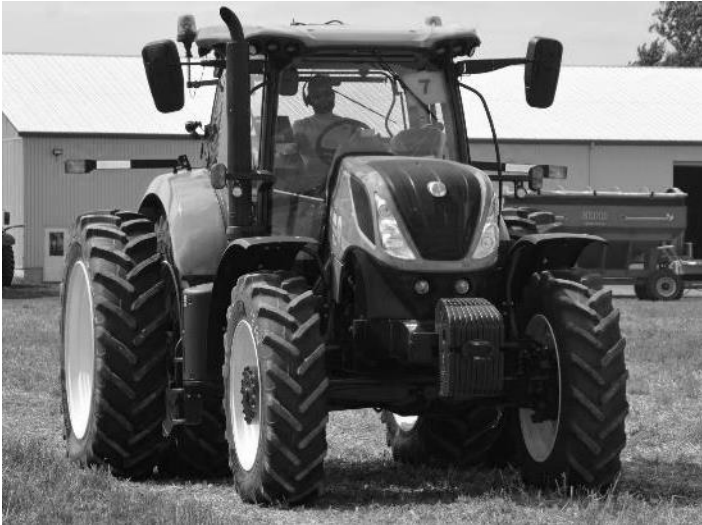
WFS Tractor - Row Crop NH T7.260 Duals - 480 x

- The first plot D7_1 is the outer rear dual. This tire would not be carrying an equal load as the inside dual is at a higher PSI.
- The inner dual show a higher stress under the front tire which would be expected due to the much higher tire pressure.
- In the 3rd graph the tractor tires are enclosed in the red boxes. The other response curves are from Exh: 27, a gravity wagon.
- The tractors soil stress is much lower at all depths than the Gravity Wagon (see Exh: D27).
