2019 Dundas SCIA Compaction Event

Winchester, Ontario

August 29th, 2019

Dundas SCIA Compaction Event

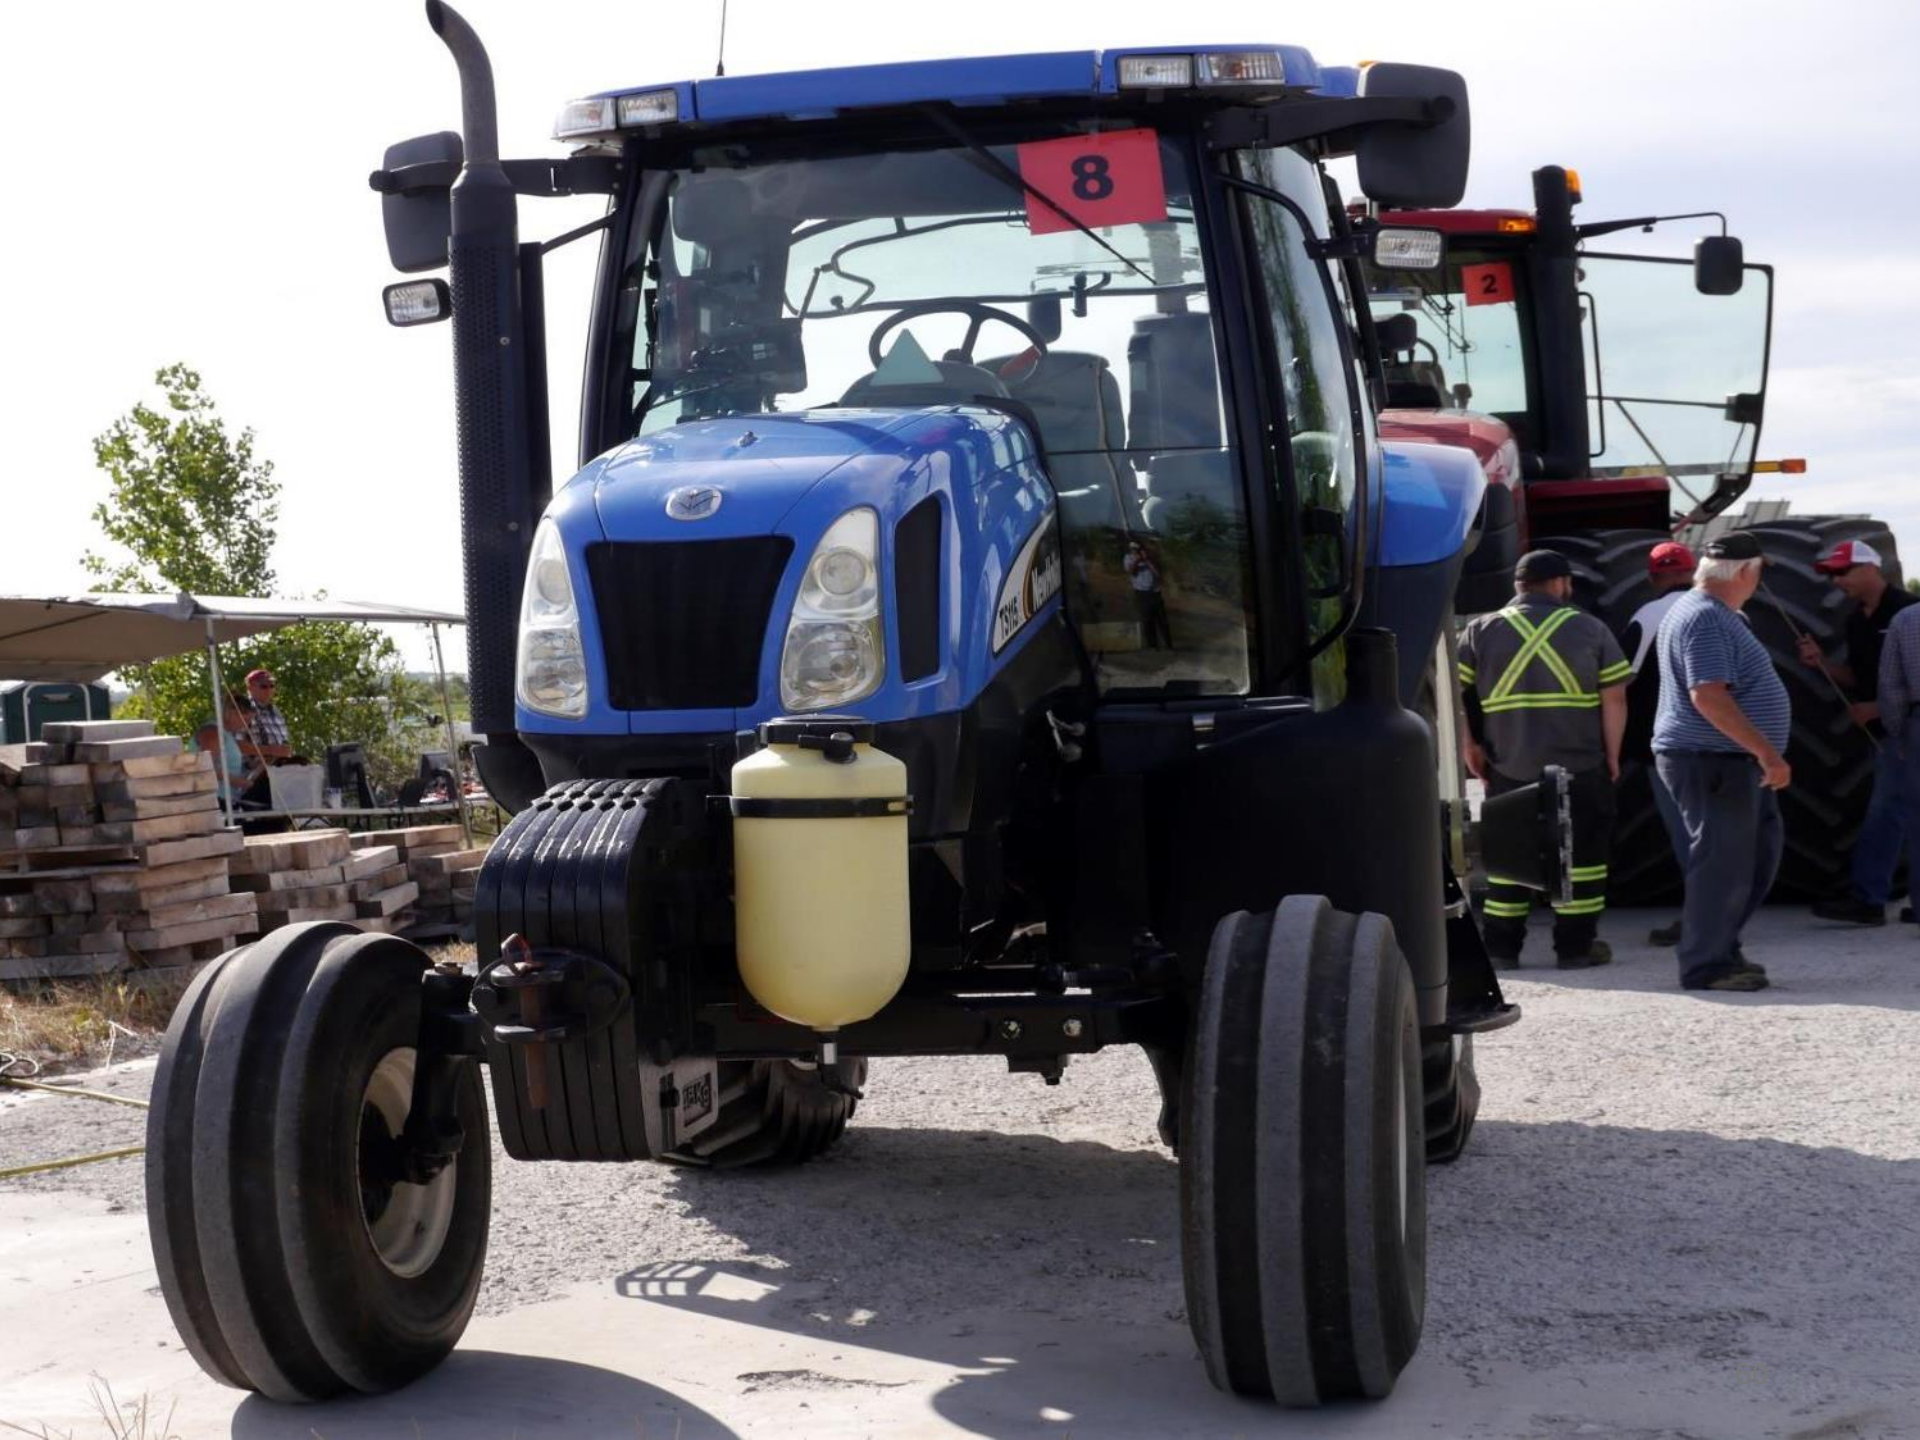
Exh: D8

**3,500
380/90R46**

**2,400
11.00-16**

**New Holland TSI15A
12,080 lbs (5.5T)**

**3,700
380/90R46**

17 PSI

**2,480
11.00-16**

25 PSI

- This is a much light tractor but has significantly high tire pressures and narrow widths
- The front tires are Bias and have a round contact profile.
- The higher stress at 6 inches is an effect of the high tire pressure.
- Lower stress at depth compared to other heavier tractors is due to the much lower overall weight.

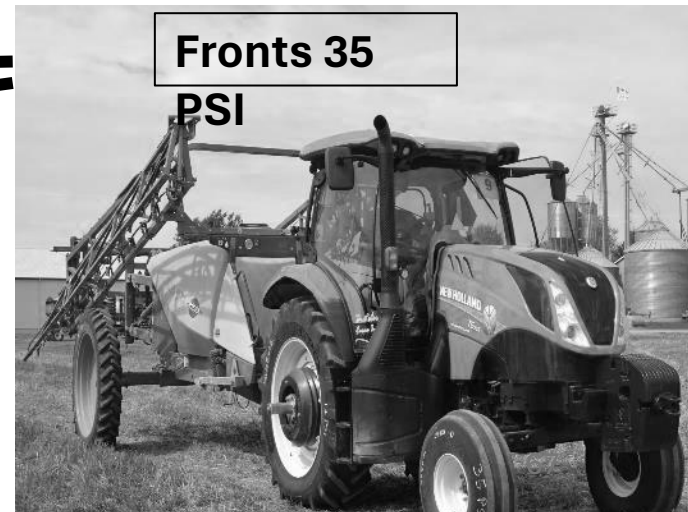
D9_Justsprayer_1
retler Tractor - Row Crop w PTSpr NH T6.155 Single

- Very narrow and high pressure tire on the sprayer combined with a heavy load means increase stress at all depths.
- The D9_justtractor_1 plot shows the tractor driving over the sensor and backing up over the sensor again to avoid the sprayer damaging the measurement equipment.
- The middle peaks on the plot are the rear tire of the tractor. The rear tire had more weight due to the tongue weight of the sprayer, increasing the stress at 12 inches.

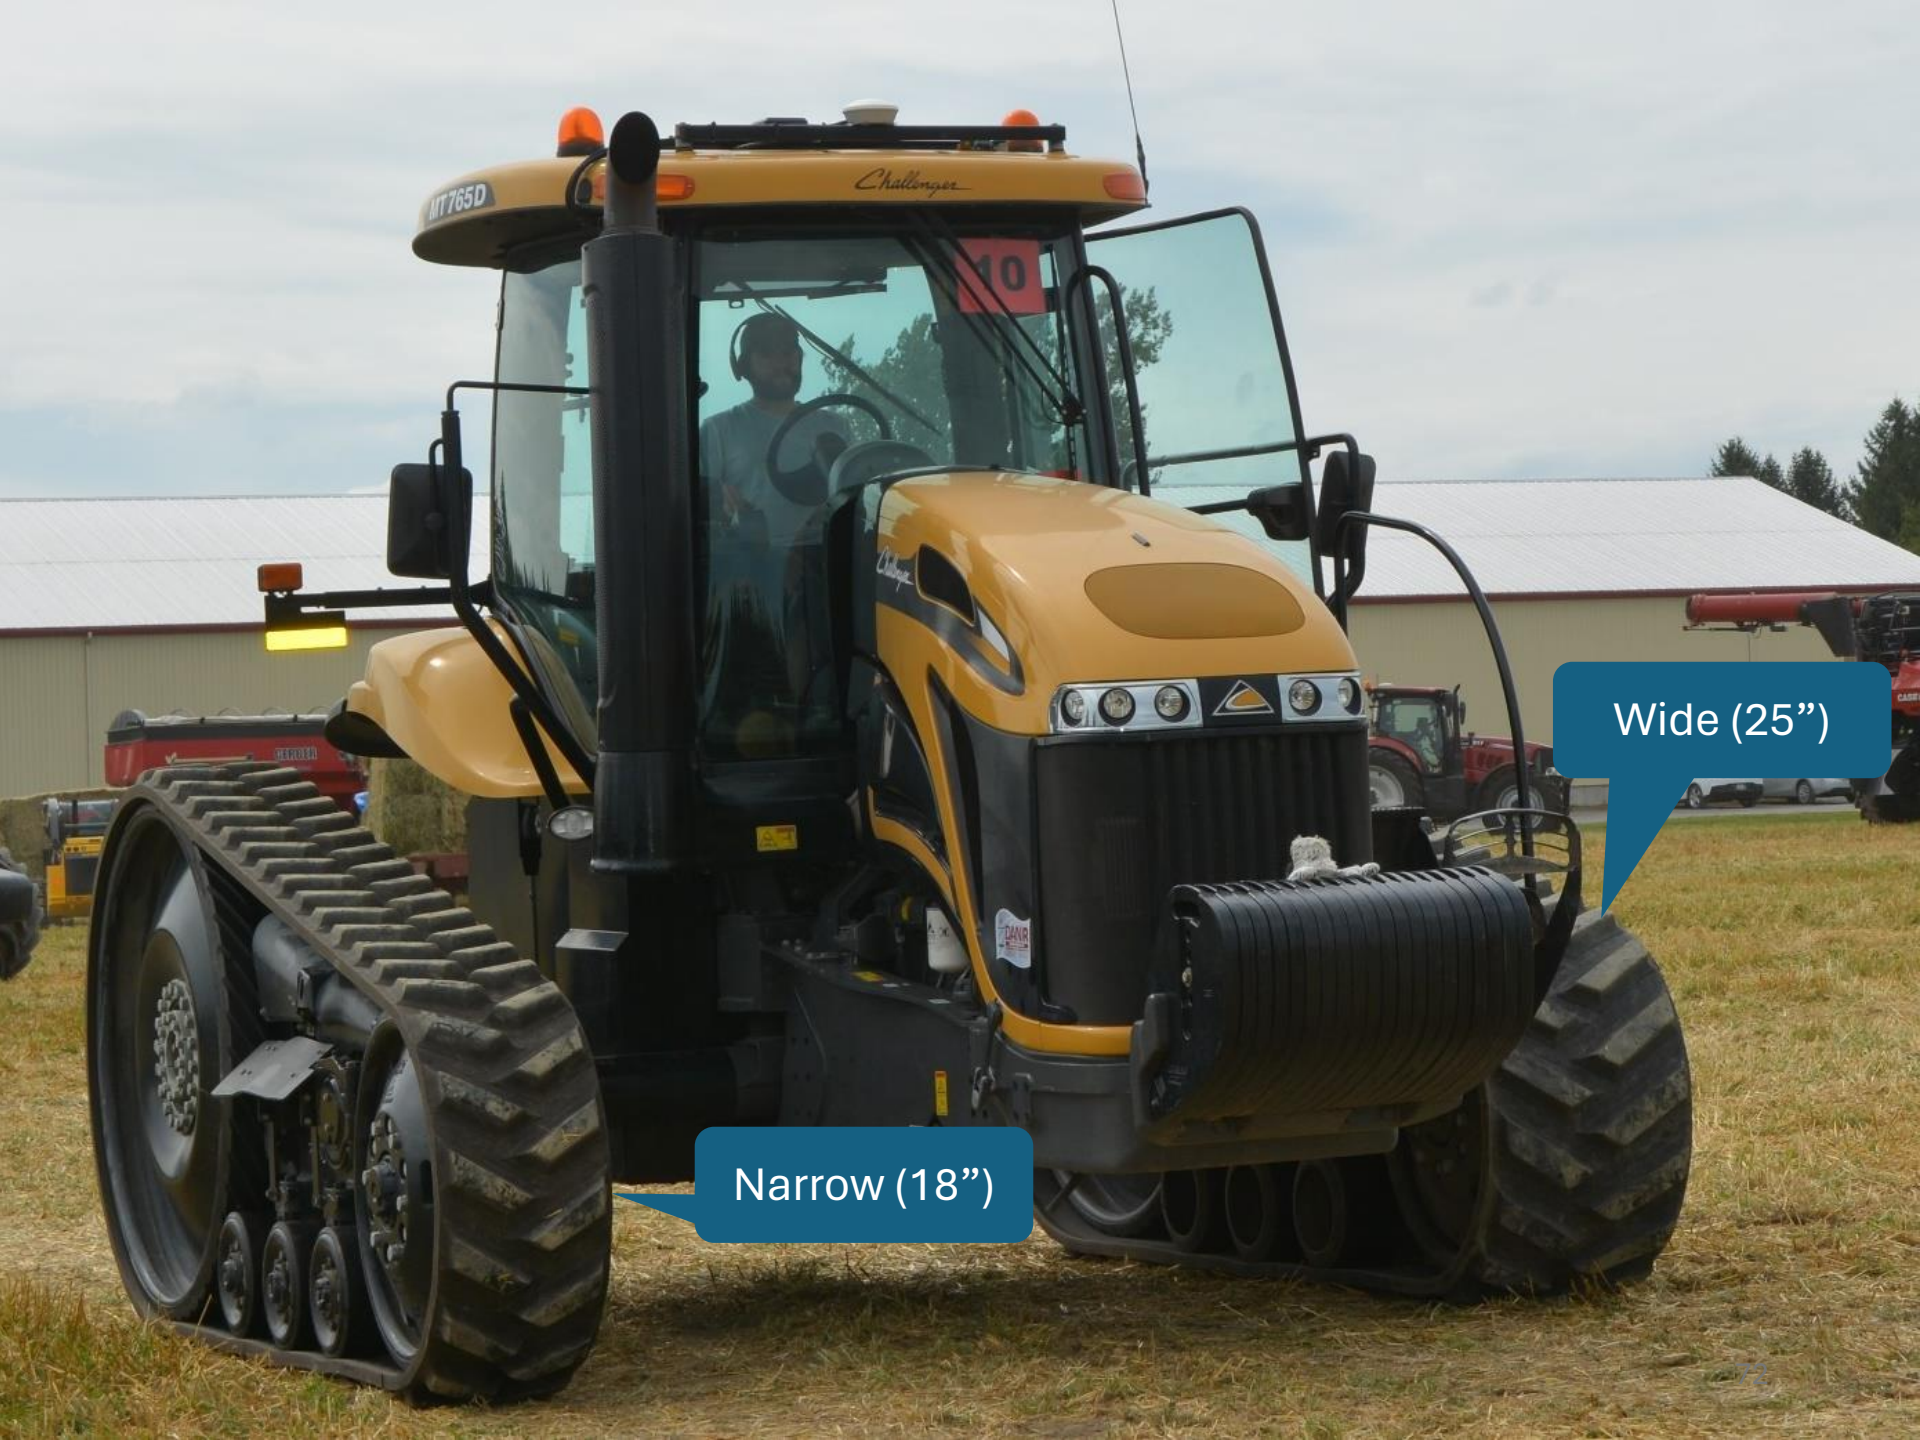
Exh: D10

Wide (25")

Narrow (18")

17,120
97 X 25'' Track

Challenger MT 765D
33,540 lbs (15.2 T)

16,420
97 X 18'' Track

- The weight of this machine can be distributed over a wider track and reduce the stress at 6 and 12 inches.
- However, the stress at 20 inches was very similar for both the wide and narrow tracks since total weight is what drives compaction deeper and can only be offset by lightening the total load.

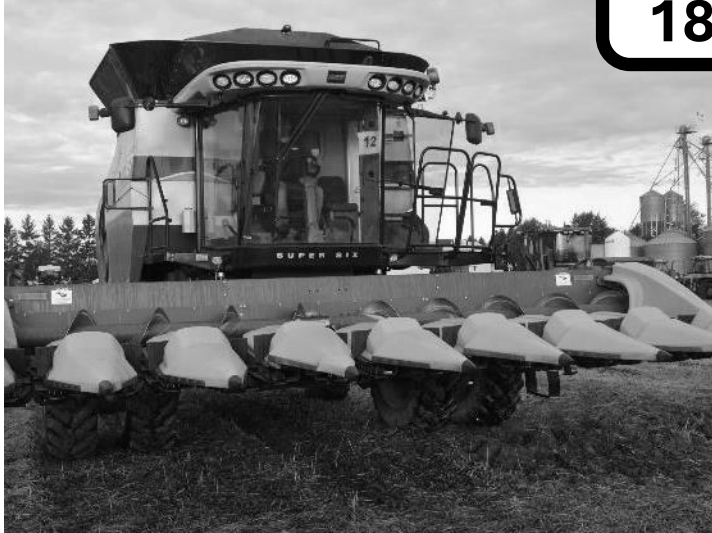
D12_outerdual_3

- This combine shows a similar trend to most combines
 - Heavy weight will tend to show more stress at depth
- Relatively narrow dual wheels at 30psi is on the poor end of a combine setup.

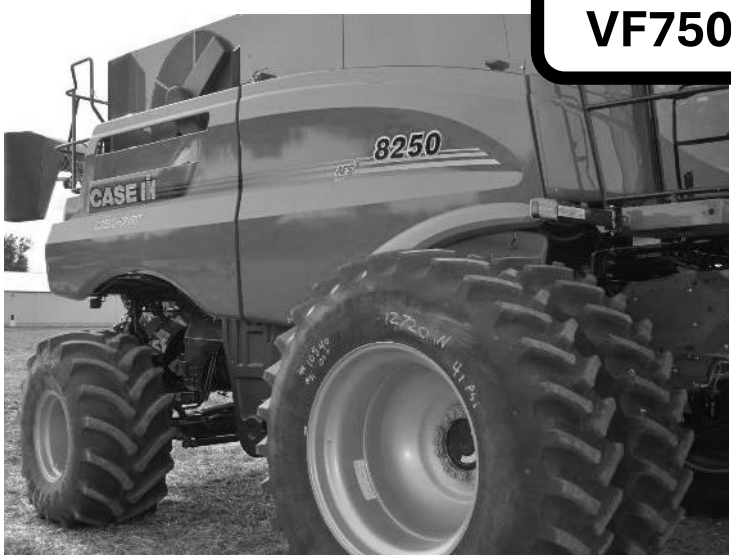
D16_reartire_2
Reis Combine CIH Duals IF

- This combine, although it was sporting IF dual radial tires, still had 41 PSI, where we should be targeting less than 20 and preferably less than 15 if not lower.
- This is seen in the plot with very high stress at the surface

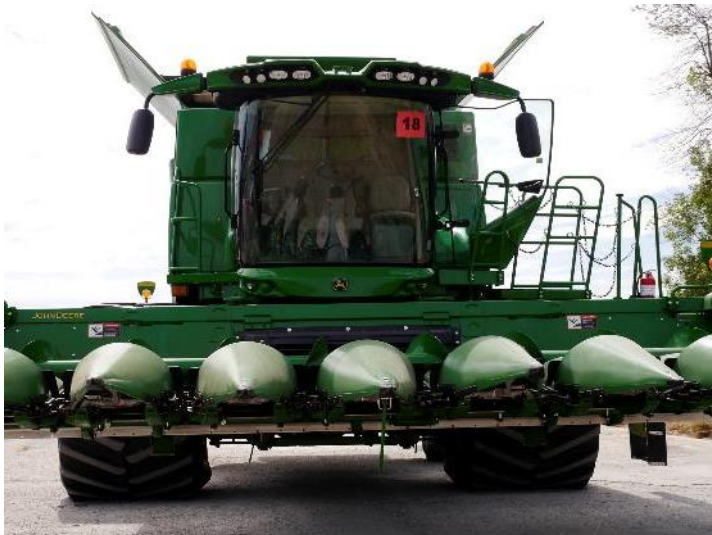
D18_1

- Large tires at a moderate pressure again show lower stress in the upper soil but note the Blue and Red curves near the dotted blue line, this is cause for concern.
- Heavy weight is apparent with the stress at 20 inch depth for Pit 1 and 5. Different from Pit 4 and reinforces the issue about changes in soil and moisture between pits in the same field.

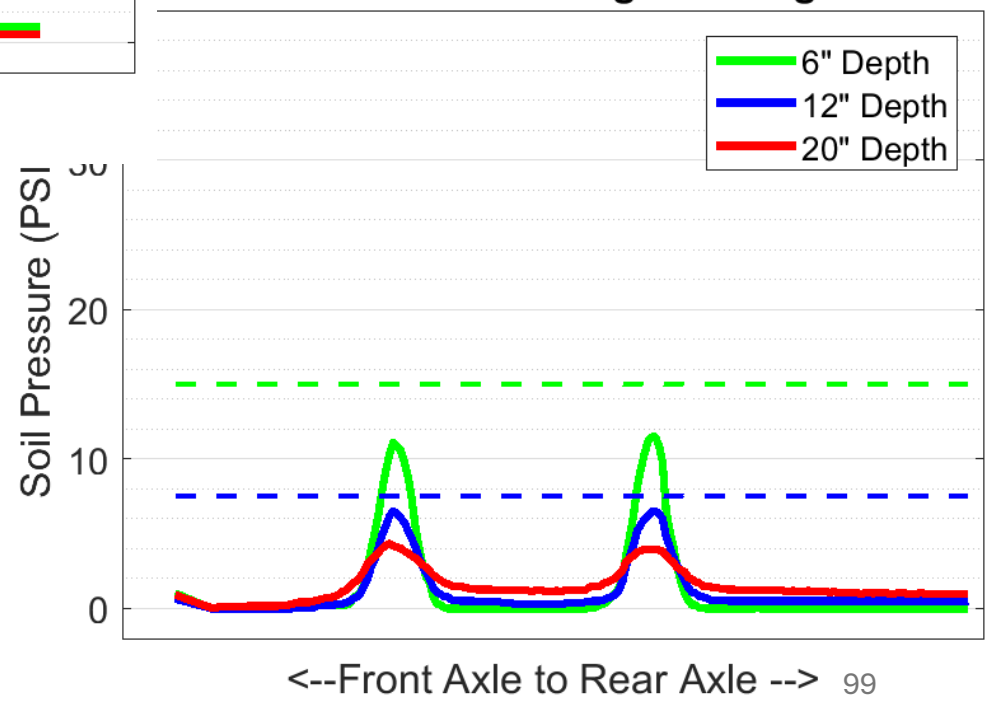
D18_5

Woerlen's Combine JD Singles - Large Flotation

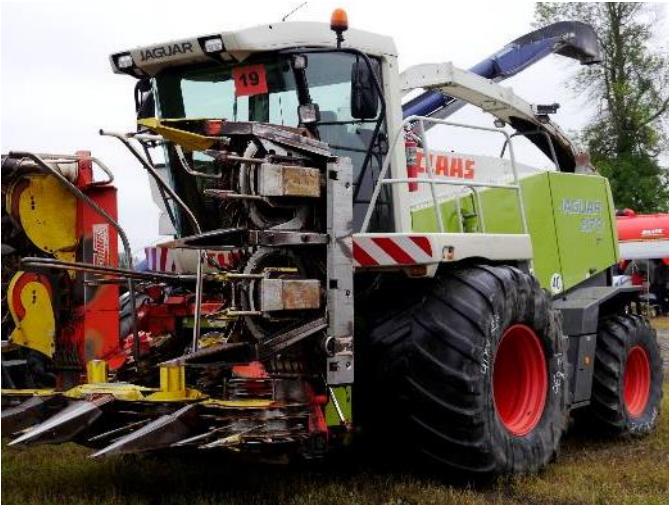
D19_3

Owner operates at 25 but tire rec is 41 psi

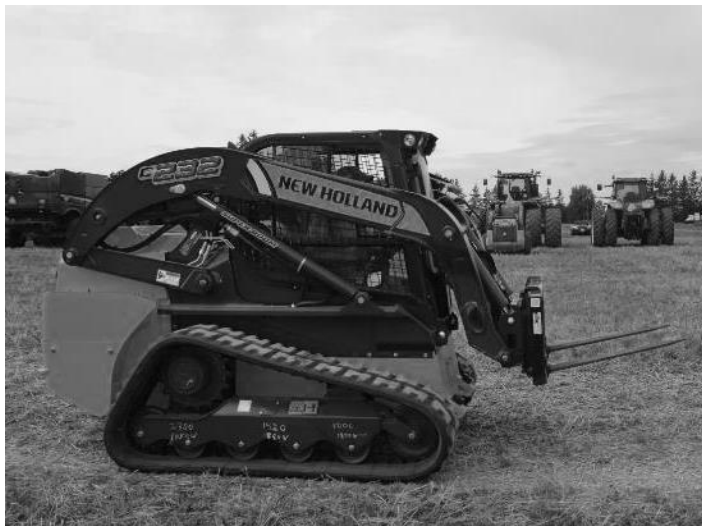
D20_again_1
WFS? Skidsteer NH Tracks

- This a light machine so stress is low
- When the bale is carried you can see the slight shift of pressure to the front rollers on the track represented in the plot.

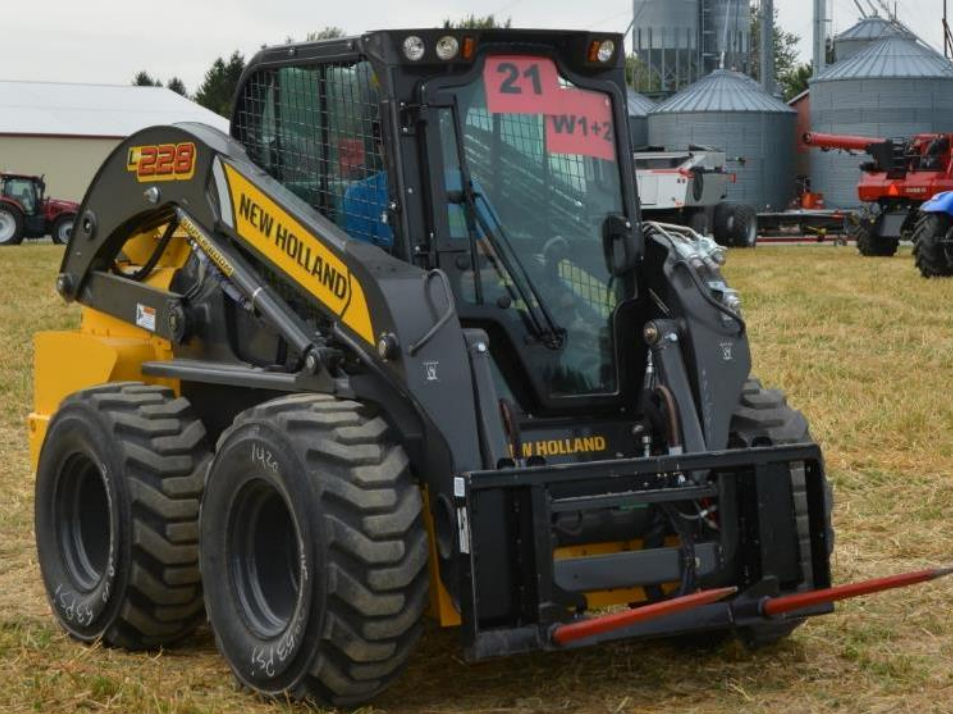
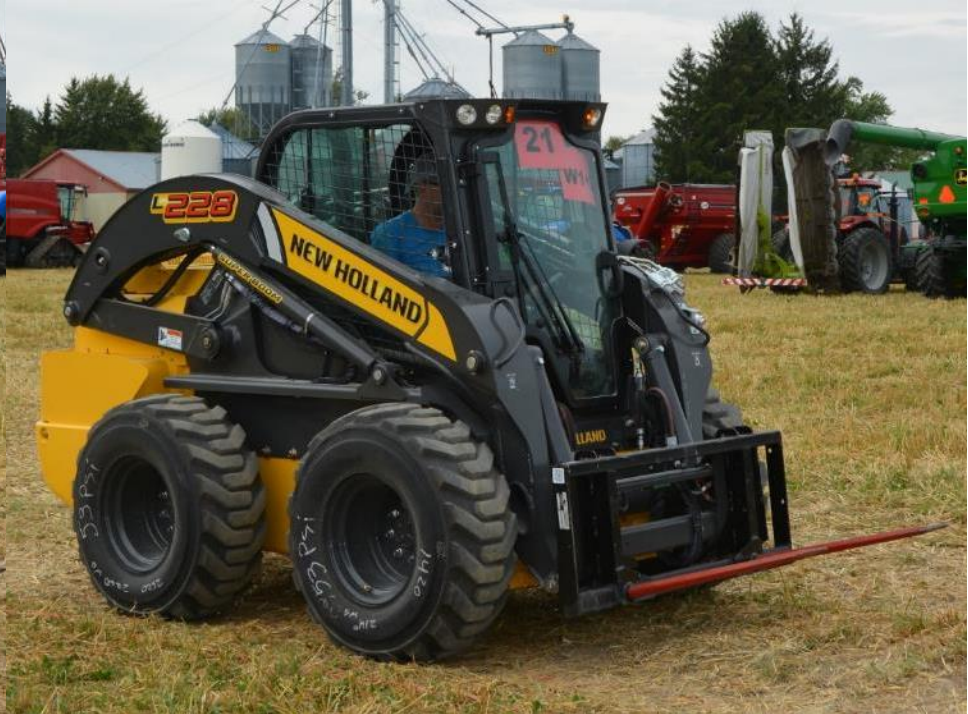
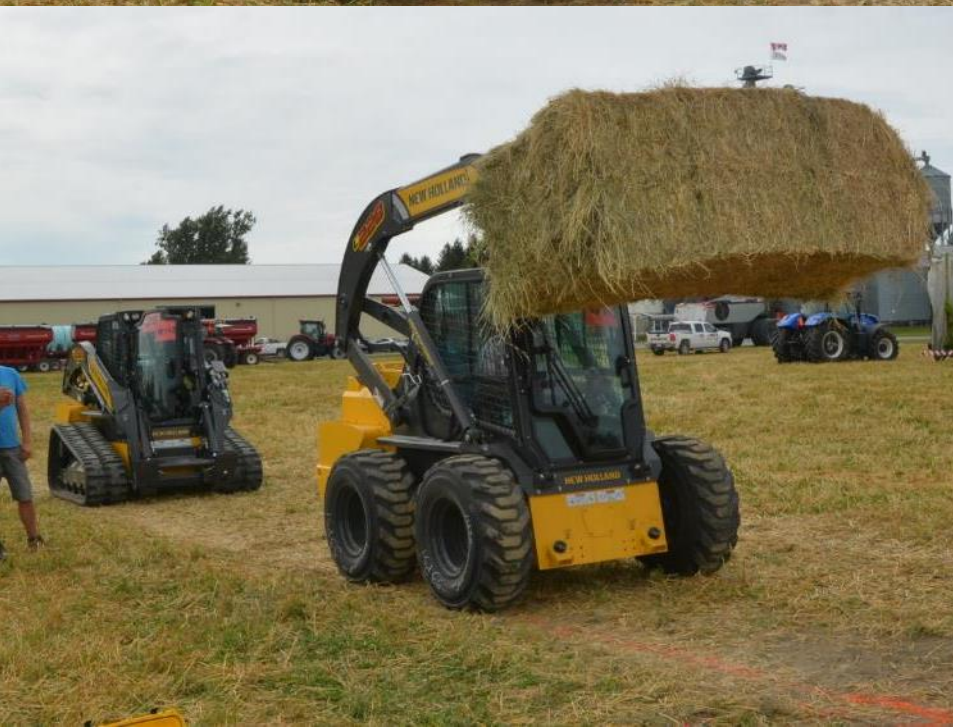
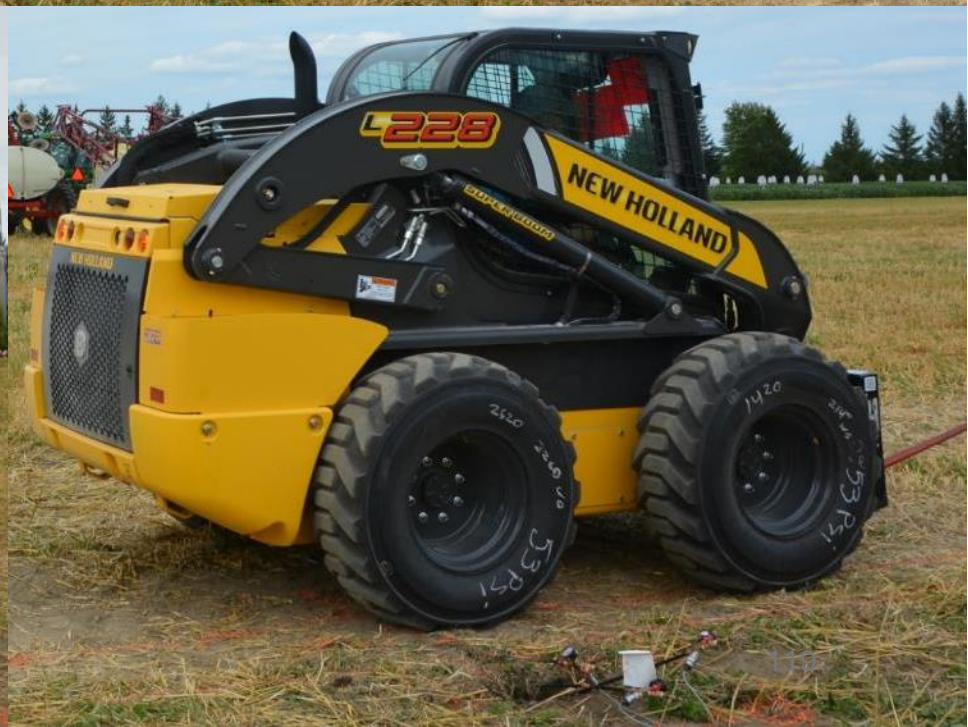
- Although a much lighter machine than the tracked skid steer there is much high soil stress both with and without the bale.
- Bias tires requiring high PSI (53) transfers more weight into the soil than better tires with lower PSI.

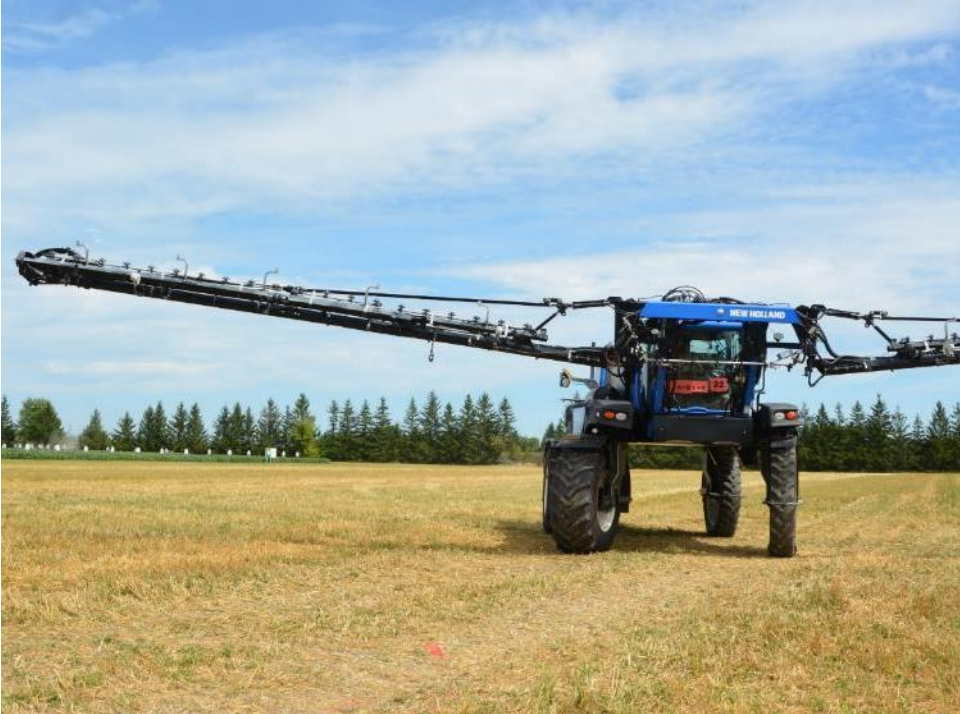
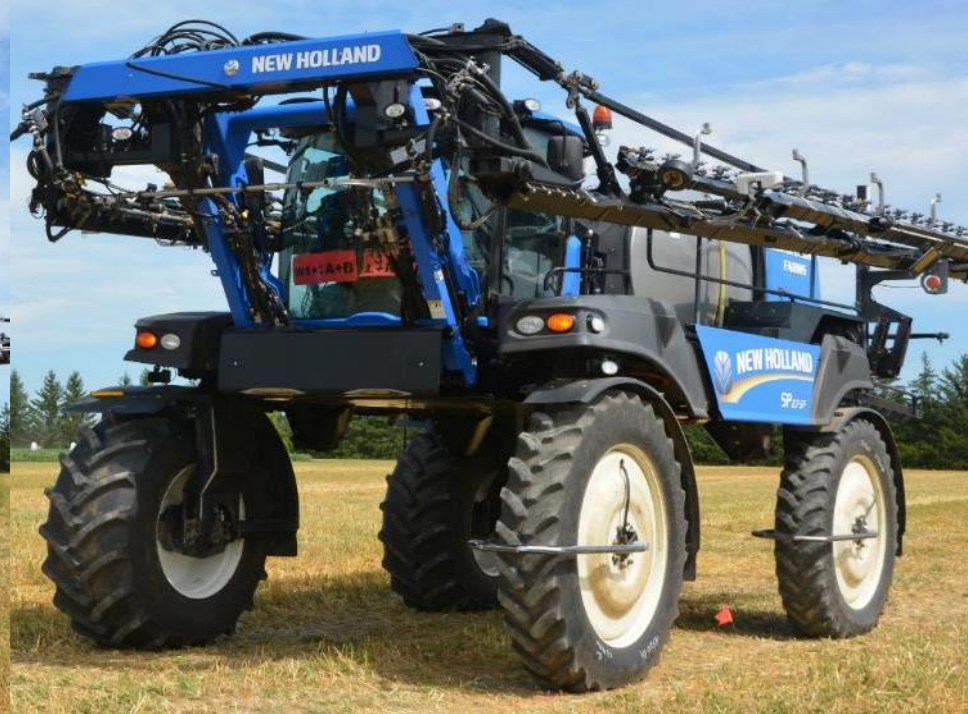
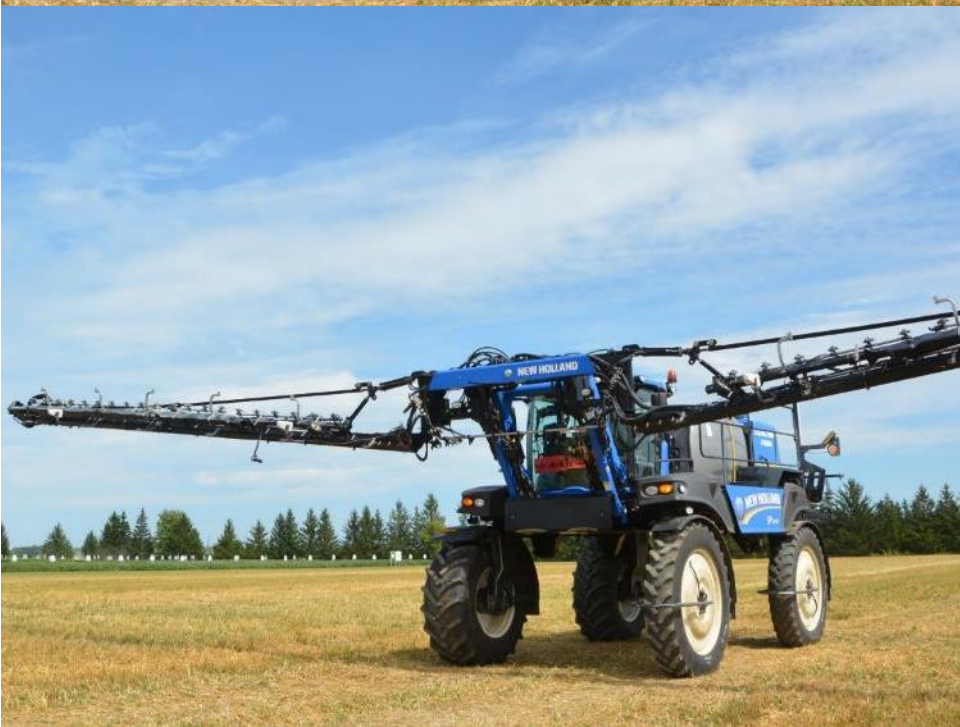
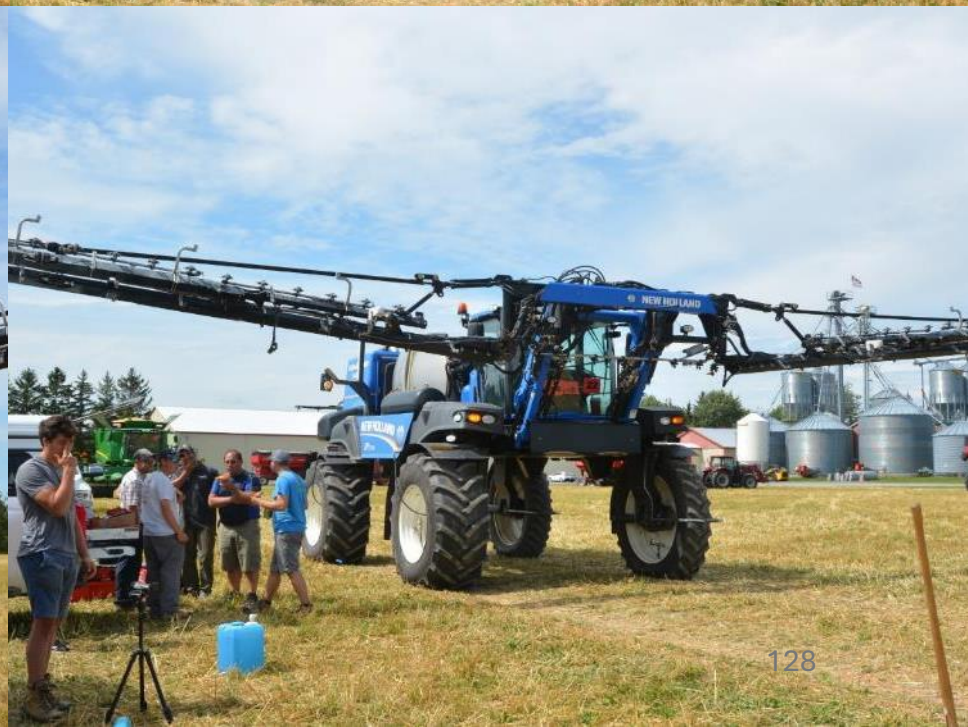
- Graph 2 – Field boom position and lower rated PSI resulted in less stress with 710 larger tires.
- Graph3 – a second repeat of graphs from Graph2 showing slight differences due to testing in different pit and day.

- Graph4 – boom in field position with low Psi showing more change in 6” stress with 710s, but at 12” and 20” the stress is nearly same as high PSI because it’s the total implement weight that is the main factor.

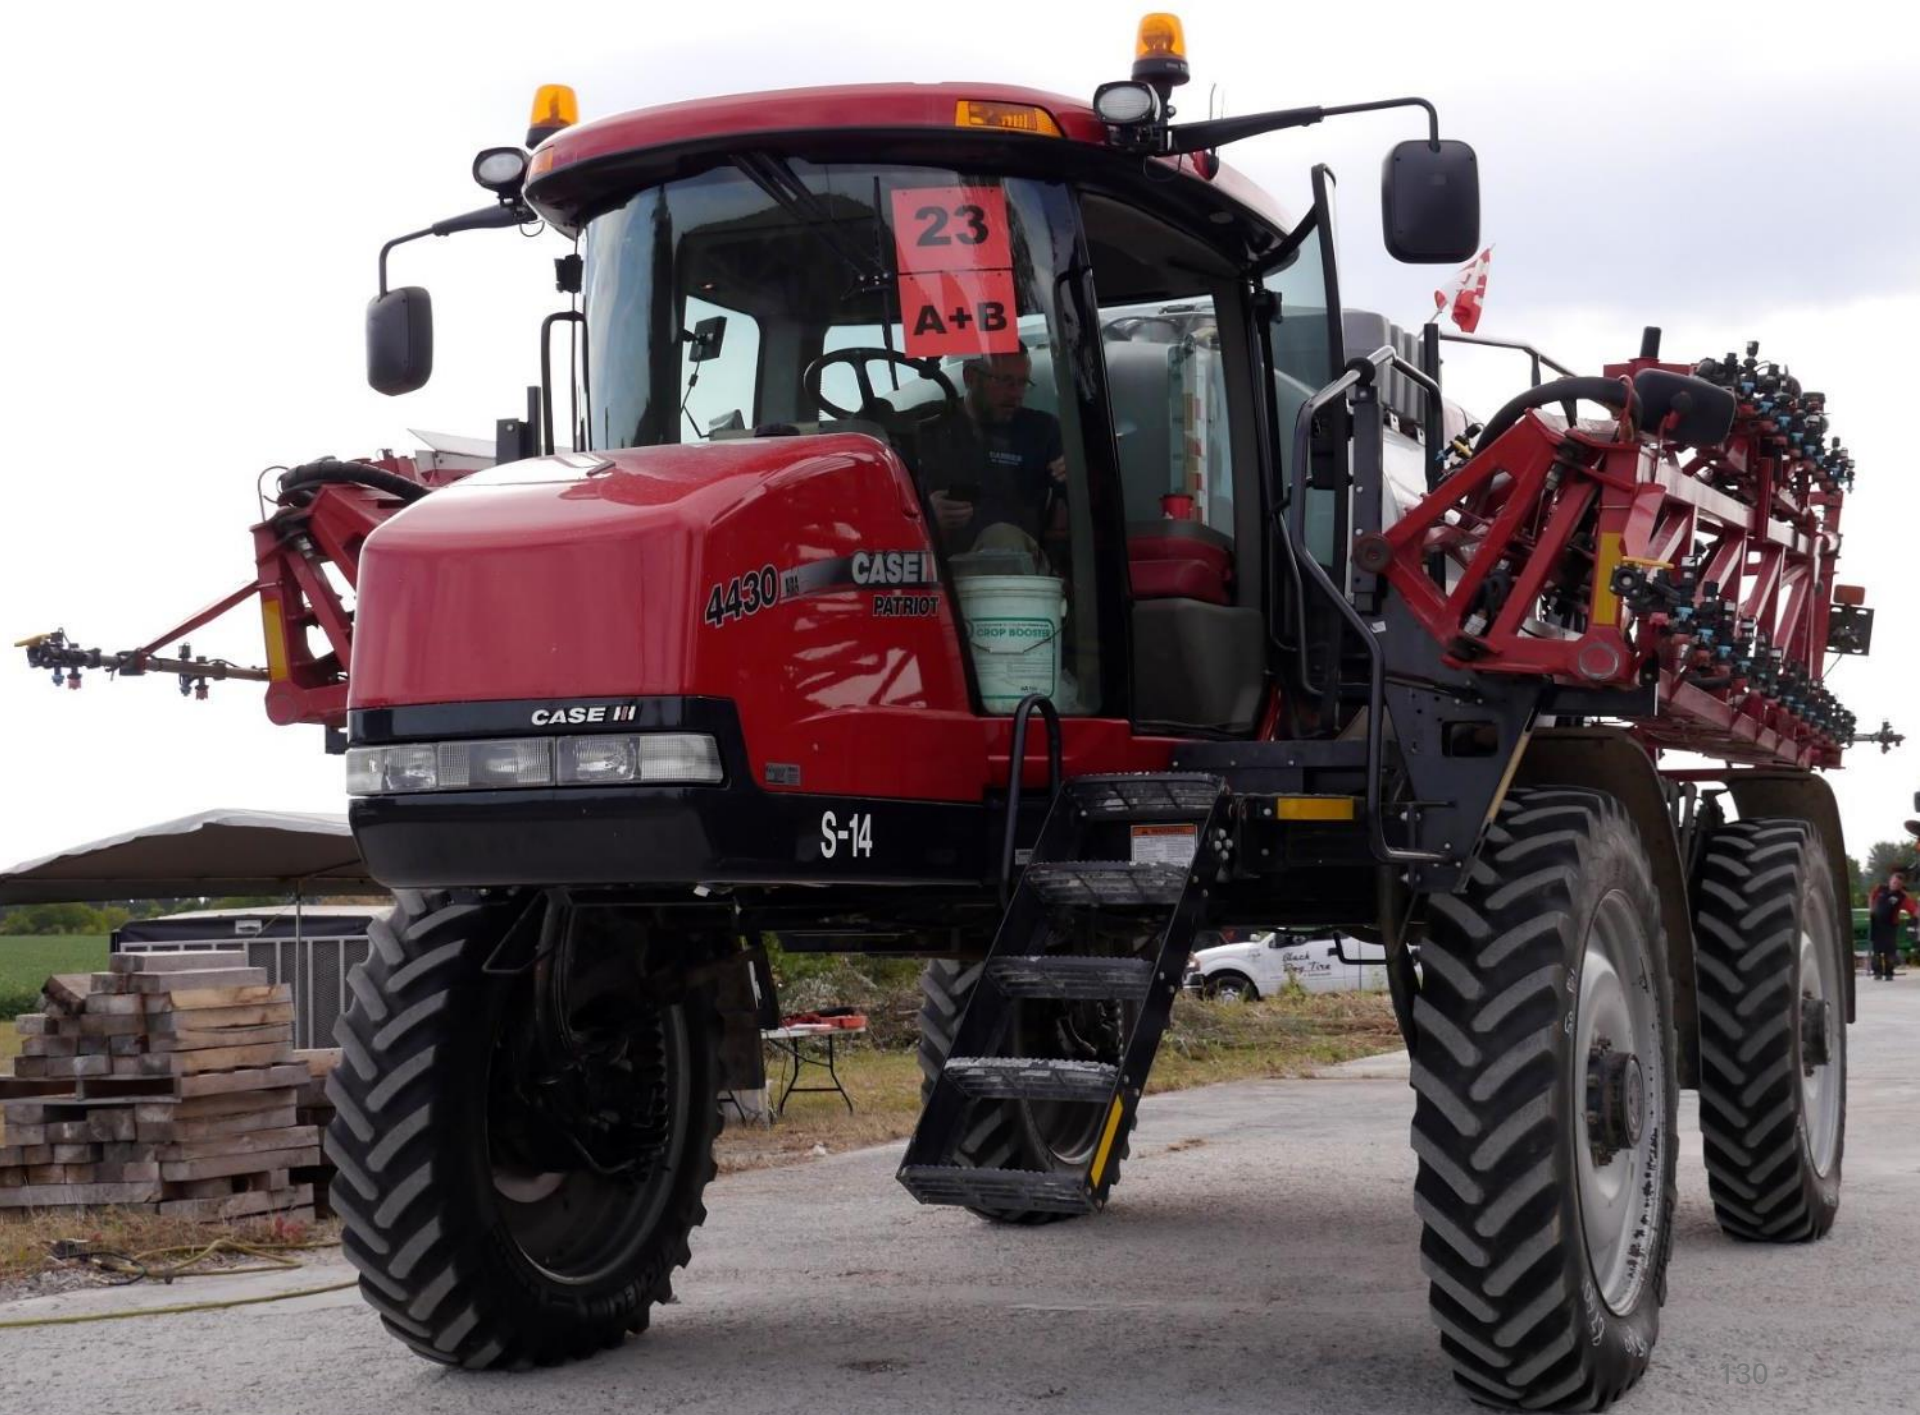
Exhibit: D23

**CaseIH Patriot 4430 Self
Propelled Sprayer w 380s**

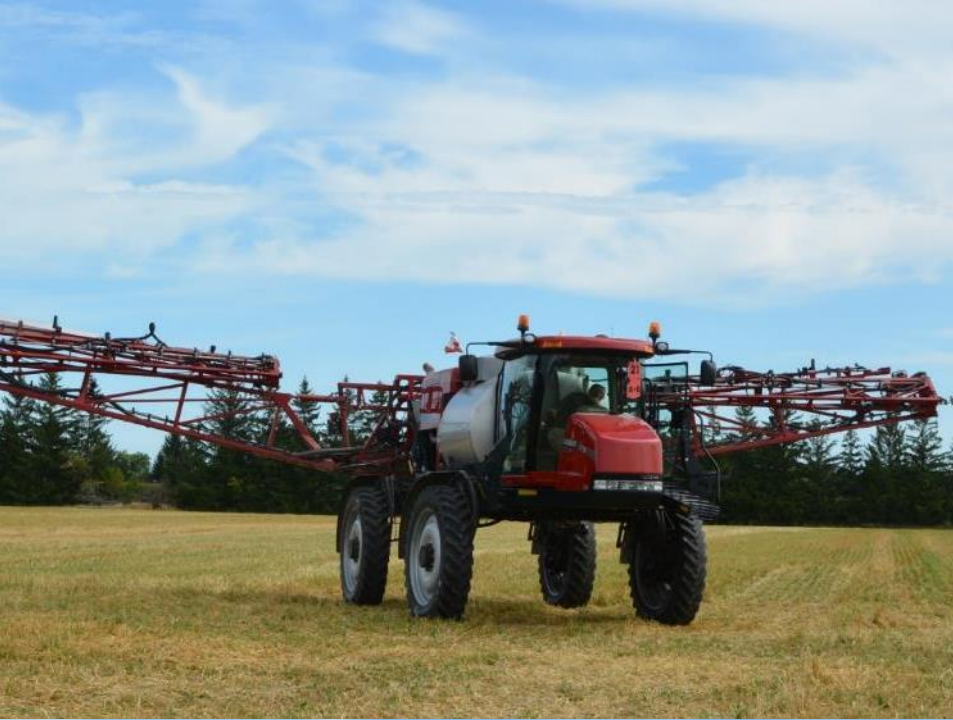
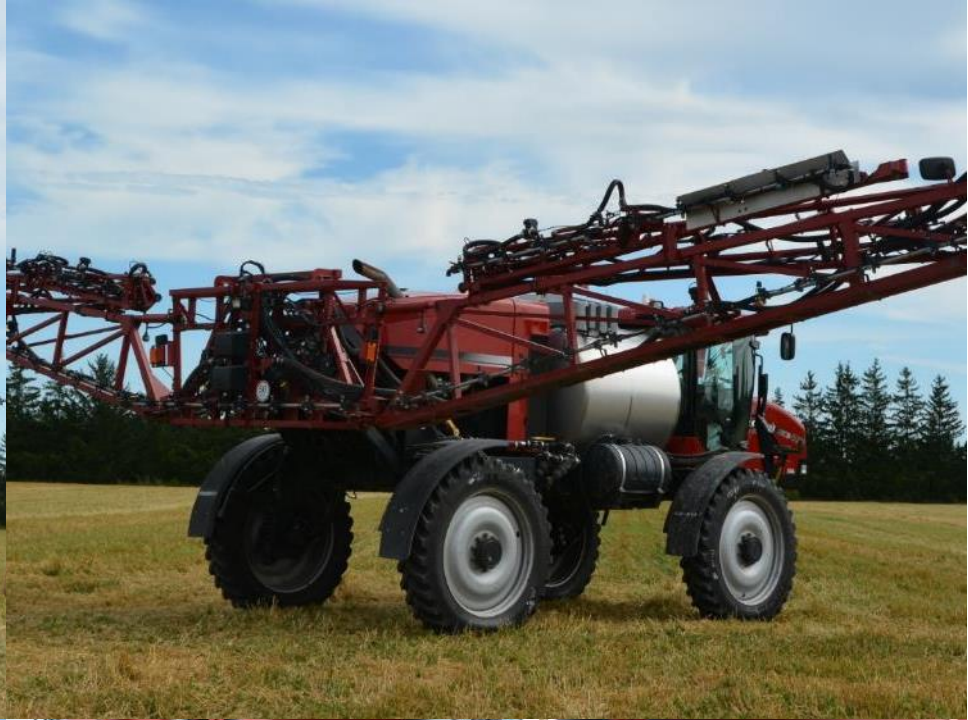
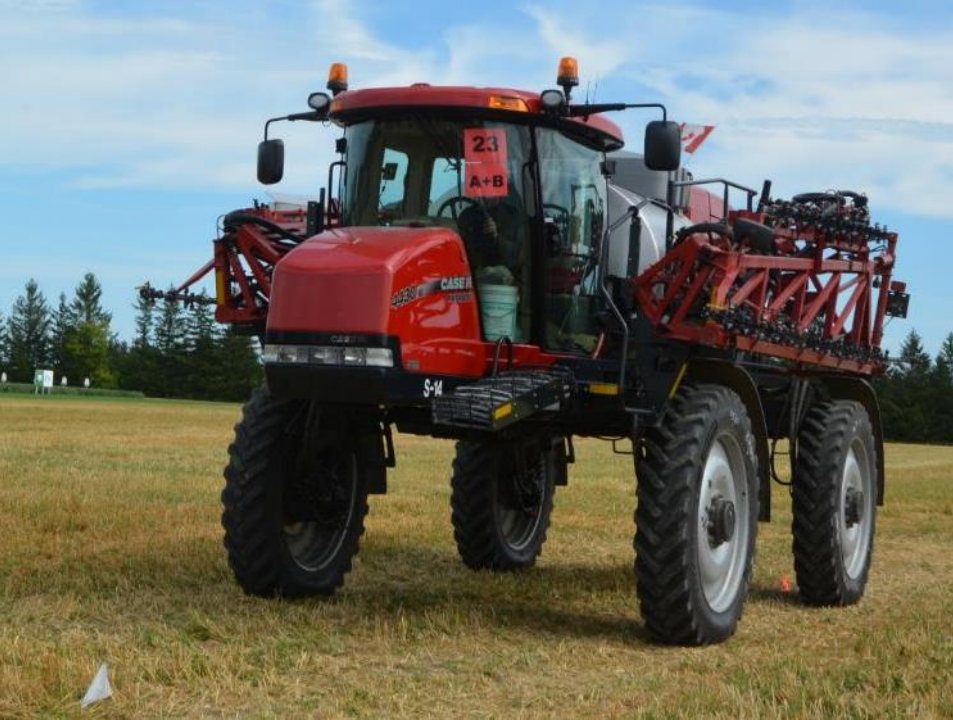
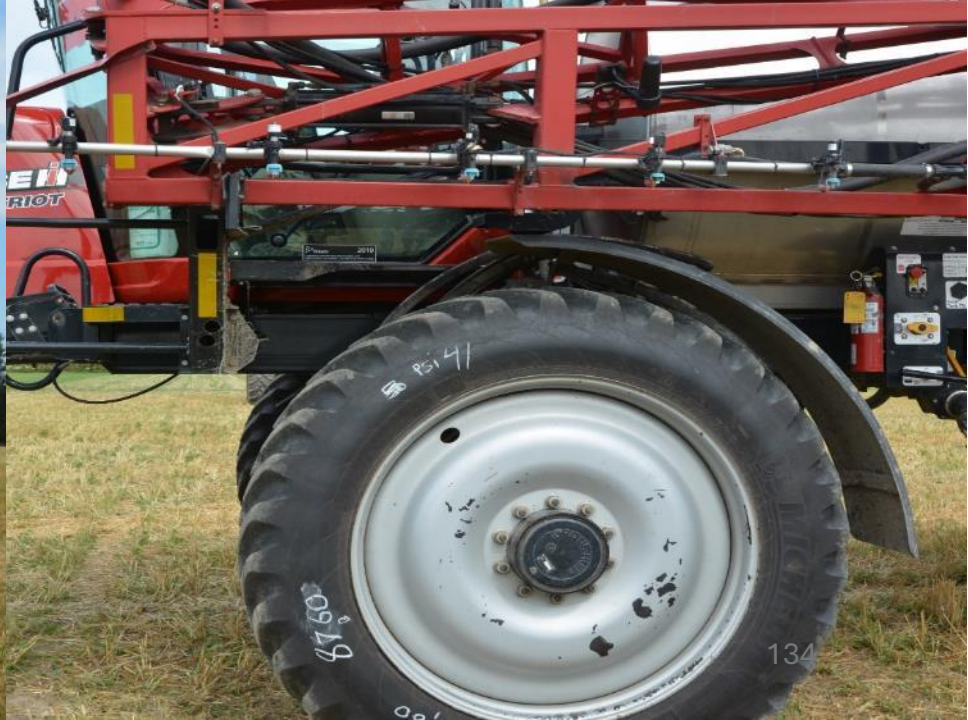
- These plots again show high pressure in the topsoil from high pressure tires
- Notice the weight distribution when the boom is folded in
- These 380s exceeded stress level at 12” and barley at 6” despite the high PSI
- At 20” the overall weight causing stress a function of equipment weight

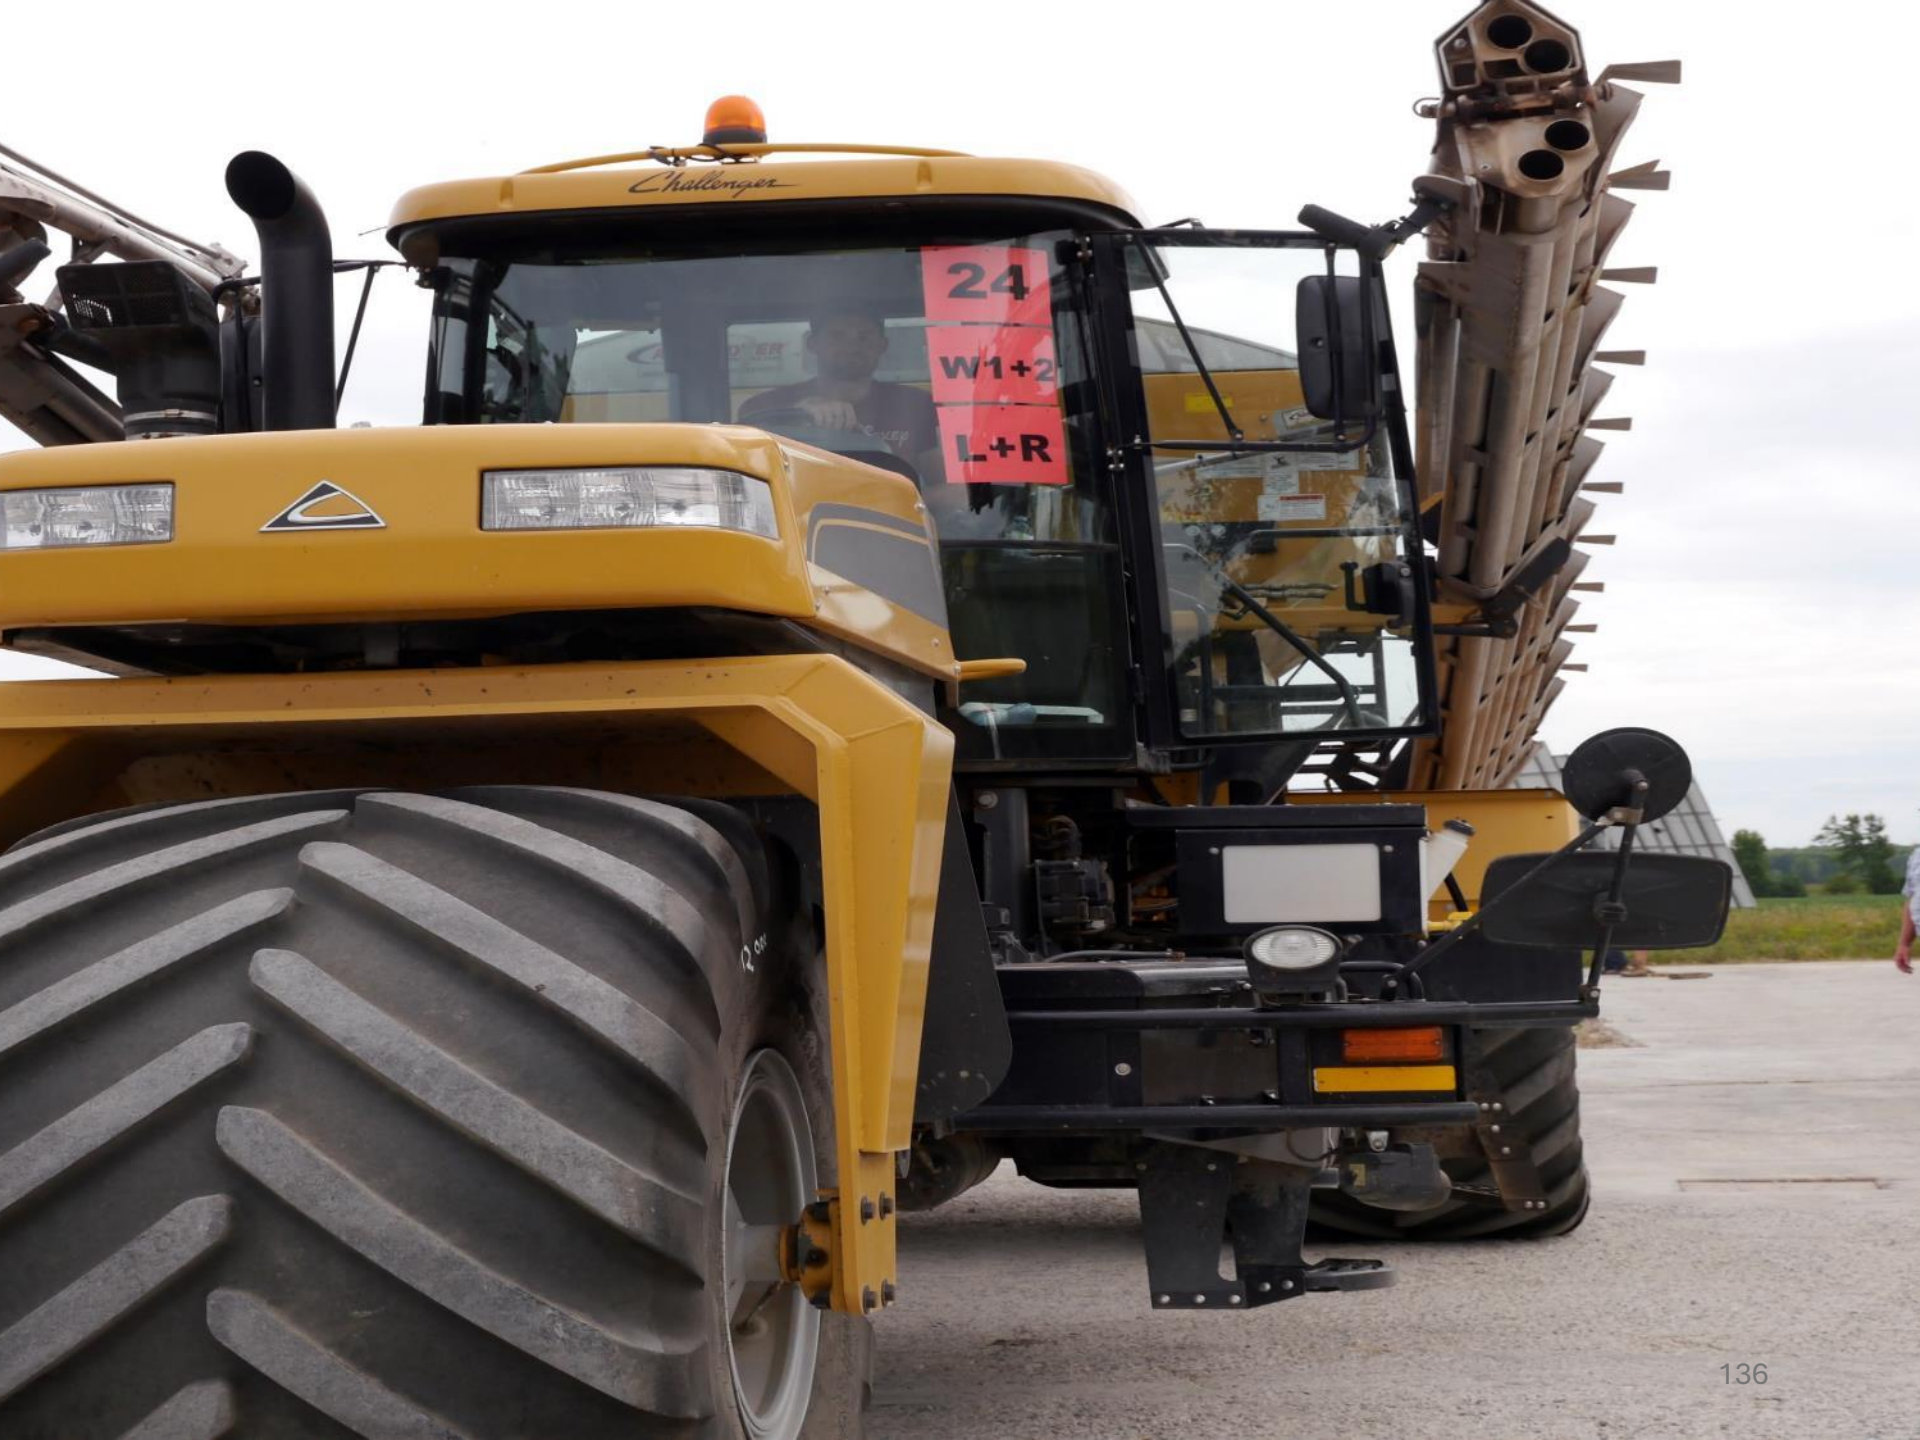
Exhibit: D24

**AGCO Terragator TG8300B
Trike Dry Fertilizer Spreader
w 1000s**

35 PSI all tires
