2019 Dundas SCIA Compaction Event

Winchester, Ontario

August 29th, 2019

Dundas SCIA Compaction Event

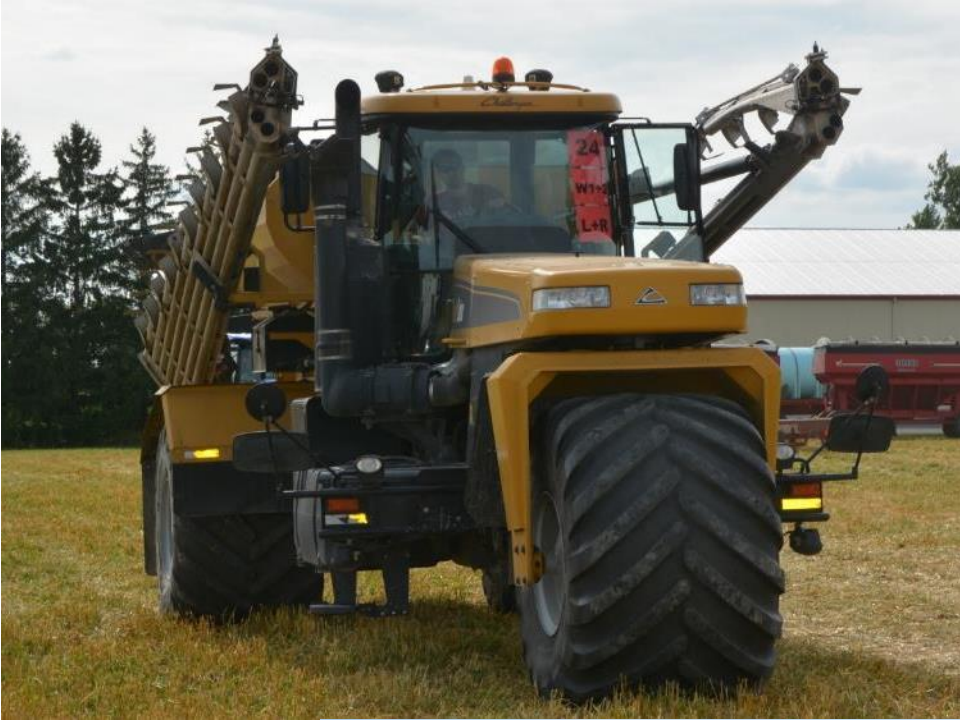
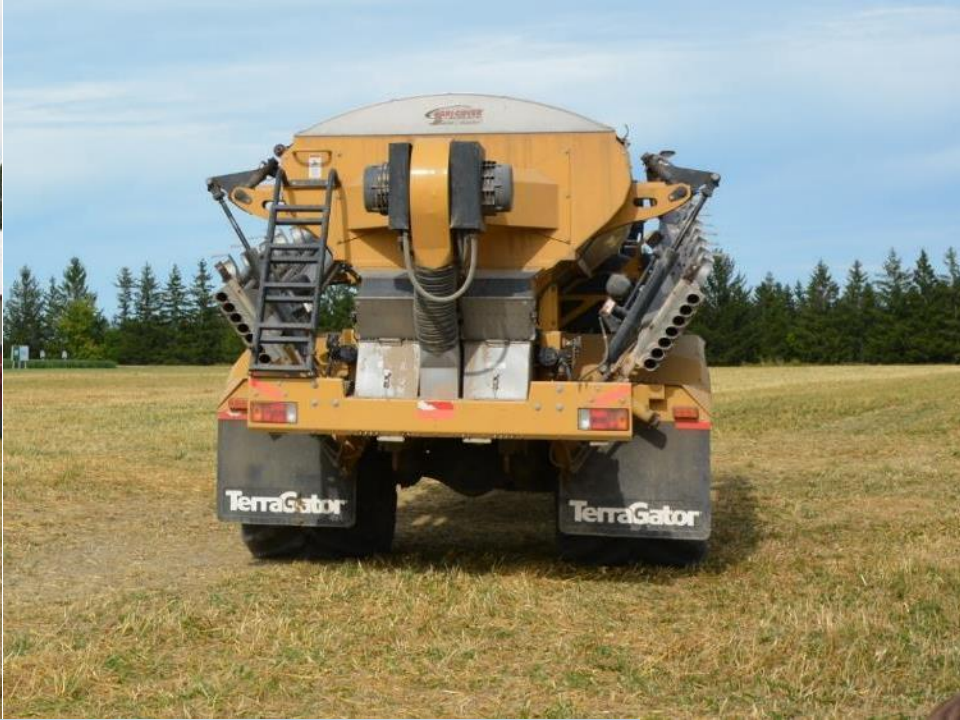
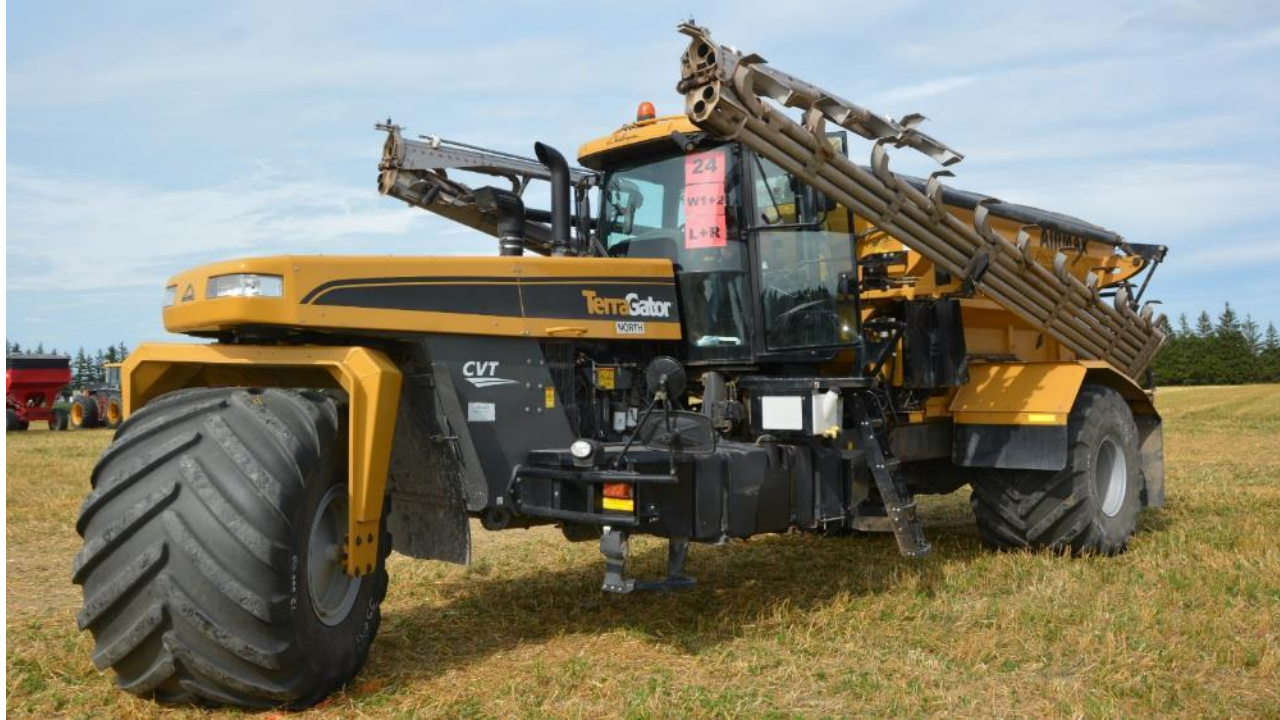
- The first plot is the right side rear tire.
- The second plot is the front tire as it drove over and the reversed over the sensor to avoid the measurement equipment.
- Relatively high PSI by weight causing slight spike in 6” stress
- Weight relative to tire size a good configuration for this soil since 12” and 20” sensors not receiving much pressure.

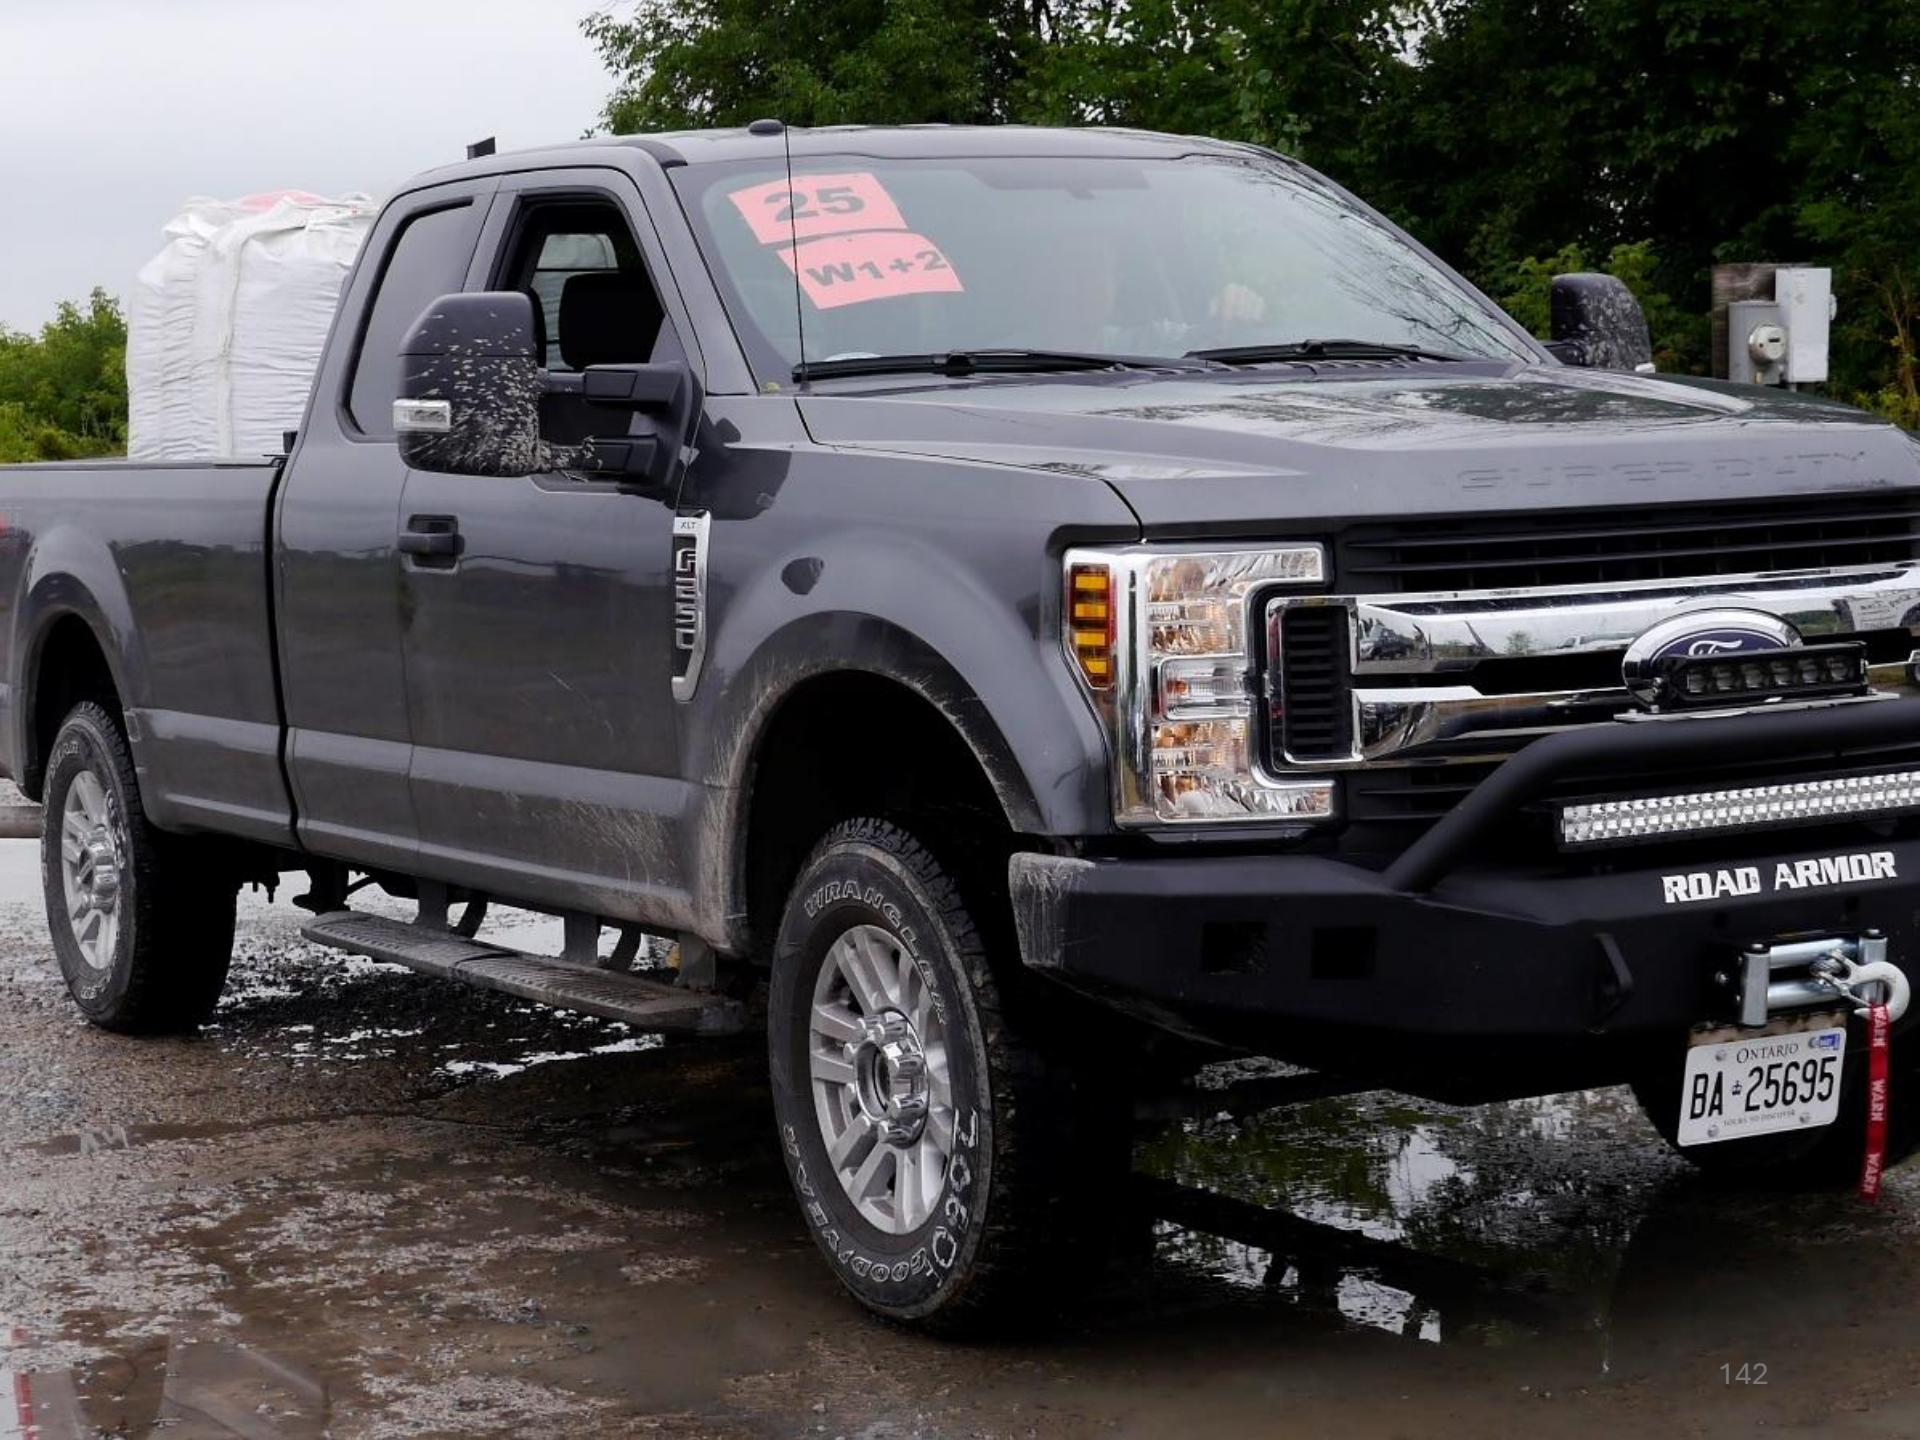
Exhibit: D25

**Ford F-250 w/wo Loaded and
275/70R18 High PSI Tires**

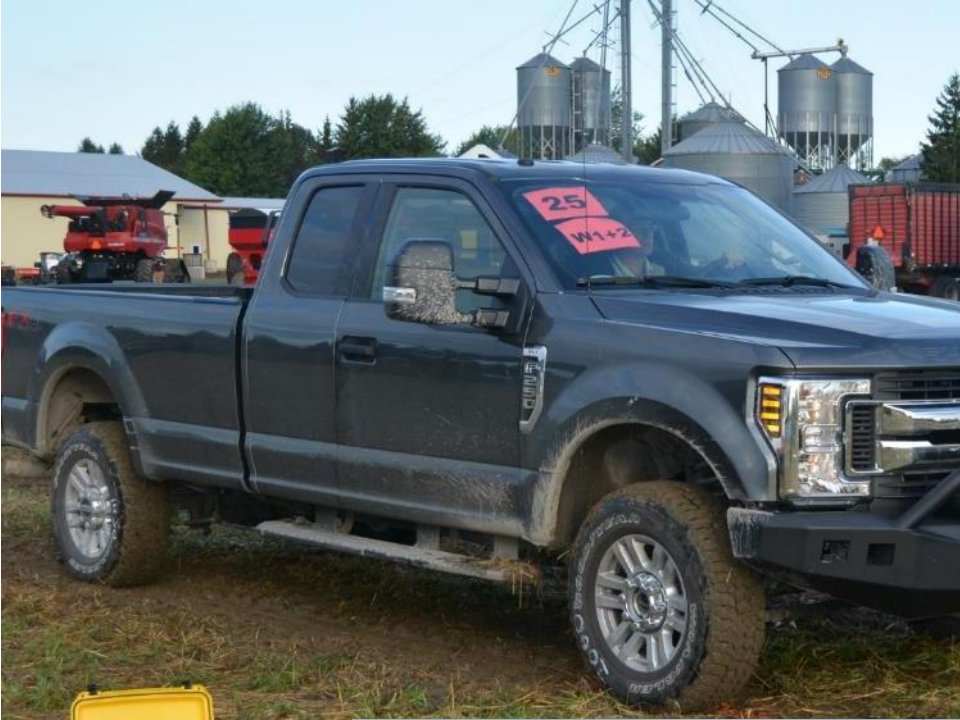
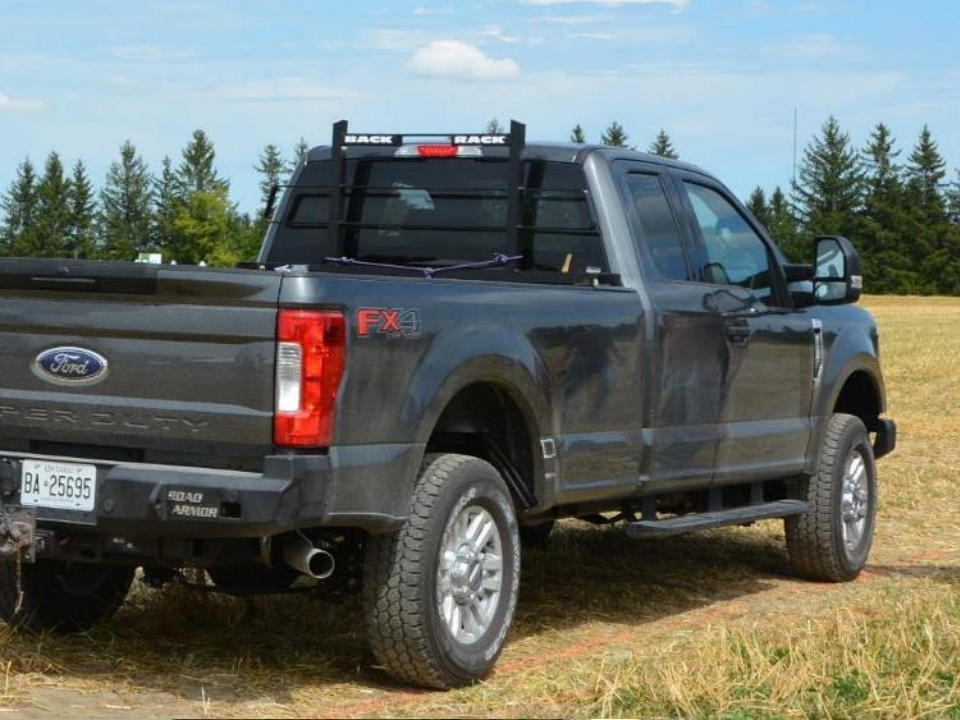
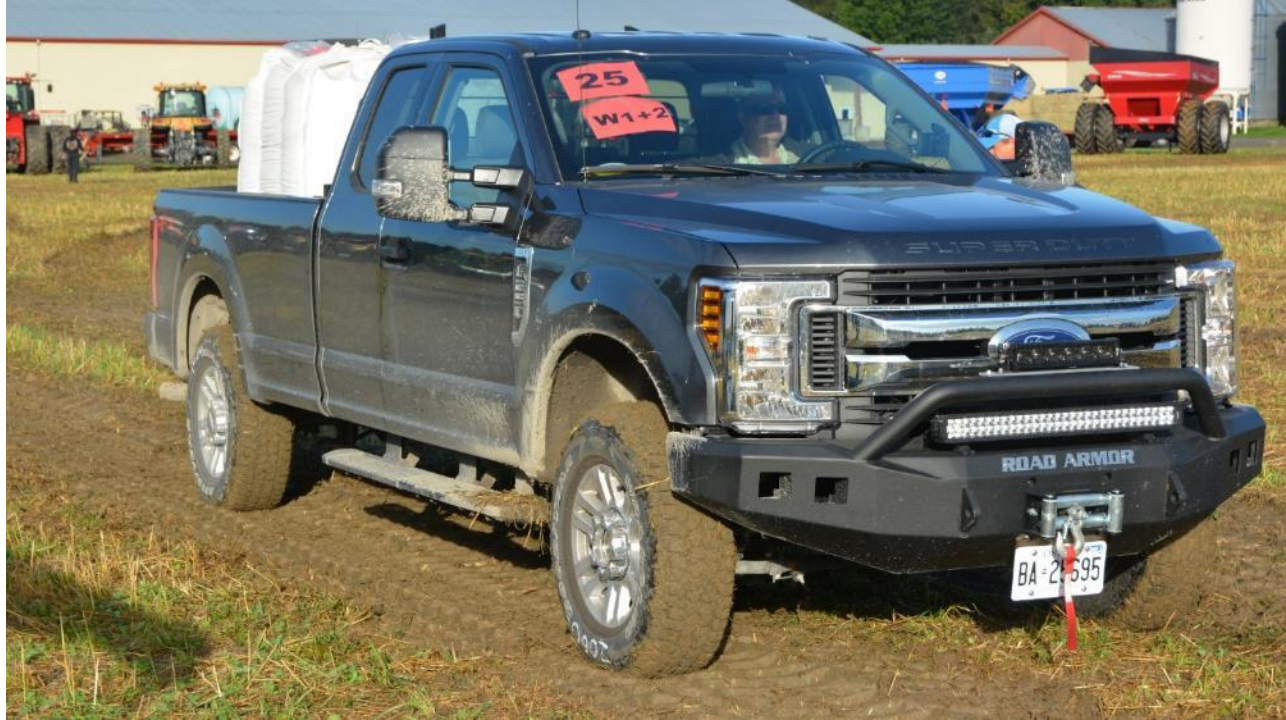
- The left two plots show the increase in pressure when weight is added to the vehicle.
- The right plot is again with weight in the vehicle at a difference sensor installation.

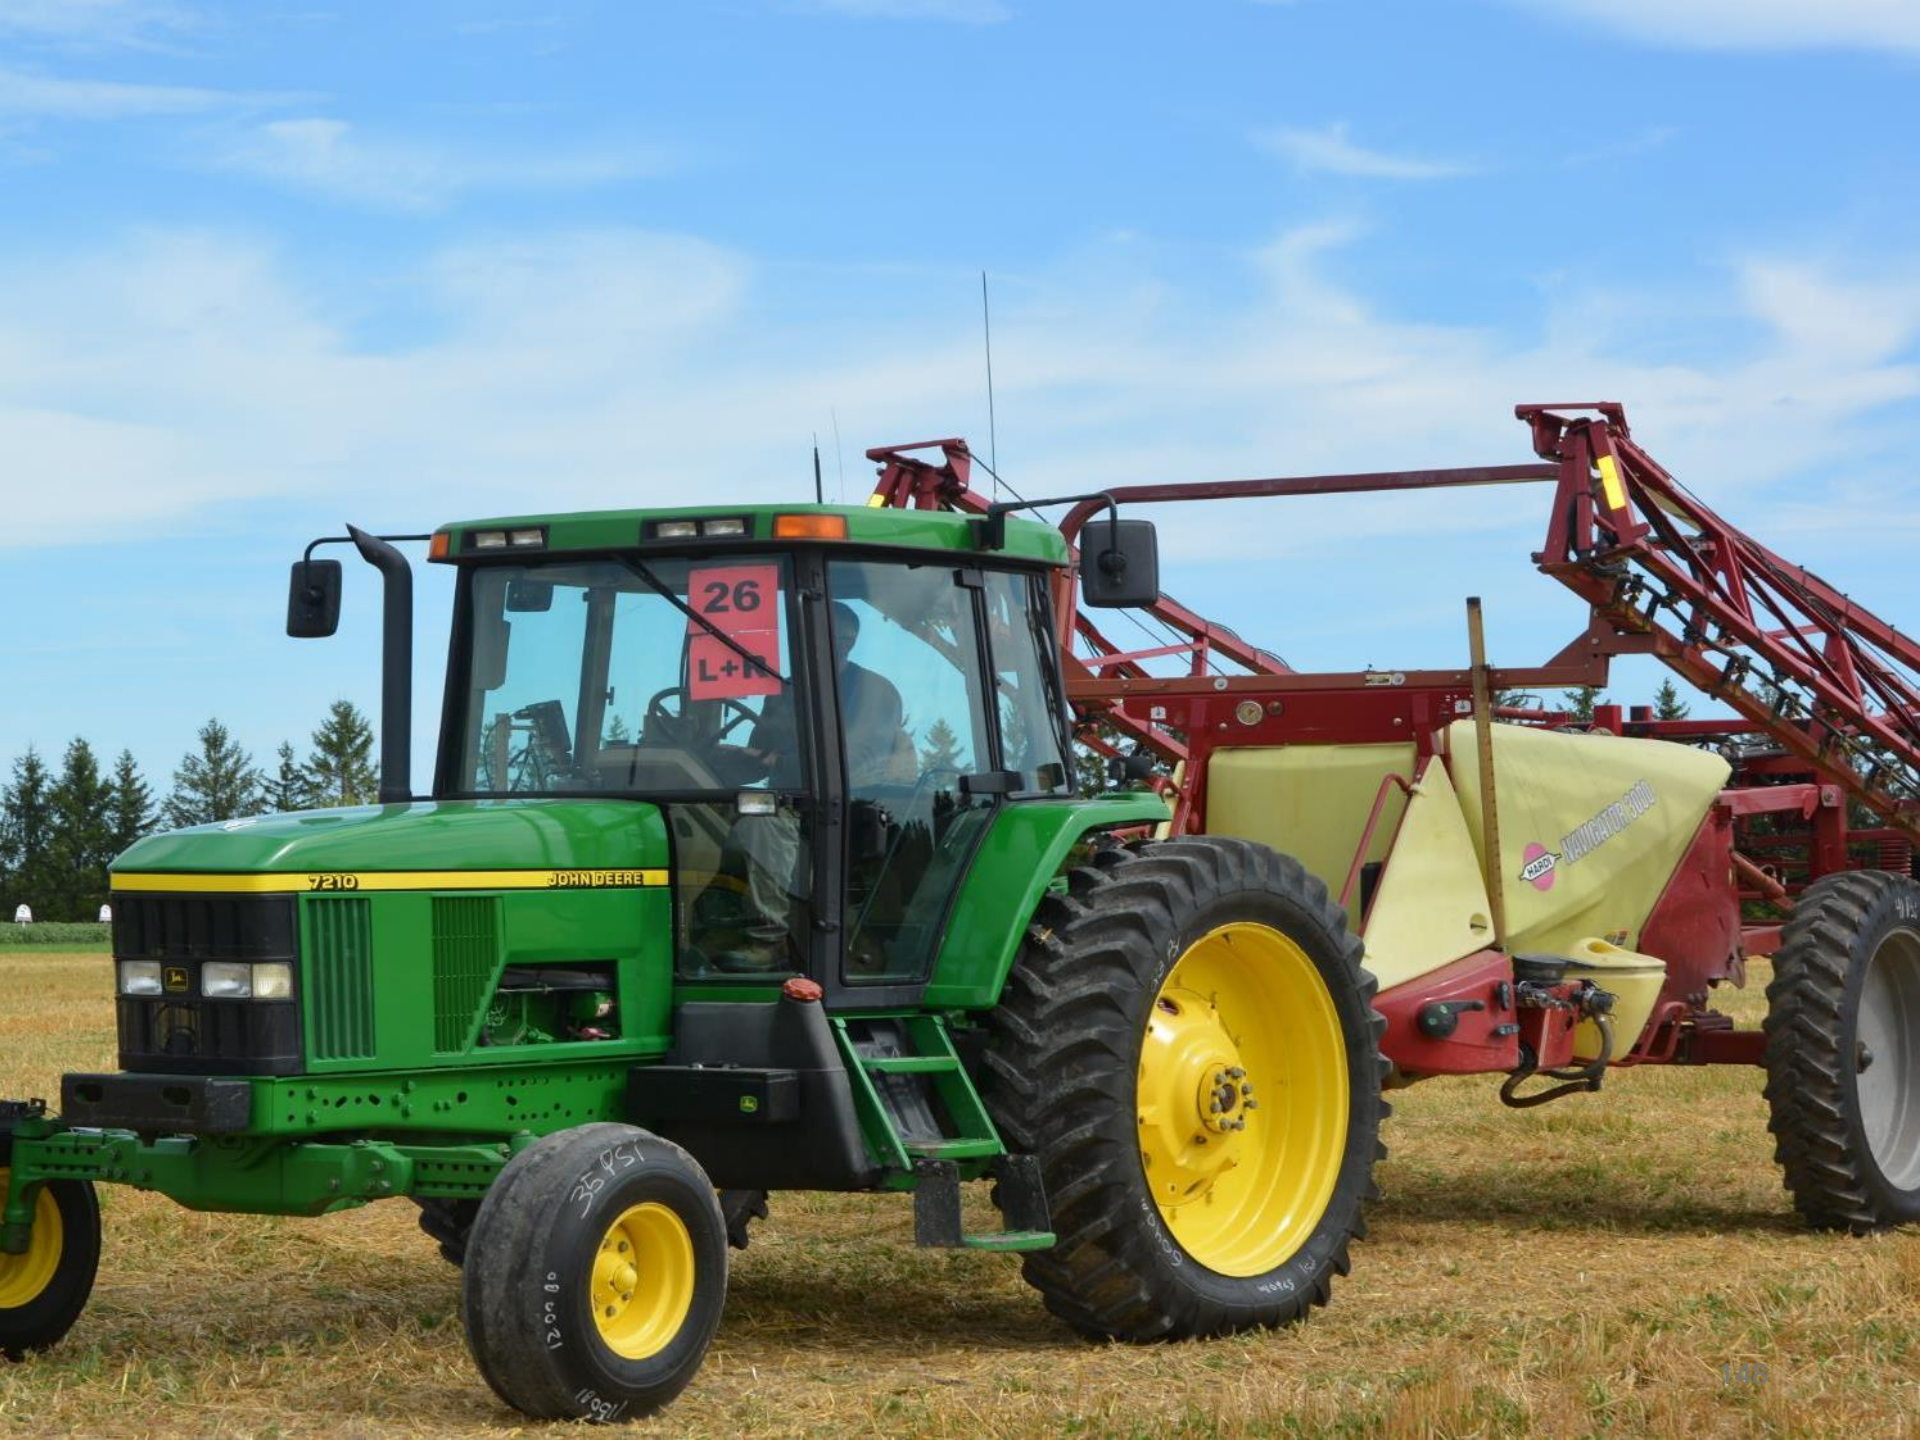
Exhibit: D26

Tire Set 1: 320/90R46 – 41 PSI

Tire Set 2: VF380/90R46 – 32 PSI

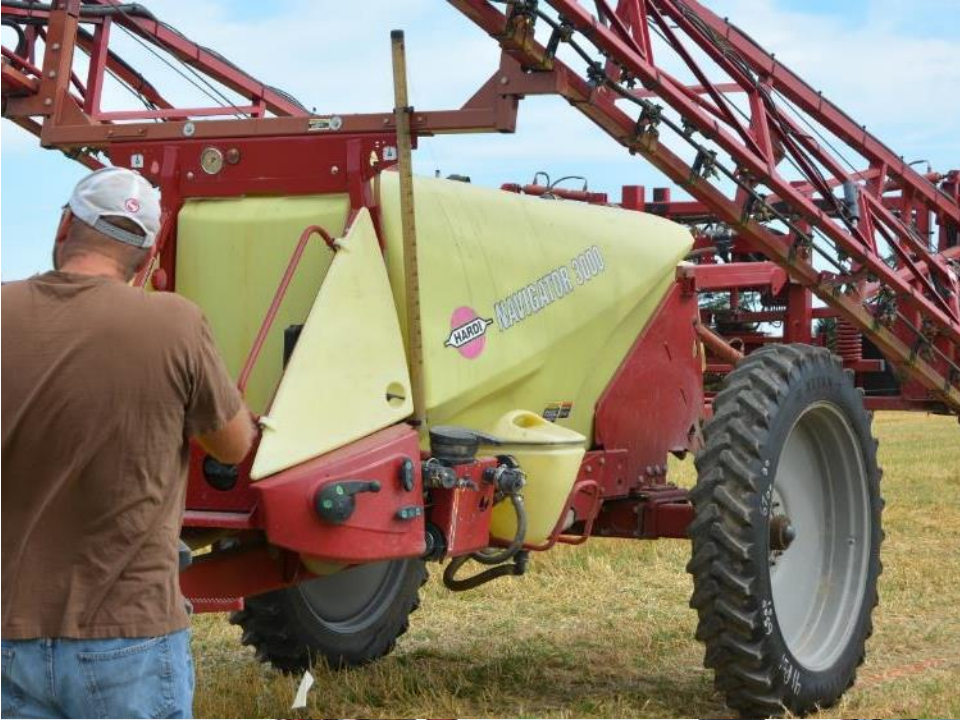
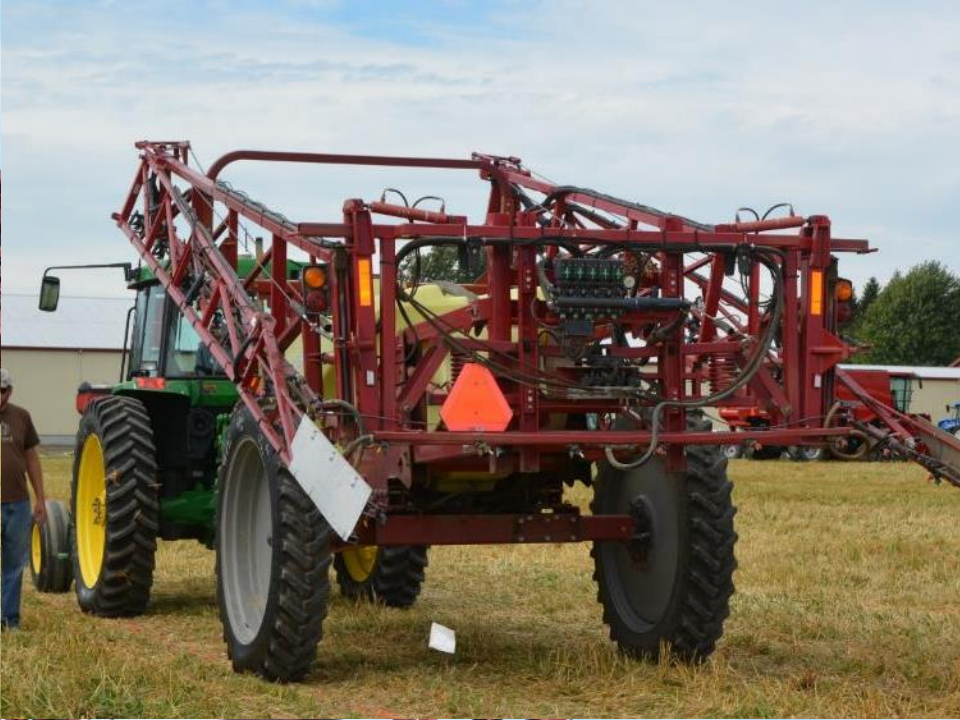
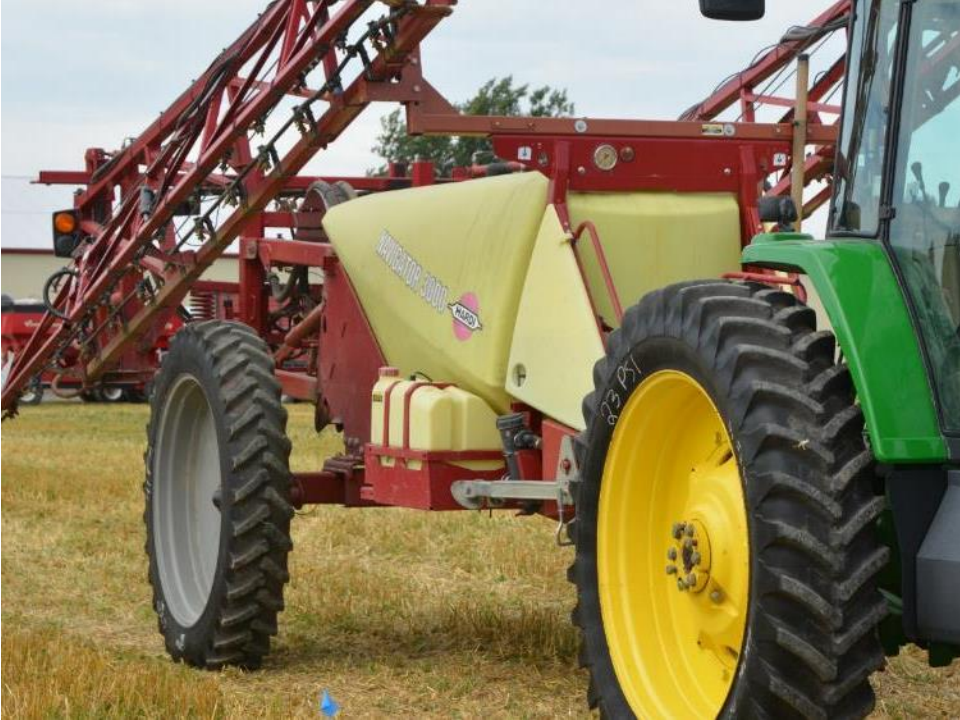
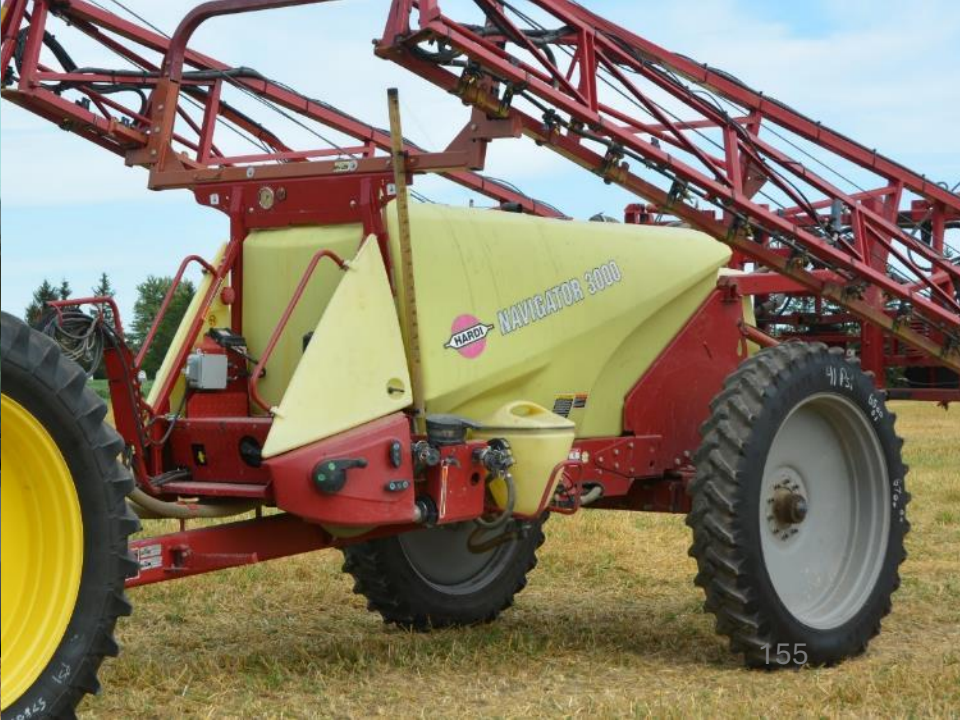
- This PT sprayer was tested with 320s first and then VF 380s resulting in two weigh forms
- The two sets of tires were tested on different days and sensor pits so the results can not be compared between the two tire types
- Due to sensing on different days we can not comment on the performance of the 320 radial vs VF 380 tire.
- There was a substantial rainfall between sensor pits #3 and #4,5 the following day which would have impacted responses.

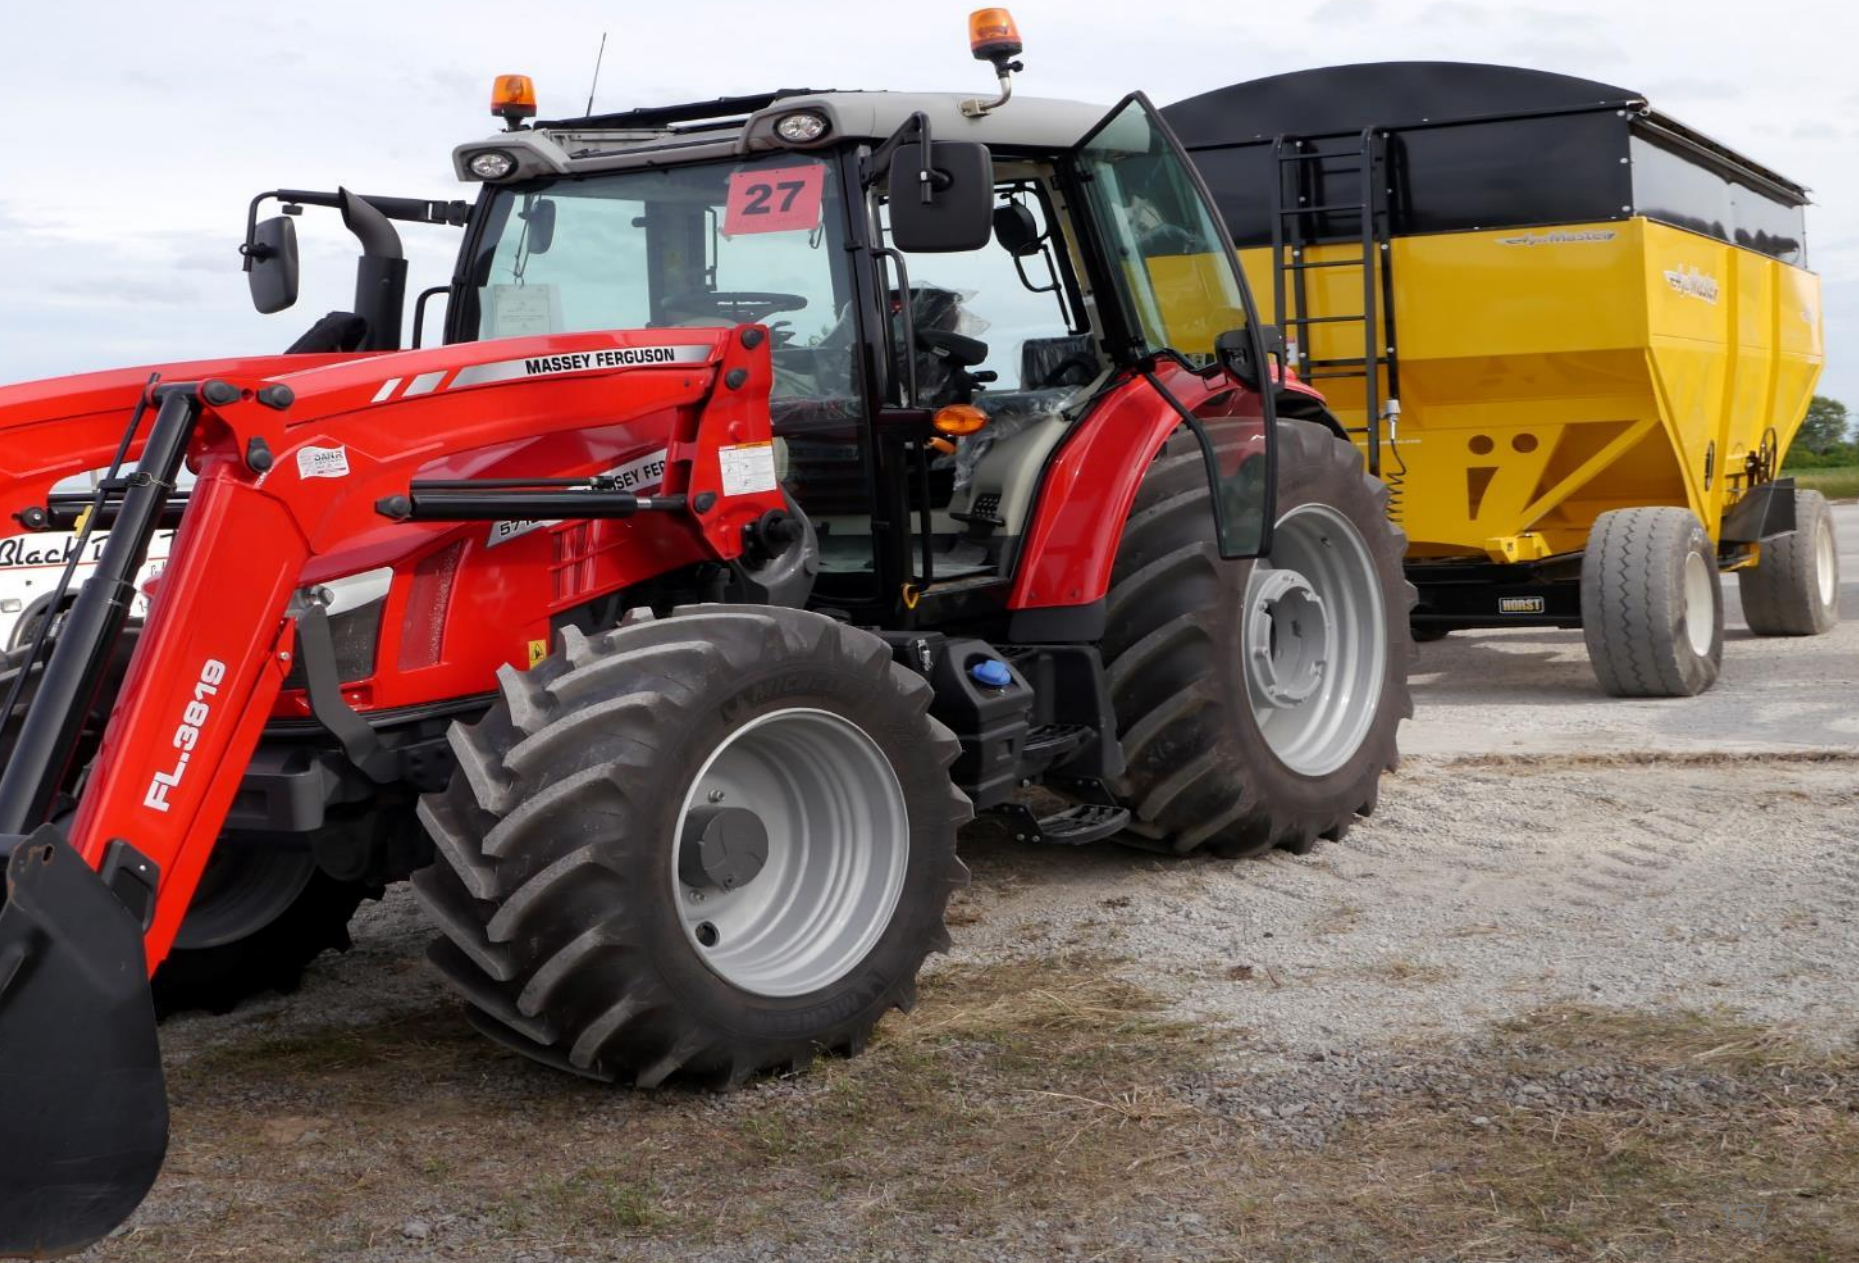
Exhibit D27

**Agrimaster A600 Gravity
Wagon with 425 Radials**

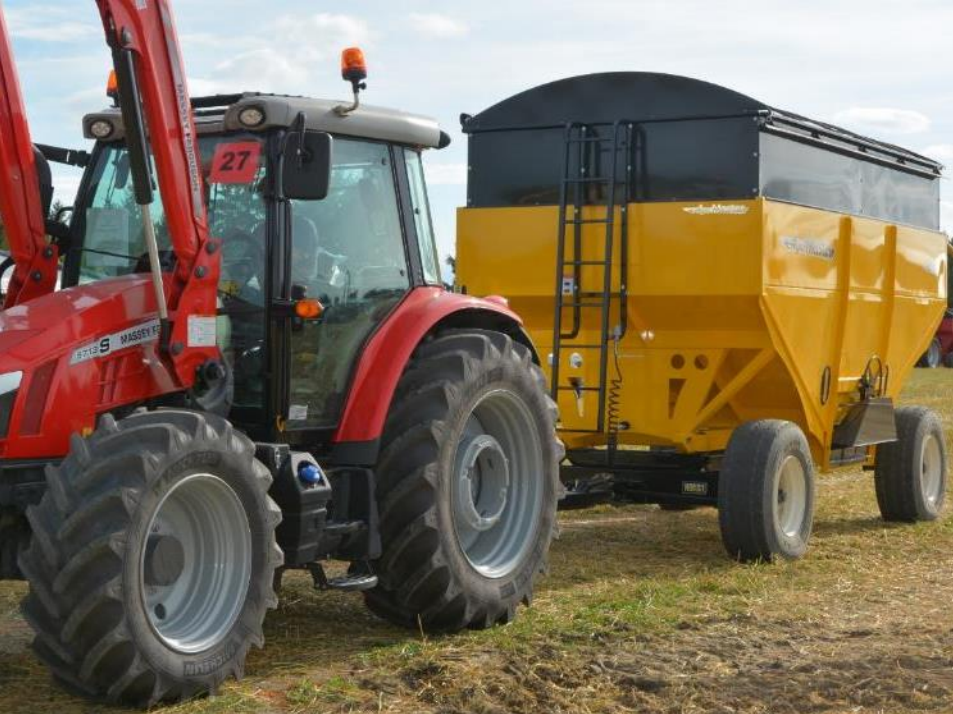
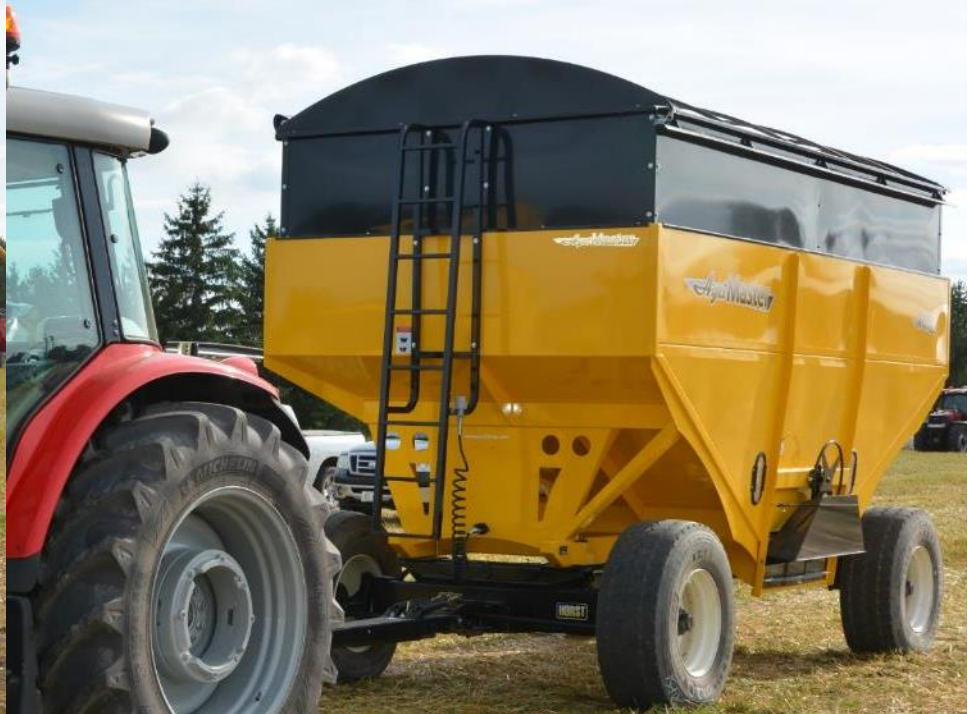
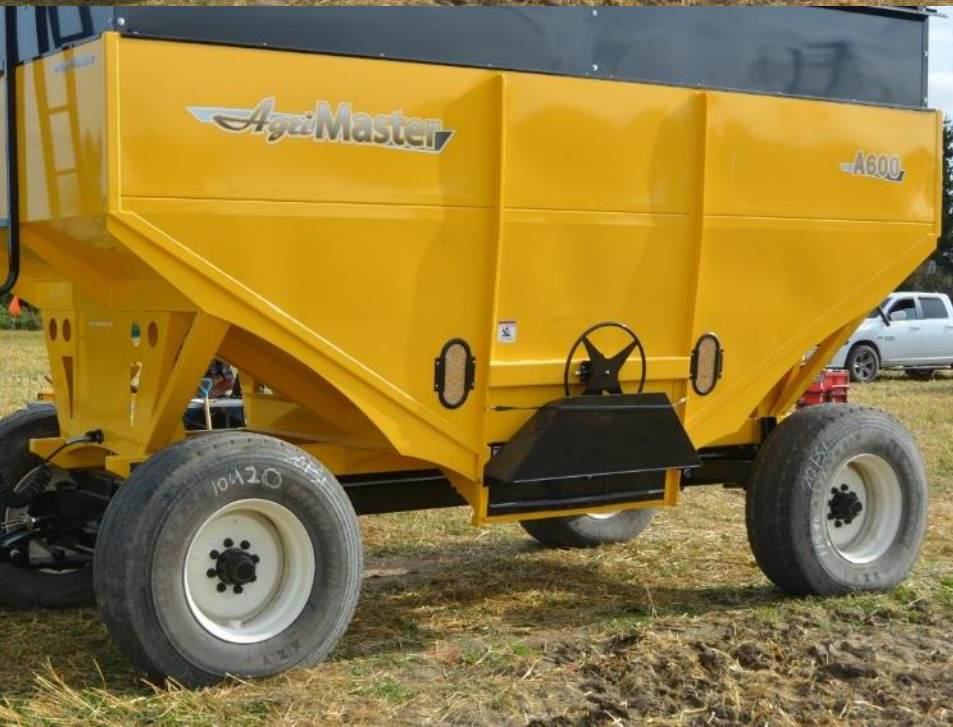
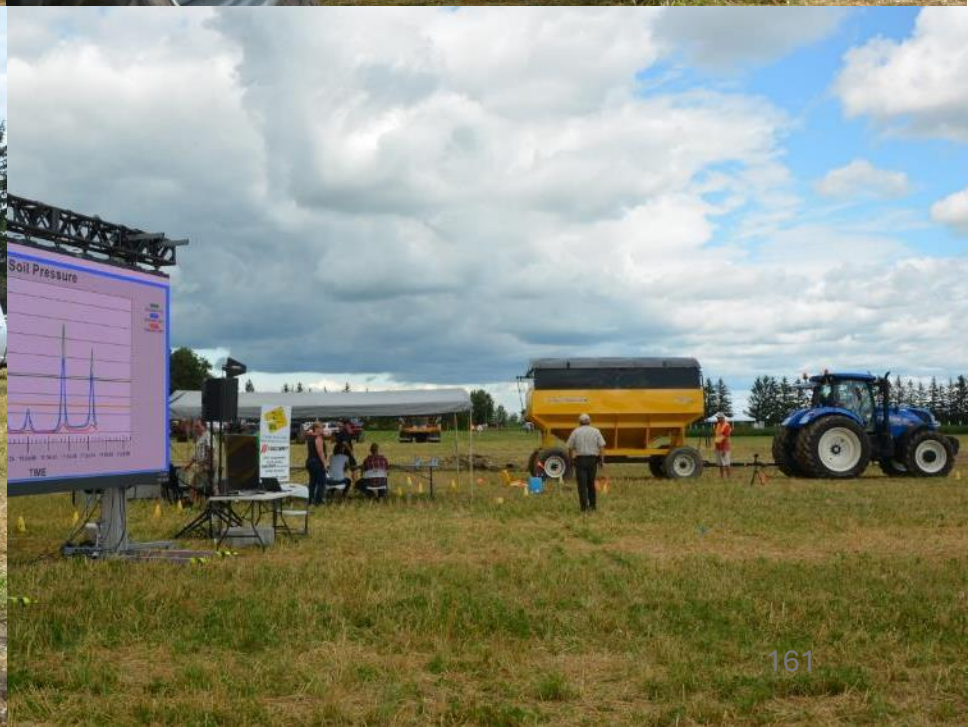
- Very high topsoil stress under grain wagon tires
- This was true for all tire types.
- Notice the strange weight distribution of the wagon.
- This wagon had radial tires - 425/65R22.5 but high inflation psi
- Compare to identical wagon with bias tires (D28)
- Gravity wagons should not be pulled loaded through the field. Best to be loaded close to the entrance and moved directly onto the road.

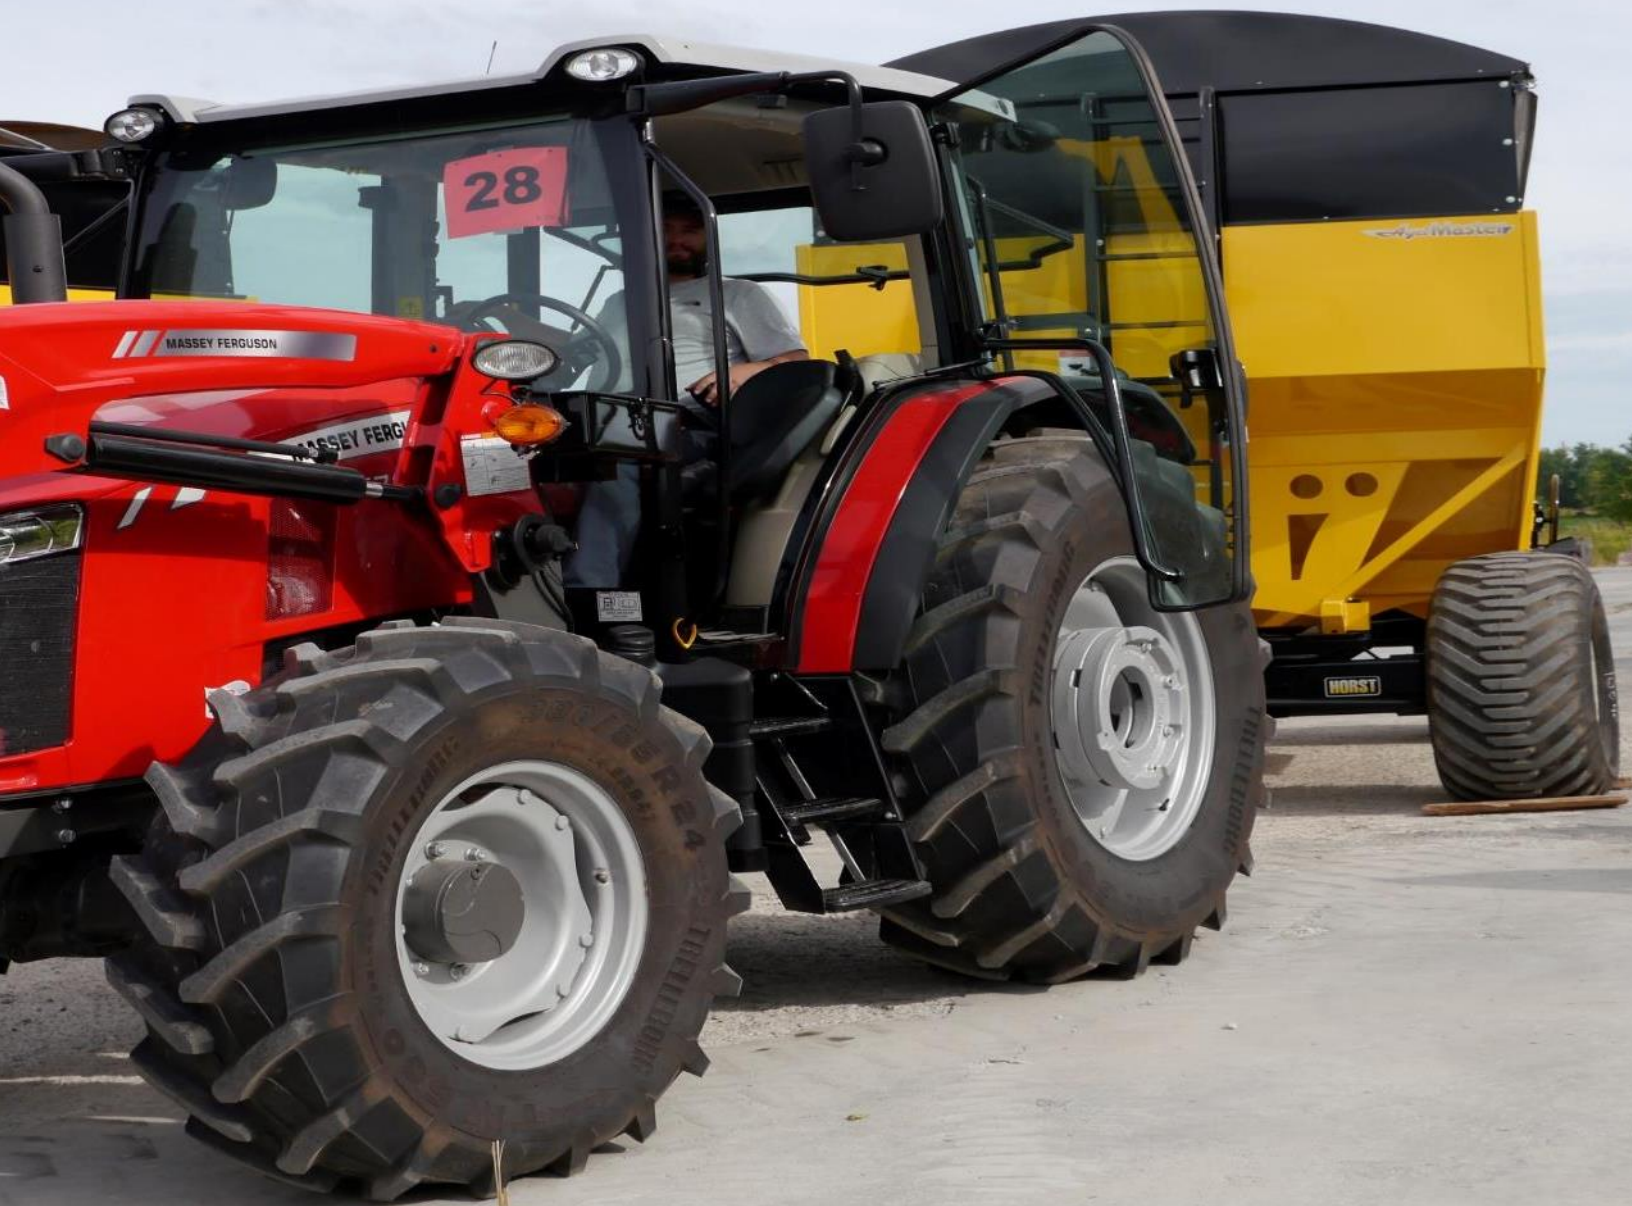
Exhibit: D28

**Agrimaster A600 Gravity
Wagon with 550 Bias Tires**

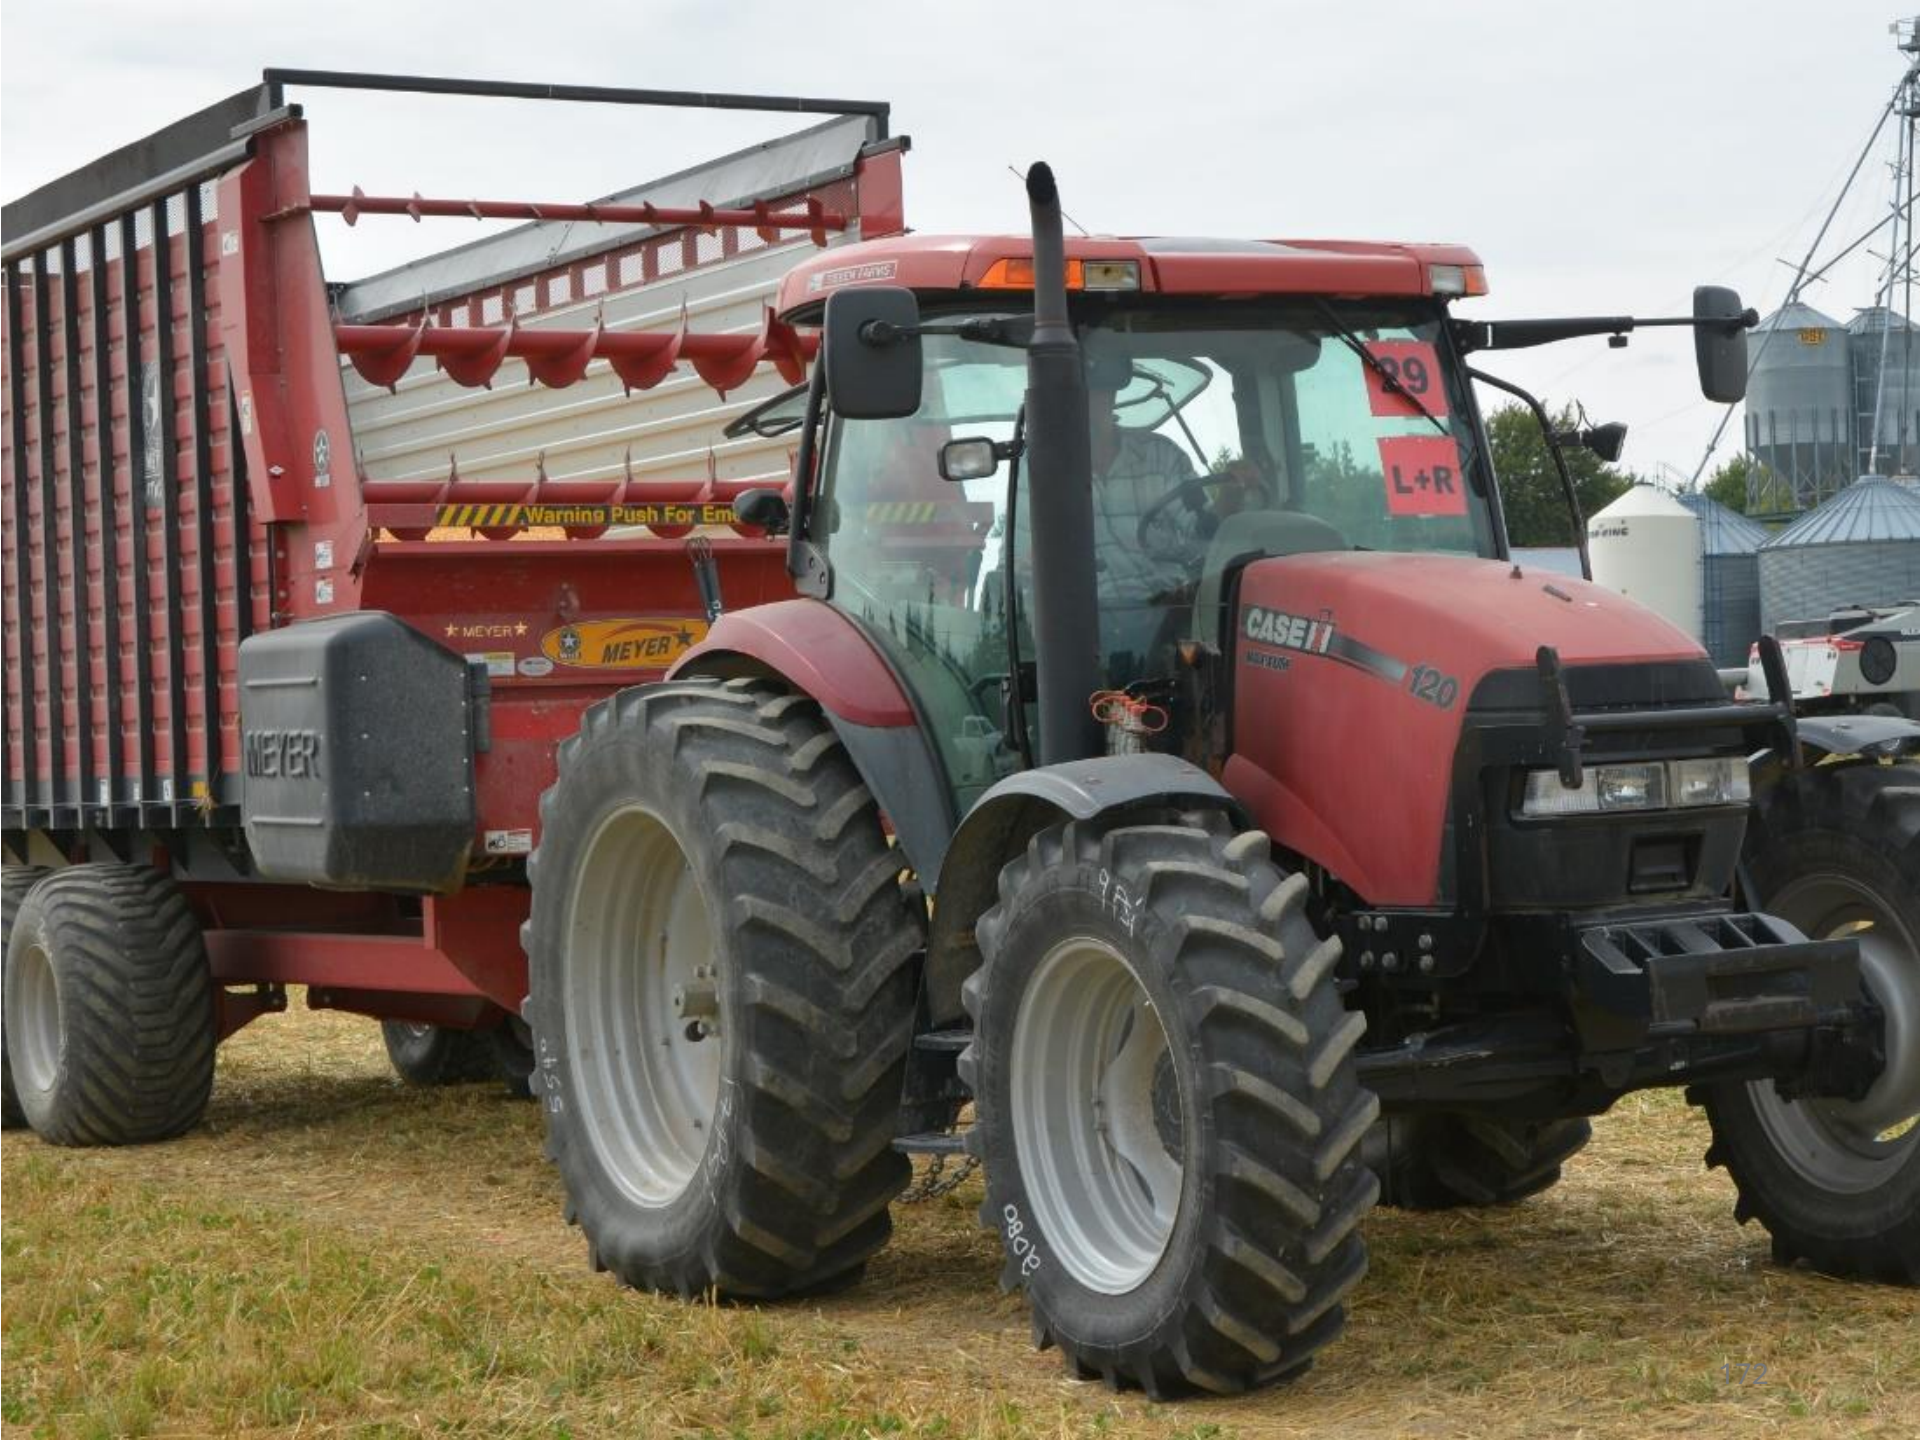
Exhibit: D29

**CIH Maxxium 120 w 480s &
Forage Box w Tandem 445s
vs 600s**
