2019 Dundas SCIA Compaction Event

Winchester, Ontario

August 29th, 2019

Dundas SCIA Compaction Event

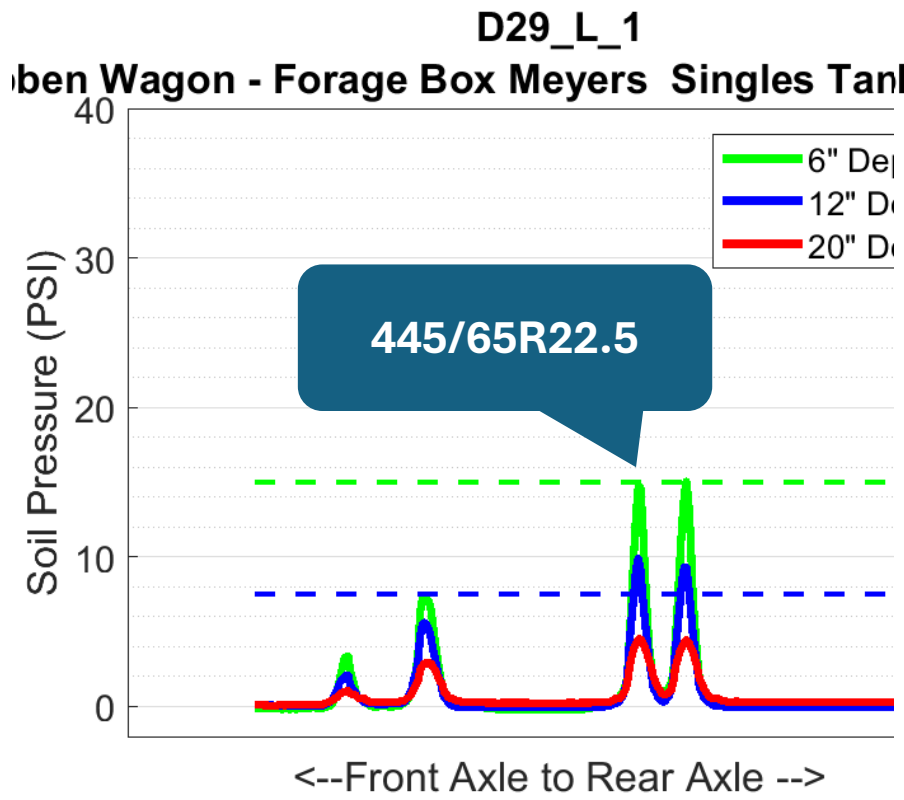
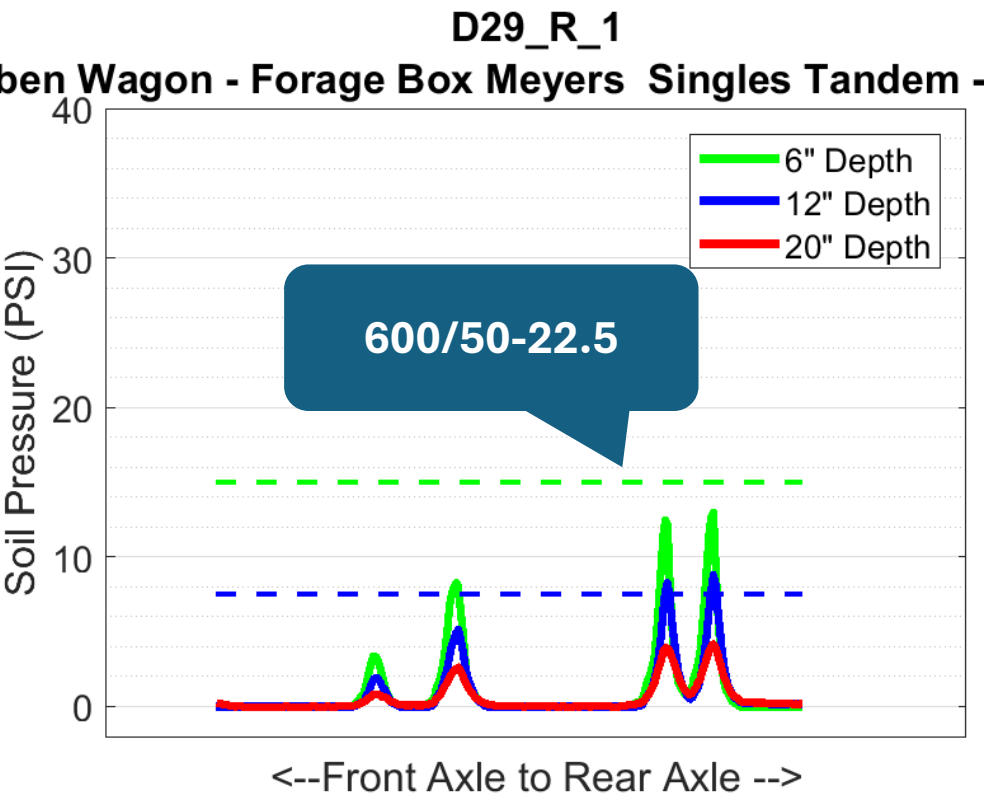
NOTE: Trailer NOT Fully Loaded!

- These plots show two types of tires, narrower radial vs wider bias
- The plot D29_R_1 shows a slight reduction in stress with a slightly larger tire despite it being a bias, but its size for the less than full load meant a lower recommended PSI.
- Size does matter! But the combination of size, tire type (VF>IF>Radial>>>Bias), and PSI means there are some variations in the “rules”. If the trailer had been full we would assume the Radial would have out performed the Bias tire.
- Stress at 20 inches was comparable.

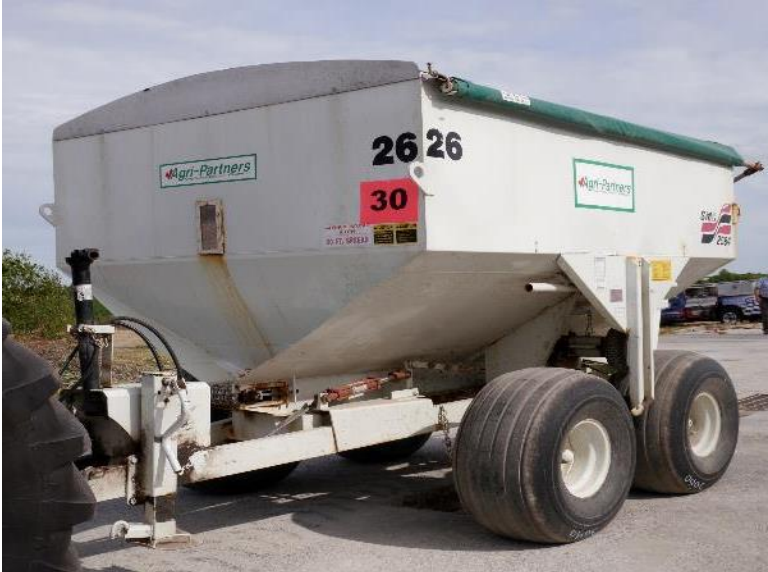
D30_2

- This plot shows that even at a reasonable 26psi, a bias ply tire with a round profile can put high stress in the topsoil, especially near the surface.
- The spreader was not full and had it been full we likely would have seen more stress at both the 12” and 20” sensors.
- Avoid bias ply tires on any implement that carries weight in the field
- The tractor tires did not line up with the spreader tires so no sensing was recorded for it.

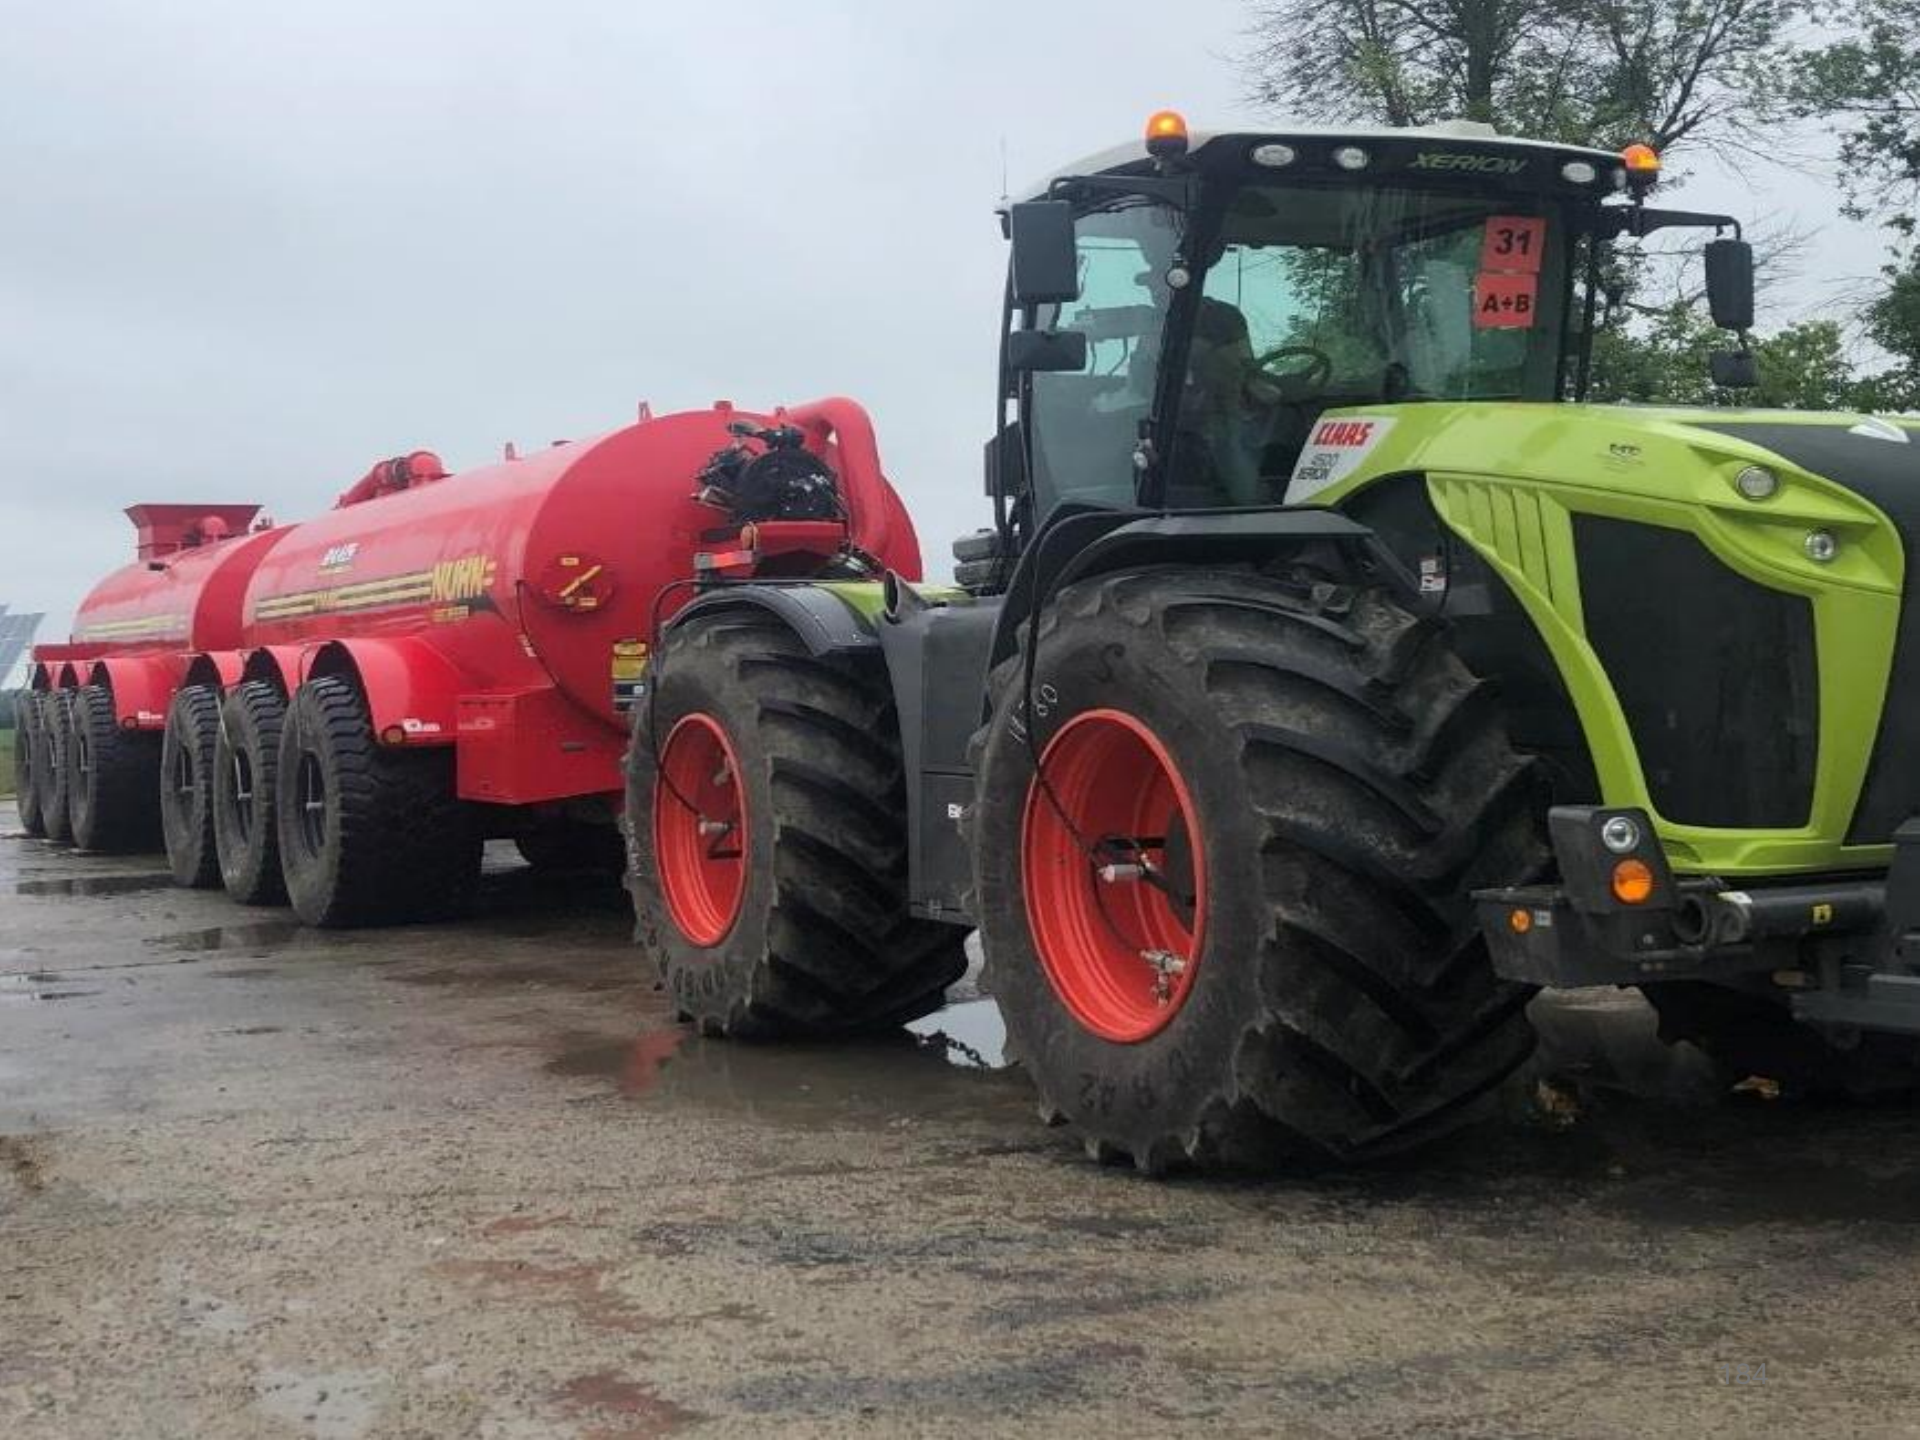
Exhibit: D31

**Nuhn Quad-Steer 17000
Liquid Manure Spreader w
35.5s + Class Xeron 4500
Tractor w Single 600s**

Spreader Tires: 35.5LR32 = 900/60R32

Equipped with CTIS

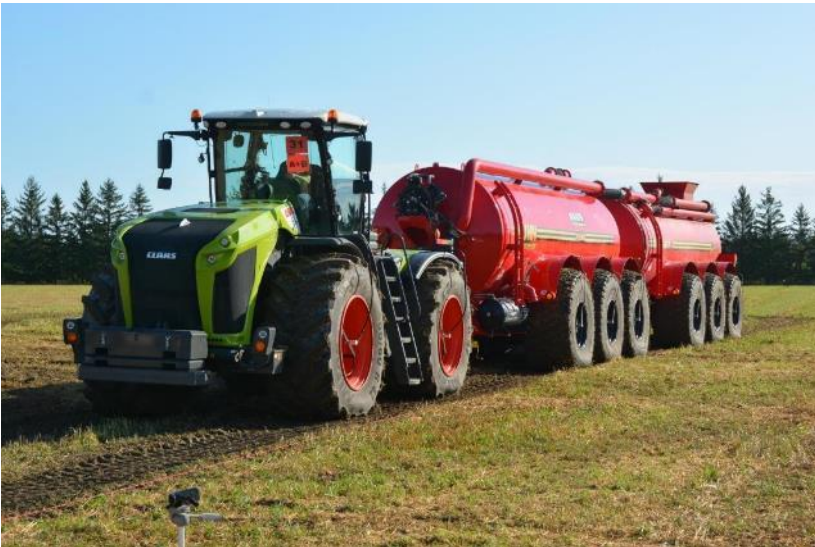
Graph 1

- Similar results to other CTIS systems
- Comparing the high pressure tires to the low pressure tires shows reduction of stress at 6 and 12 inches showing that the larger footprint at low PSI is distributing the weight more at those depths.
- Gr1 shows low vs high PSI on thurs am & Gr2 thurs pm which is after rain on the wed night.
- Gr 3 (Low) and 4 (High) show the testing issue with our method where even with big tires you can get different readings because the tires tracking slightly differently as they cross the sensors between passes.
- The heavy weight still creates high stress at 20 inches regardless of pressure
- This configuration really shows the benefits of CTIS even for the relatively low weight tractor, but big time for tankers.

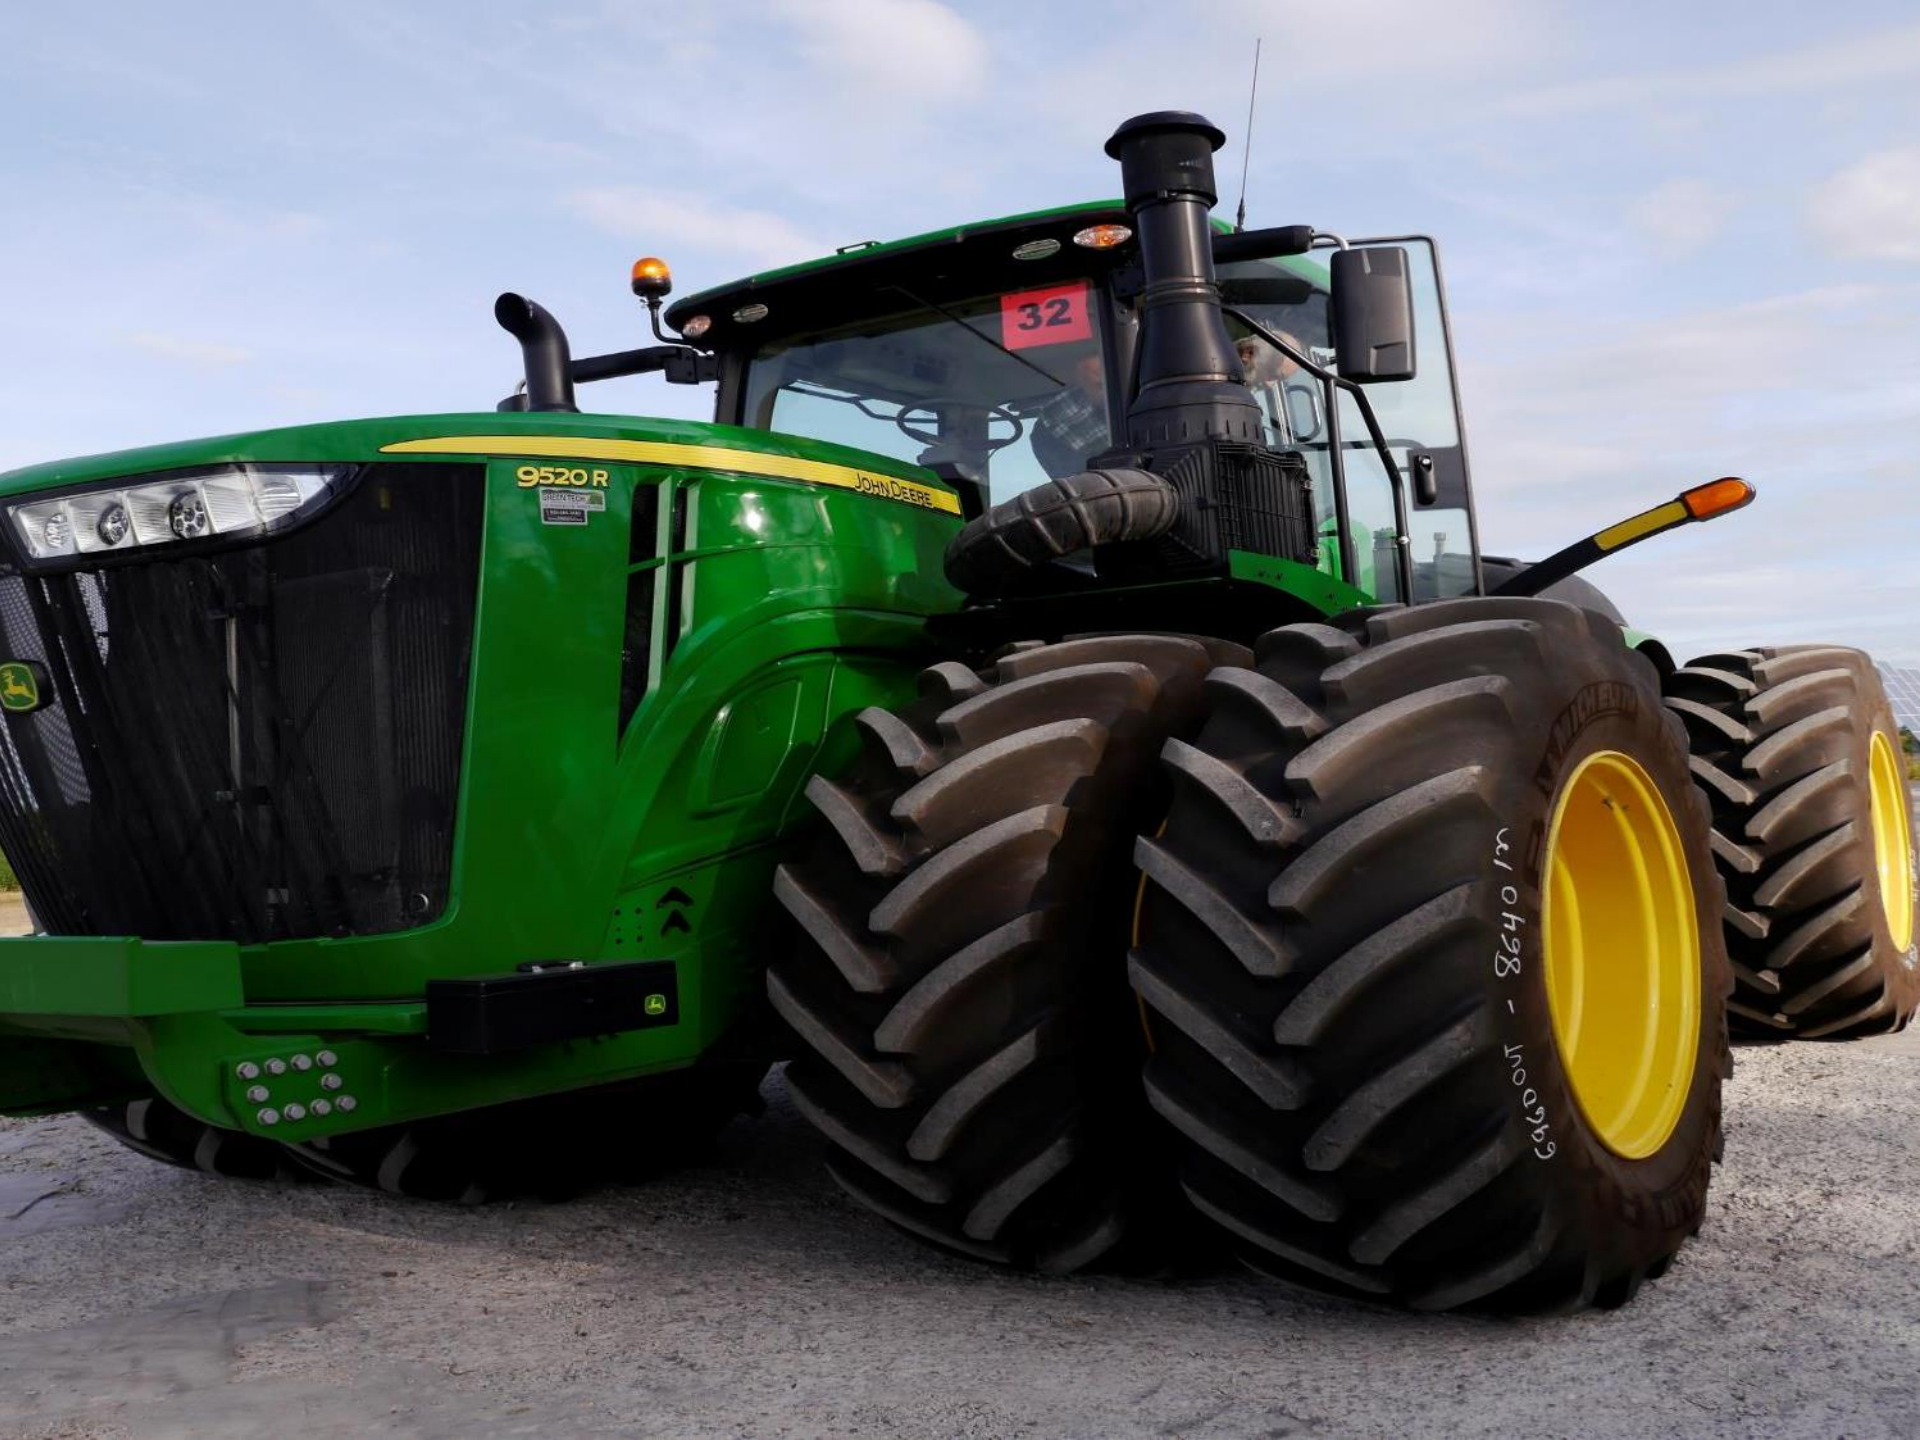
Exhibit: D32

**JD 9520R Articulated Tractor
w Dualled IF 710s**

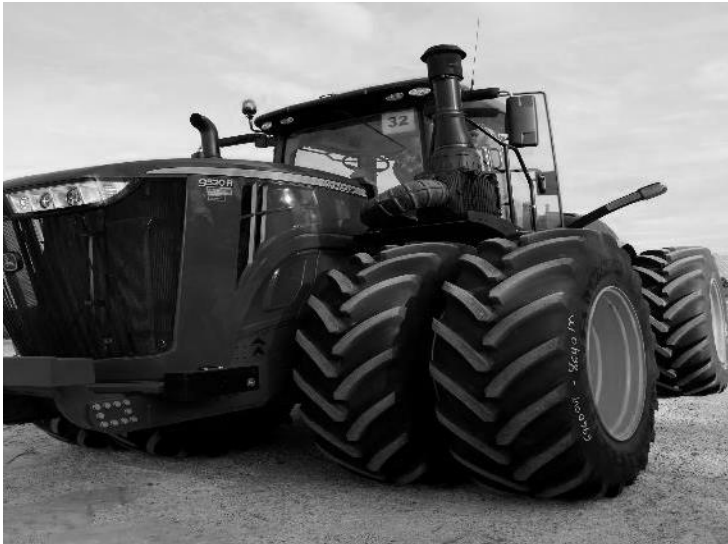
D32_2

- This configuration with IF 710 Duals is providing lots of contact with the soil to spread the weight.
- The target should be 5000 lbs maximum tire weight at less than 15 psi
- This configuration is expensive so people have to weigh the pros and cons of striving for these parameters but it shows that even big equipment can be configured to reduce the threat of compaction.
- Note that all the response is detected at the 6” depth and although we would like less, stress deeper is more of a problem.
- This configuration results in low concern for compaction under these soil conditions at 12 and 20” depth.
- The testing of this exhibit was before the rainfall.

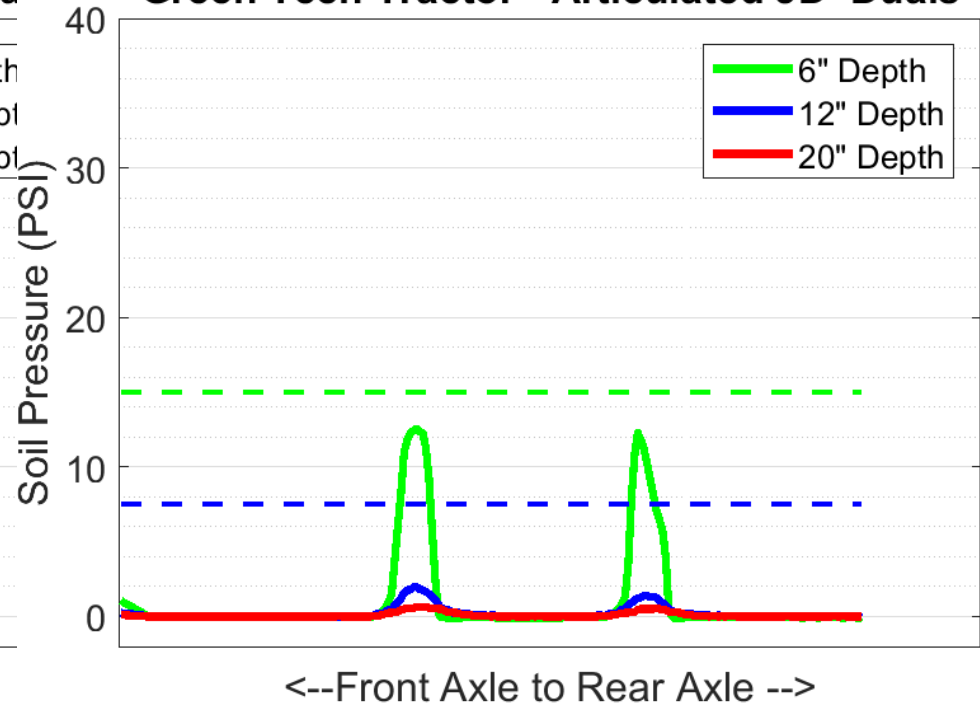
D32_Left_2

Green Tech Tractor - Articulated JD Duals

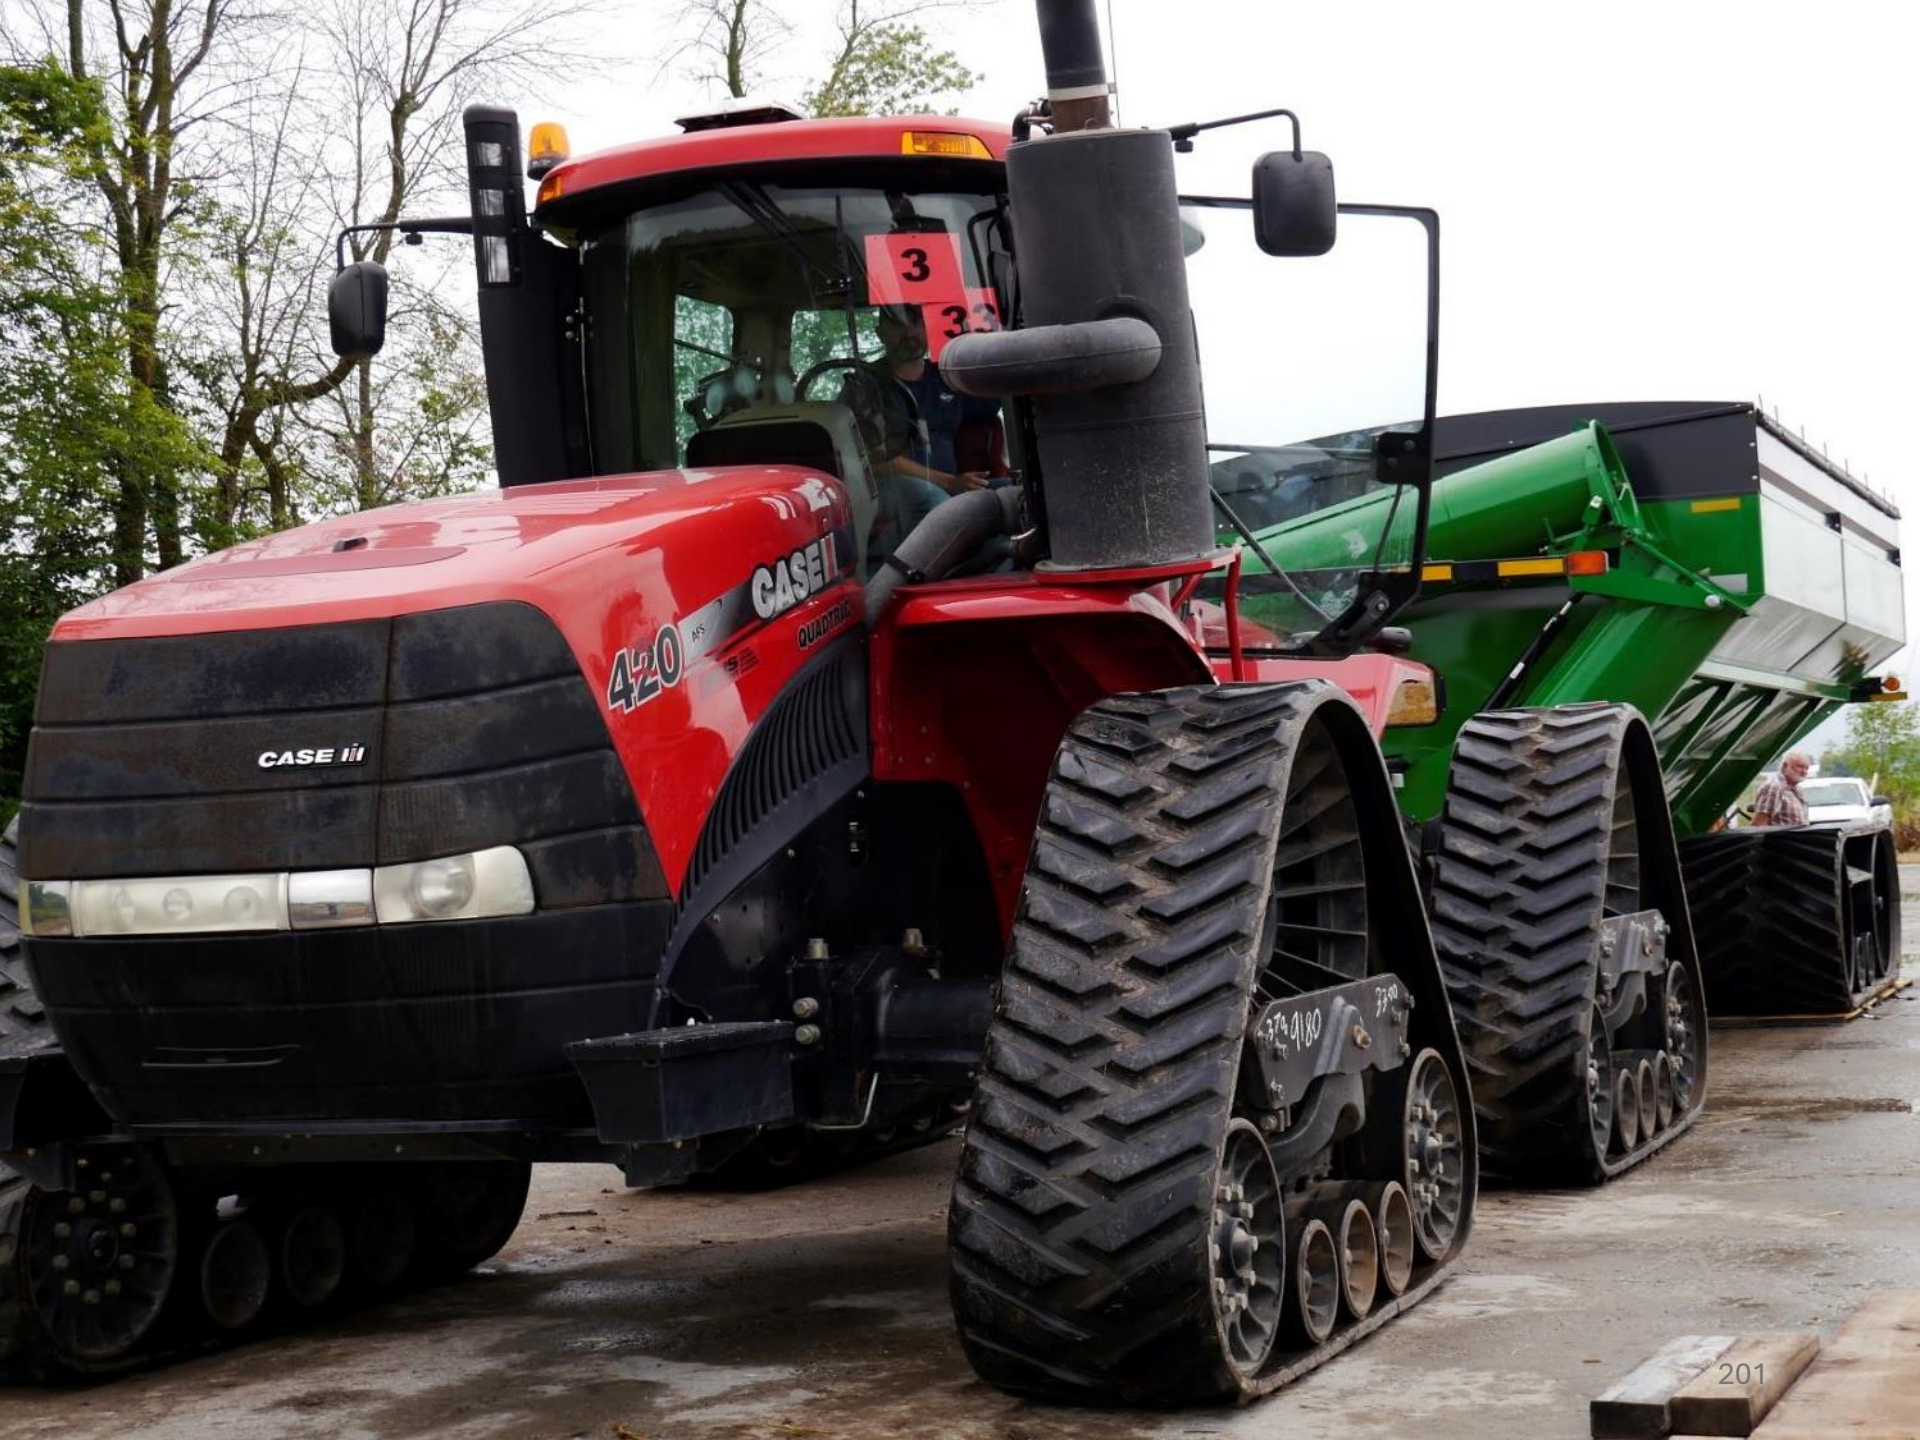
Exh: D33 + D3

**Unit D33+D3
CaseIH STX420 Articulated
Narrow Track Tractor +
Unverferth 1110 Tracked Grain
Buggy**

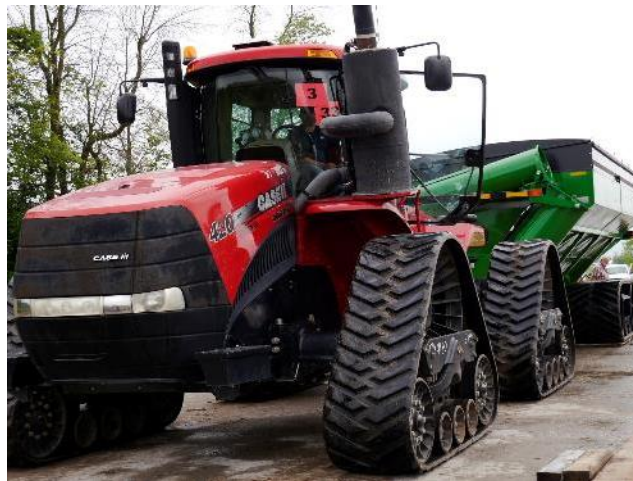
D3_withbigbuggyD33_3

- This buggy is heavy, higher stress in the lower depths when compared to lighter equipment.
- Heavy weights that drive soil compaction deeper due to sheer gross weight require more expensive and exhaustive recovery, even with tracks we are seeing significant weight being transferred deeper into the soil
- The variation in the green curve on both plots may be due to lug spacing and roller contact.

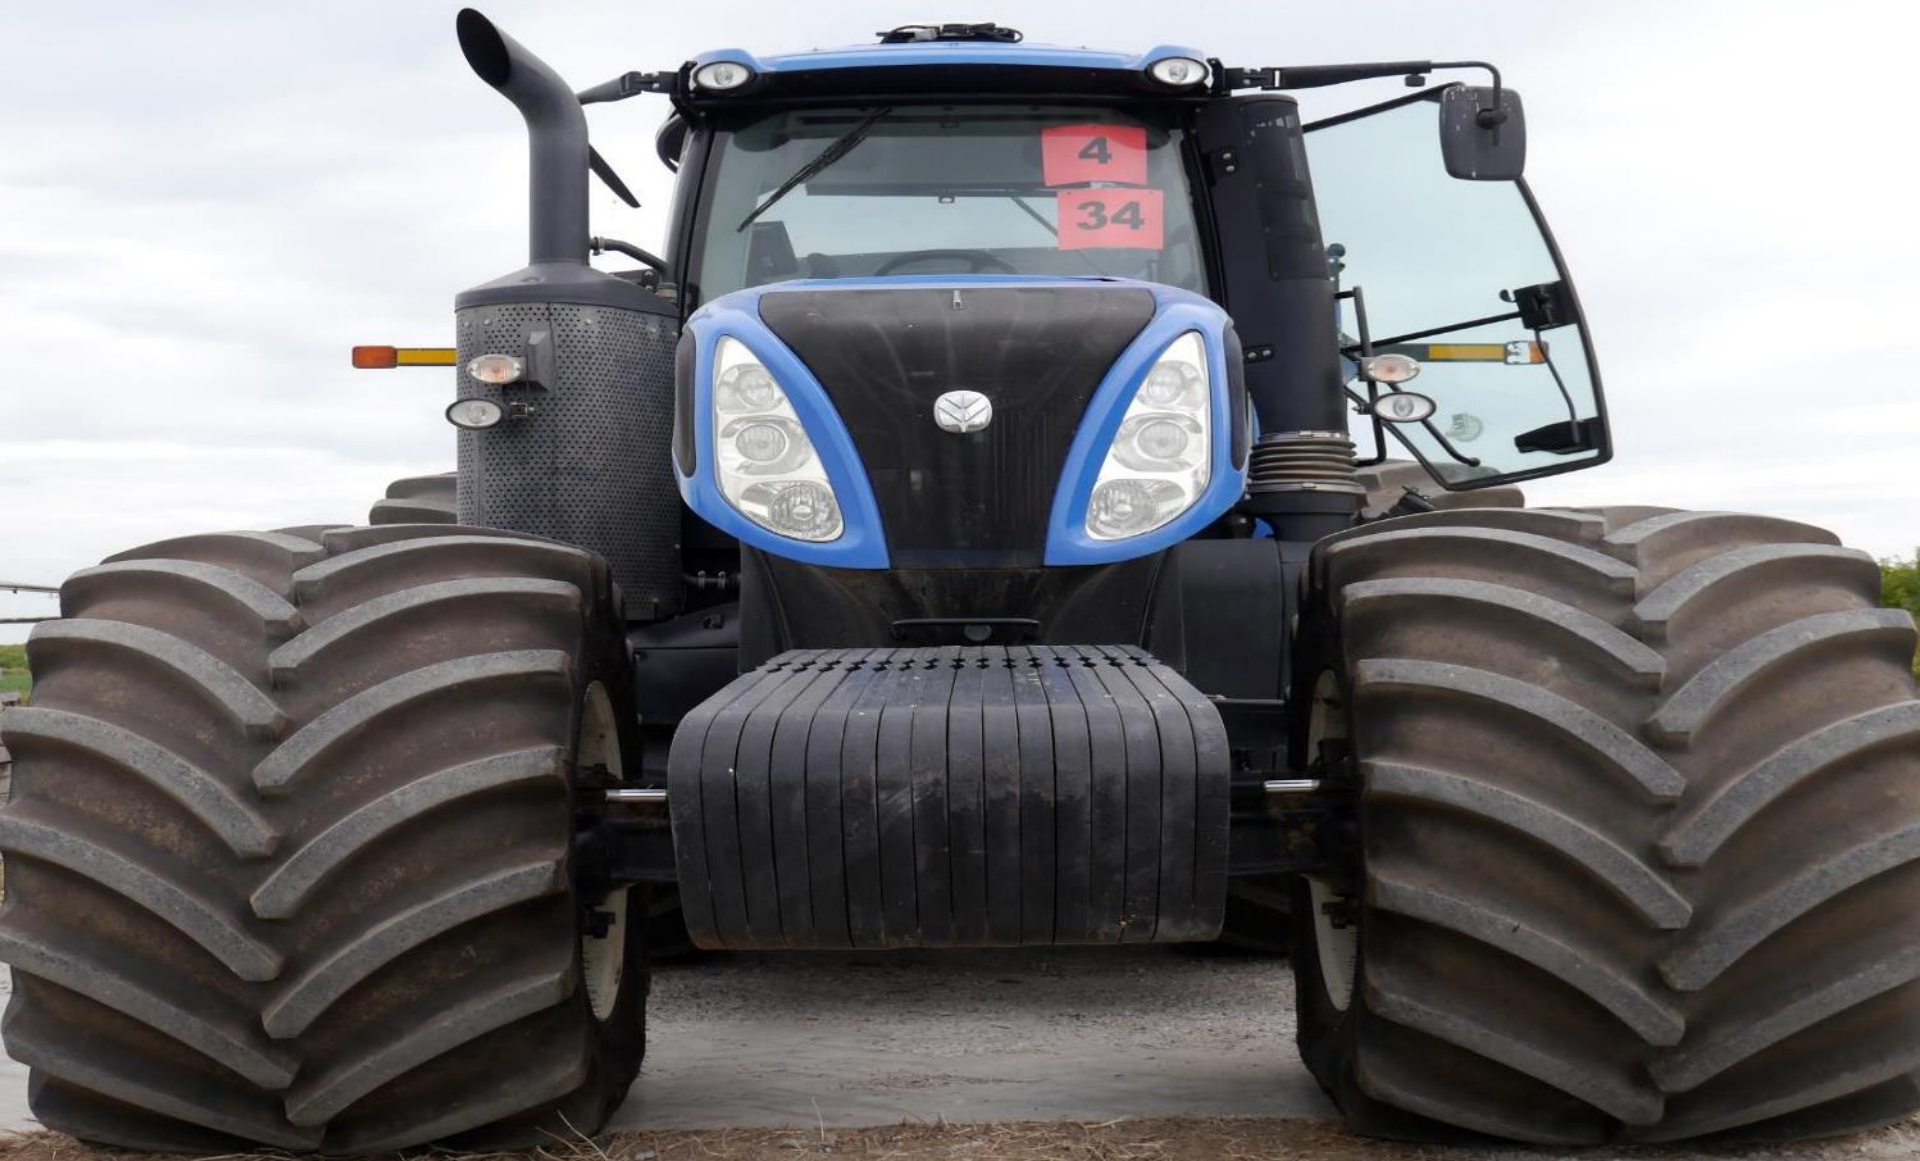
Exhibit: D34 + D4

**J&M 812X Grain Cart w 1050
Singles + NH T8.380 LSW 1000
Singles Row Crop Tractor**

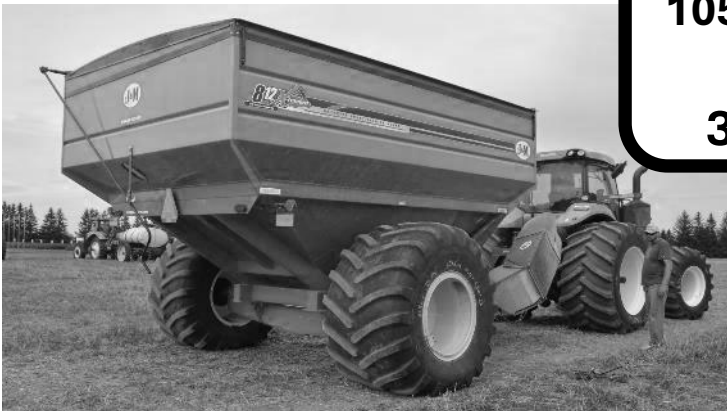
D34_1

- Very heavy single axle buggy
- Generates high stress as depth
- Based on the axle weight this buggy should have more tire on it or not be filled when soil conditions are wet

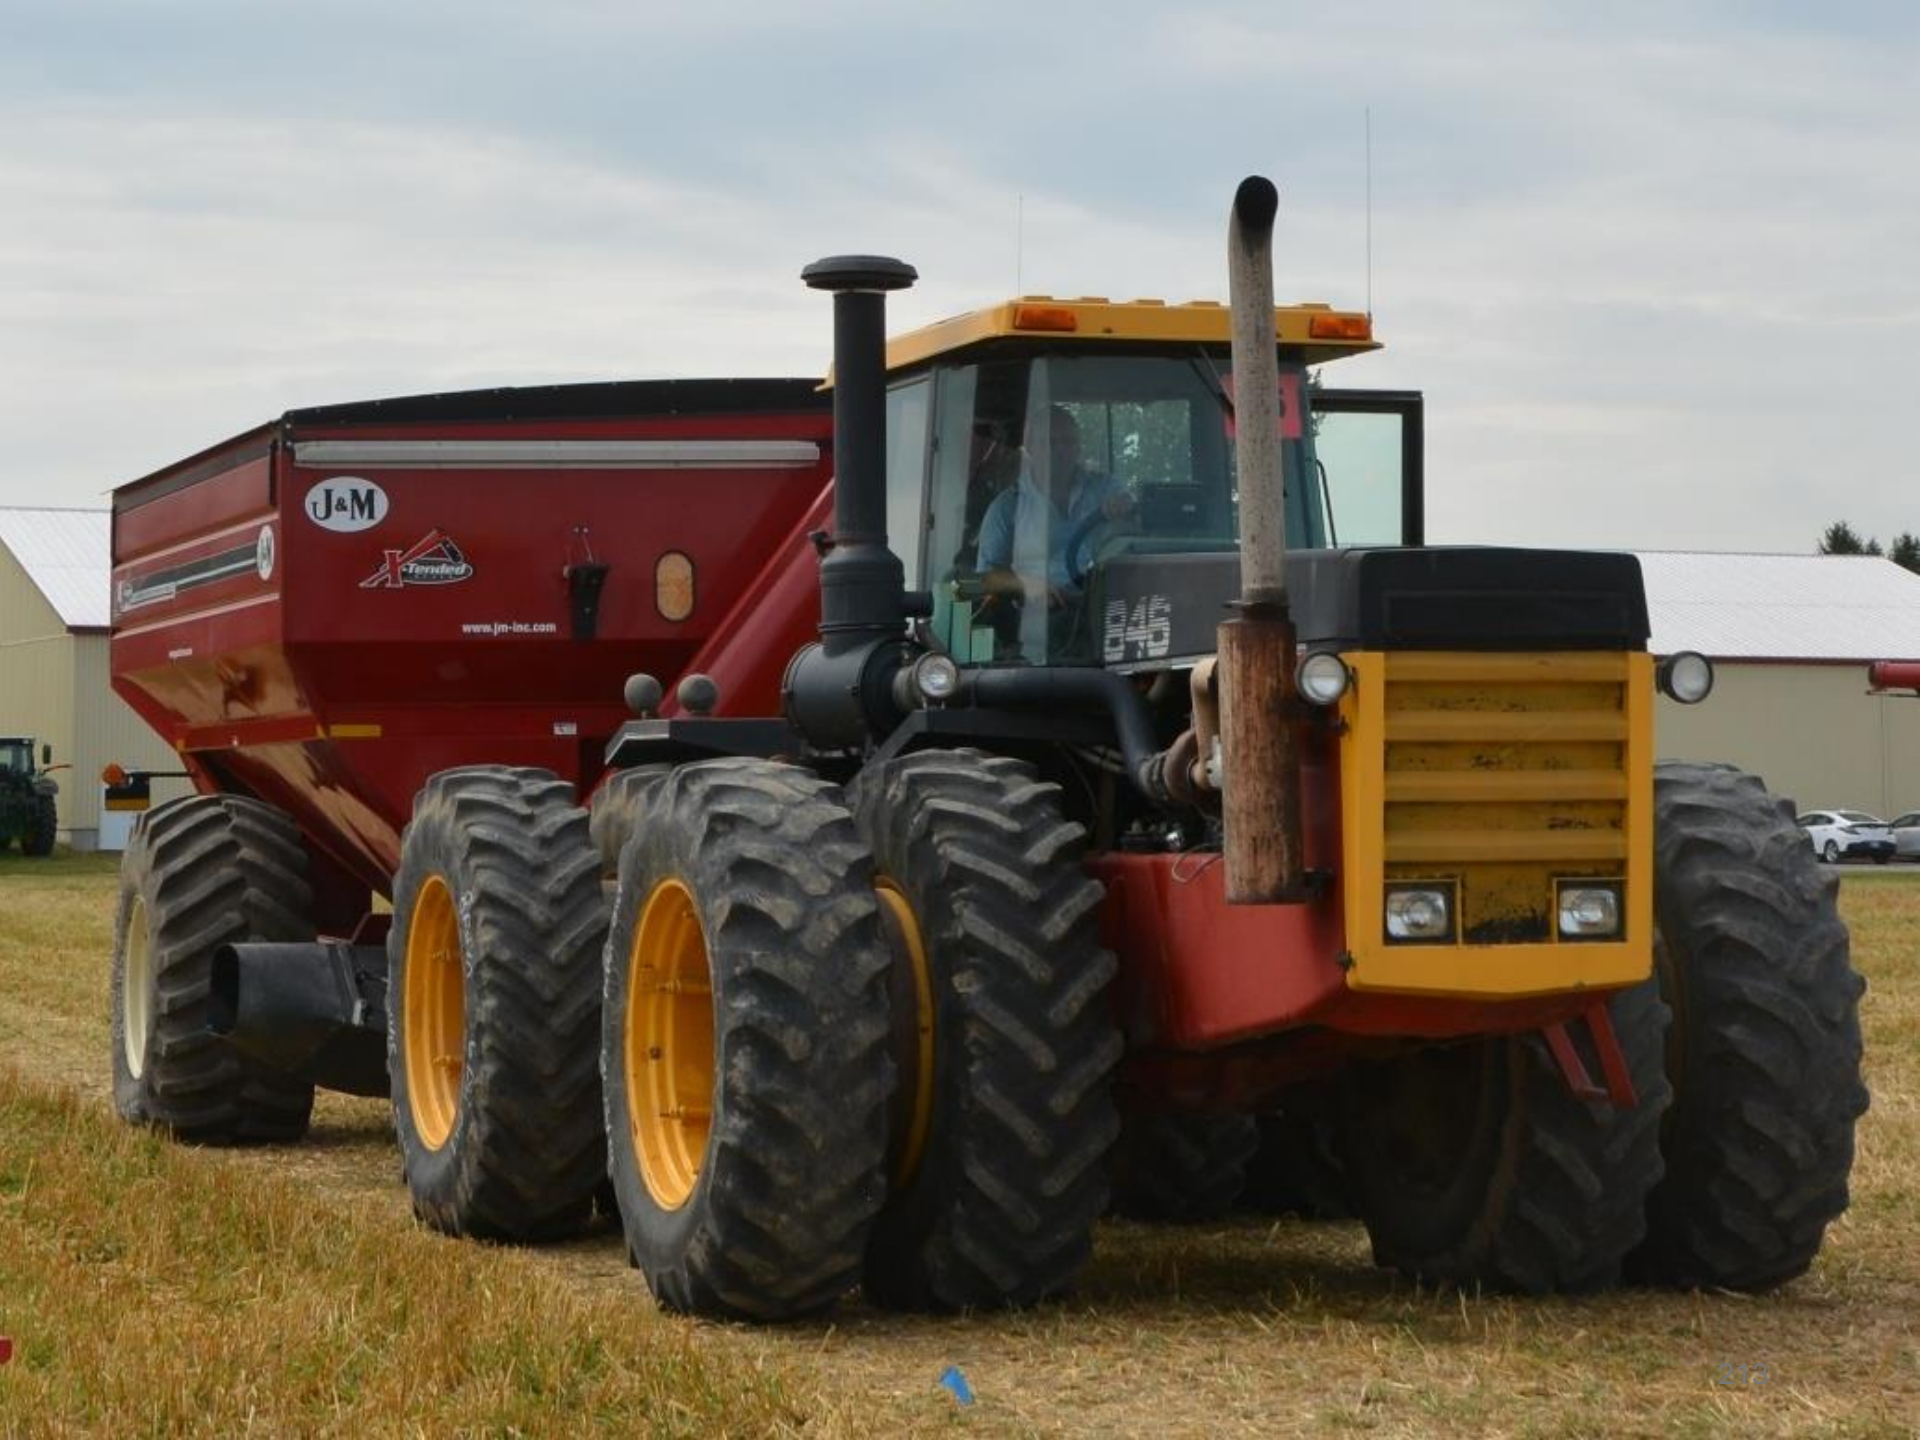
Exhibit: D35

**J&M 810 Grain Cart w 30.5L32 +
Versatile 846 Dualled
Articulated Tractor w 20.8R32**

50,110 lbs (22.7 T)

- High axle weight on the grain buggy creating a high stress in the entire soil profile.
- Note that the tractor is well configured in terms of compaction avoidance under these soil conditions.
- This is the stark example where single axle grain buggy's are too heavy. The solution is more axles, tracks, or don't fill the buggy on each trip across the field.
- This is indicated by the stress detected at all depths of the sensors.
- This is one of the pieces of equipment where compaction at depth is a concern because of total weight.

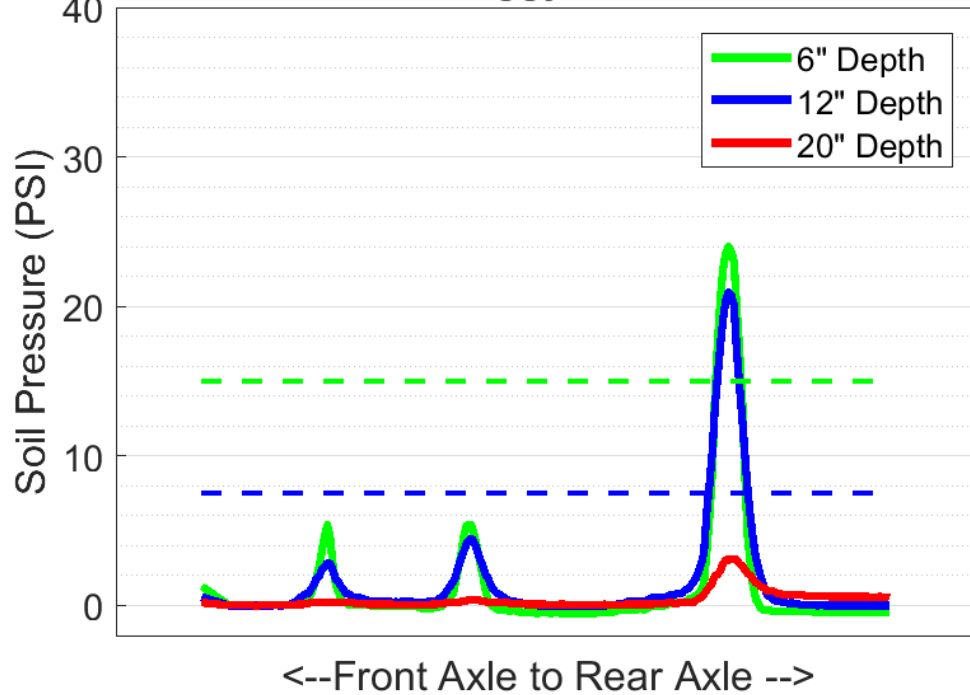
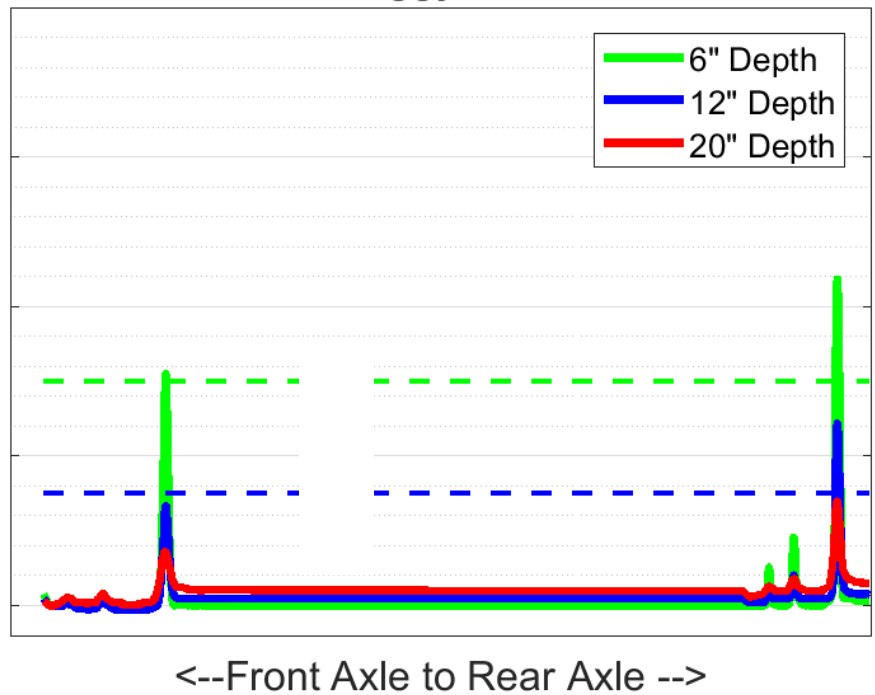
D35_5

- Articulated W Grain Buggy Versatile + J&M 846 + iculated W Grain Buggy Versatile + J&M 846 +

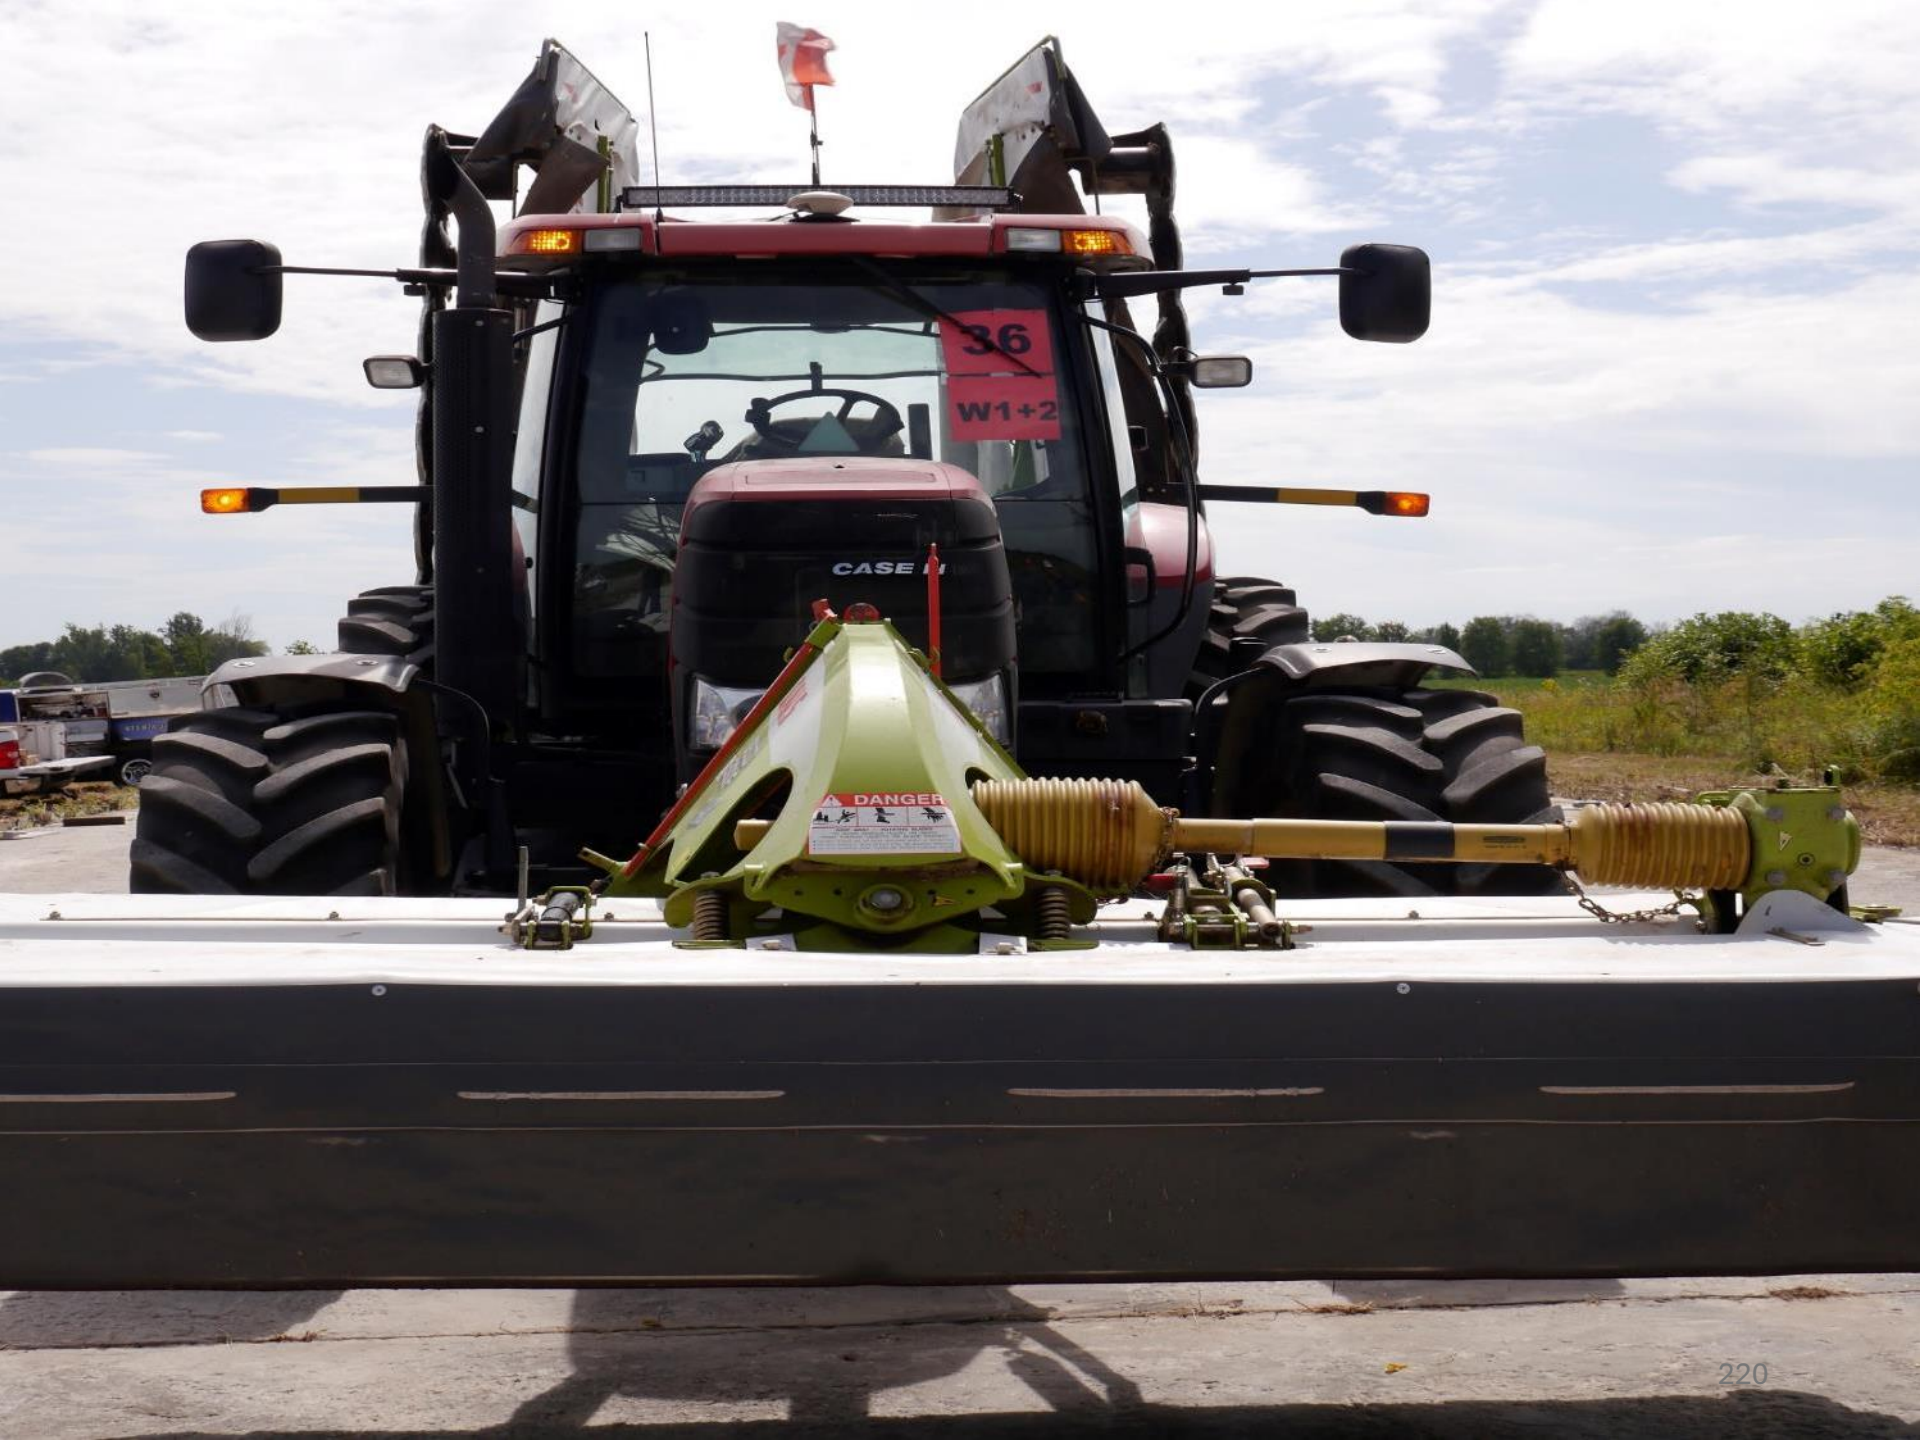
Exhibit: D36

**Claas Disco 3100F Profil
Batwing Mower + CaseIH 115
Puma Row Crop Tractor 480s**

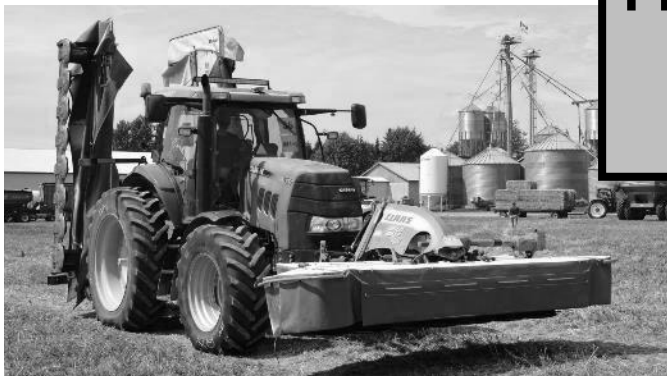
D36_W1_1

Timber Tractor - Row Crop - Tri Mower CIH Puma/Claas 30'

- This setup of radial tires is good for preventing compaction from this implement setup.
- PSI detected at all depths is below threshold.
