2019 Dundas SCIA Compaction Event

Winchester, Ontario

August 29th, 2019

Dundas SCIA Compaction Event

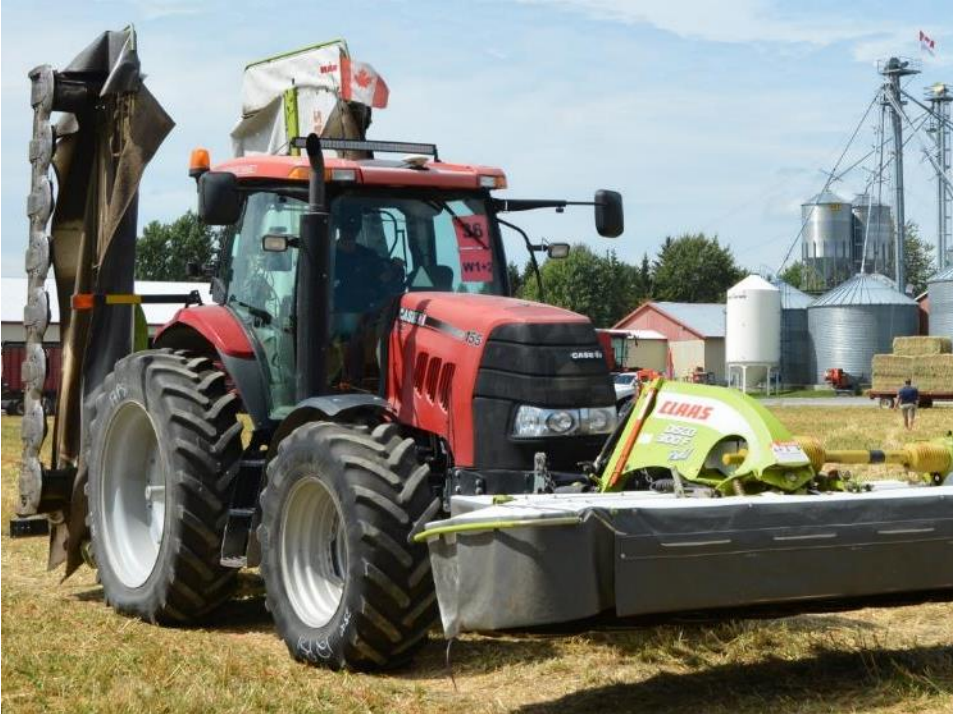
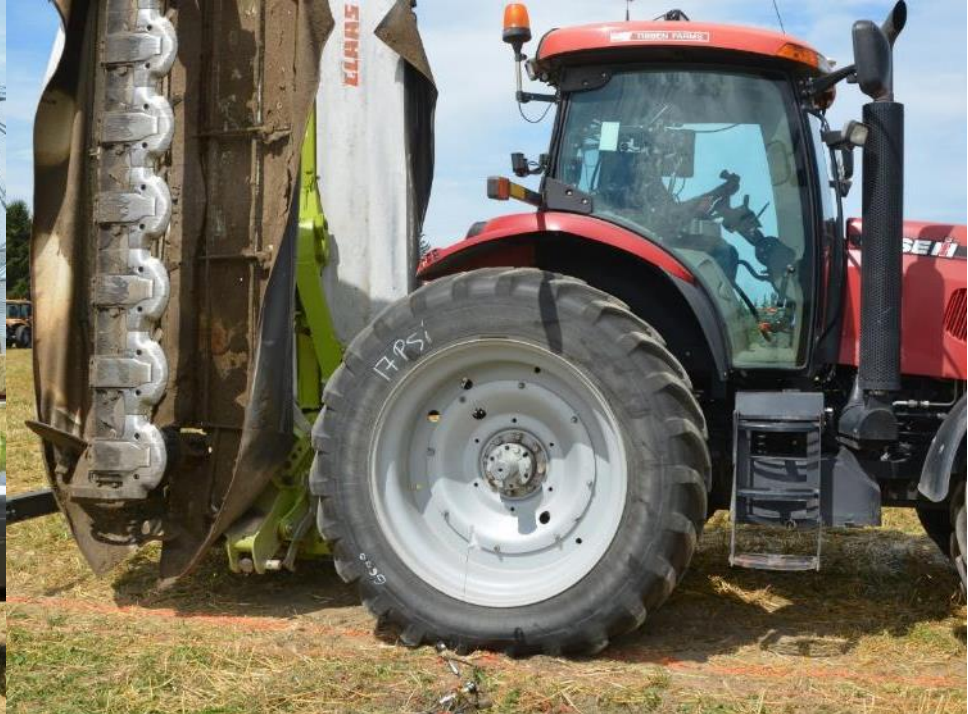
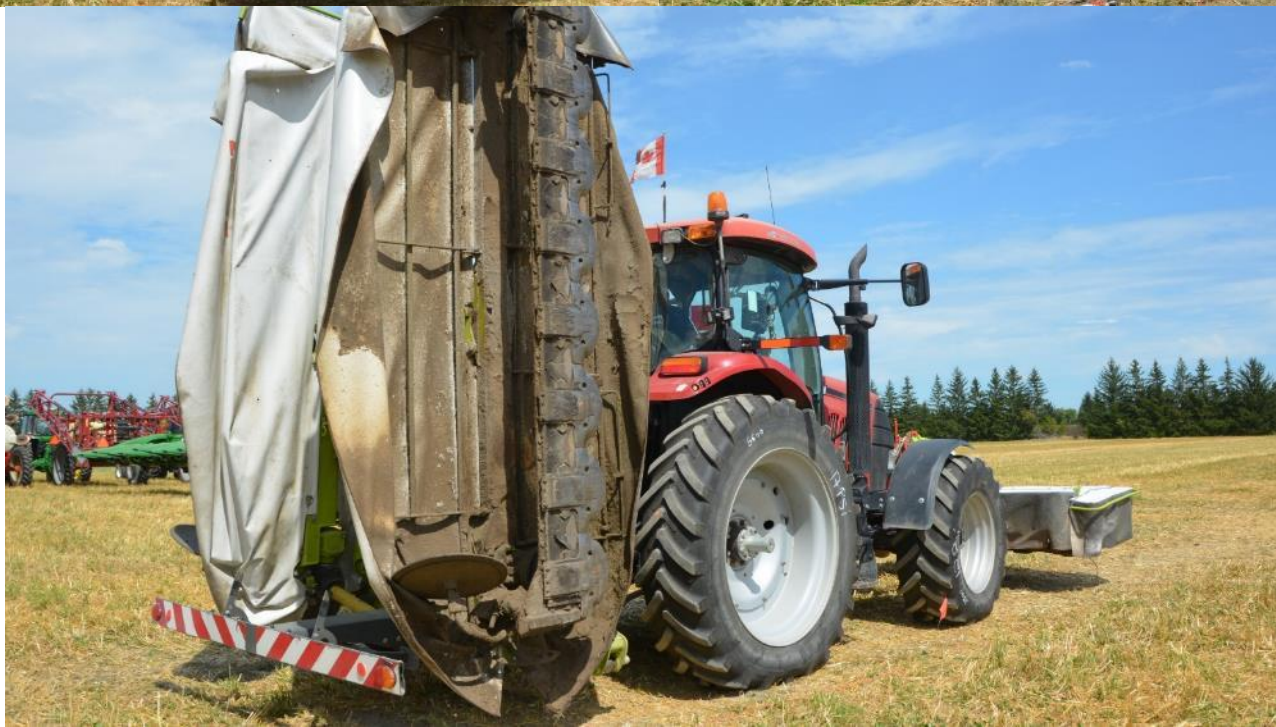
Plot Comments – D36

- This setup of radial tires is good for preventing compaction from this implement setup.
- PSI detected at all depths is below threshold.

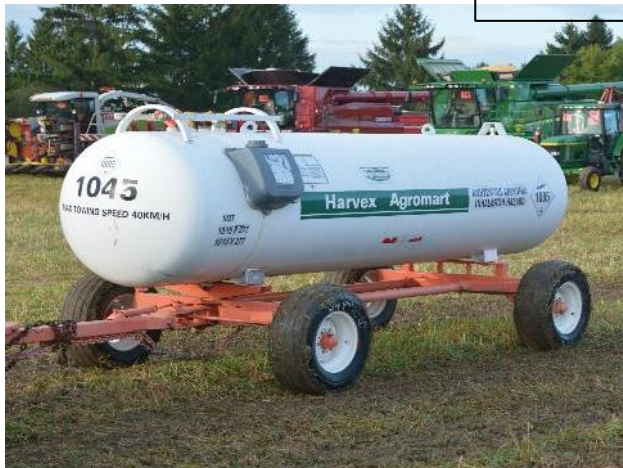
D37_3

Harvex Wagon - Anhydrous Singles - 11Lx15

- From the soil perspective, the anhydrous tank and the pickup truck are very similar.
- Stress at all depths for both the truck and tank are below threshold.
- Be cautious of pickup trucks in wet soil when loaded with significant weight in the truck bed.

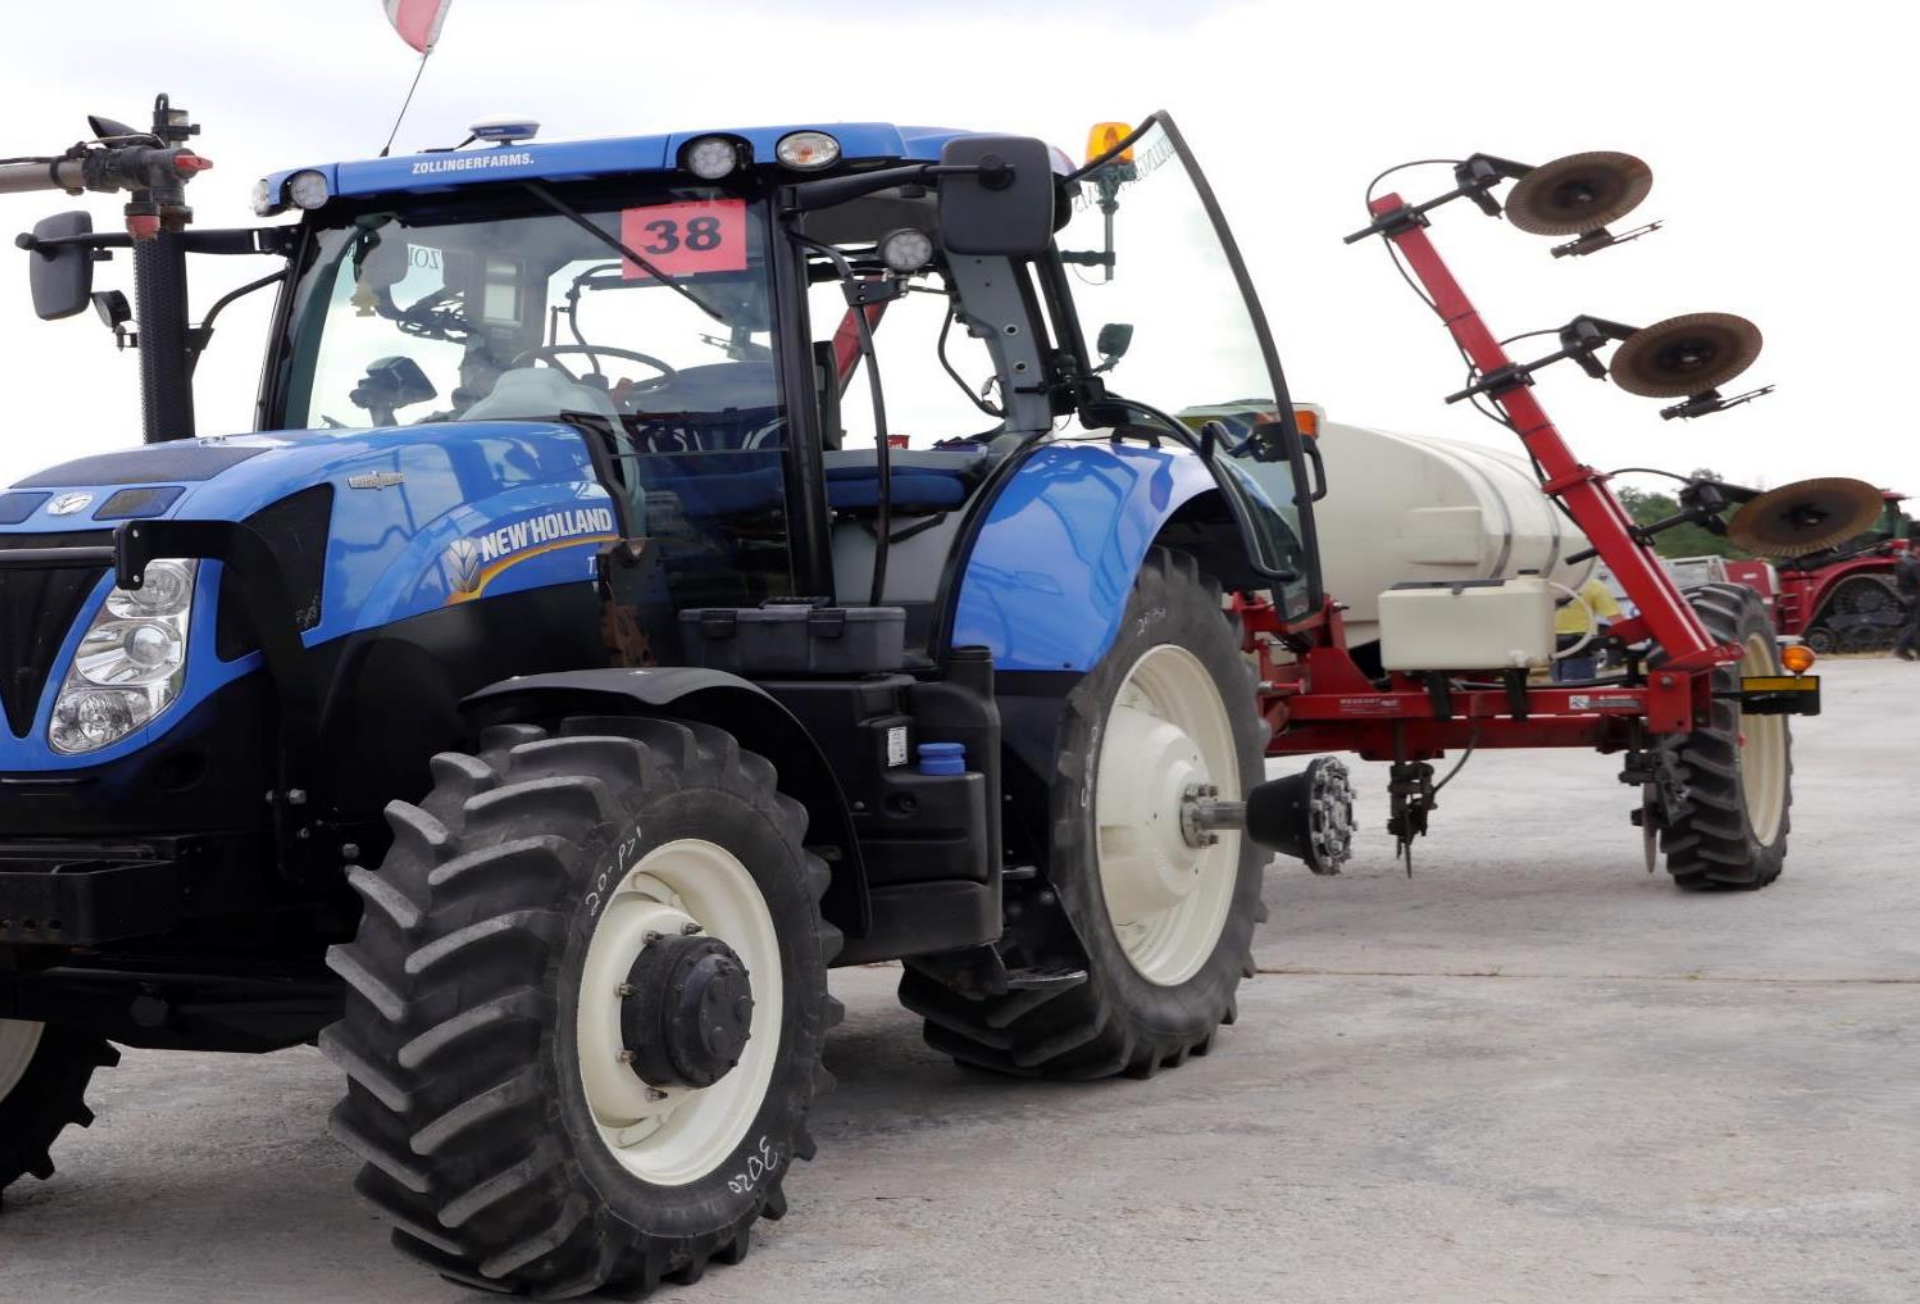
Exhibit: D38

**Farmking UAN Applicator w
320s + New Holland T7.170
Row Crop Tractor w 480s**

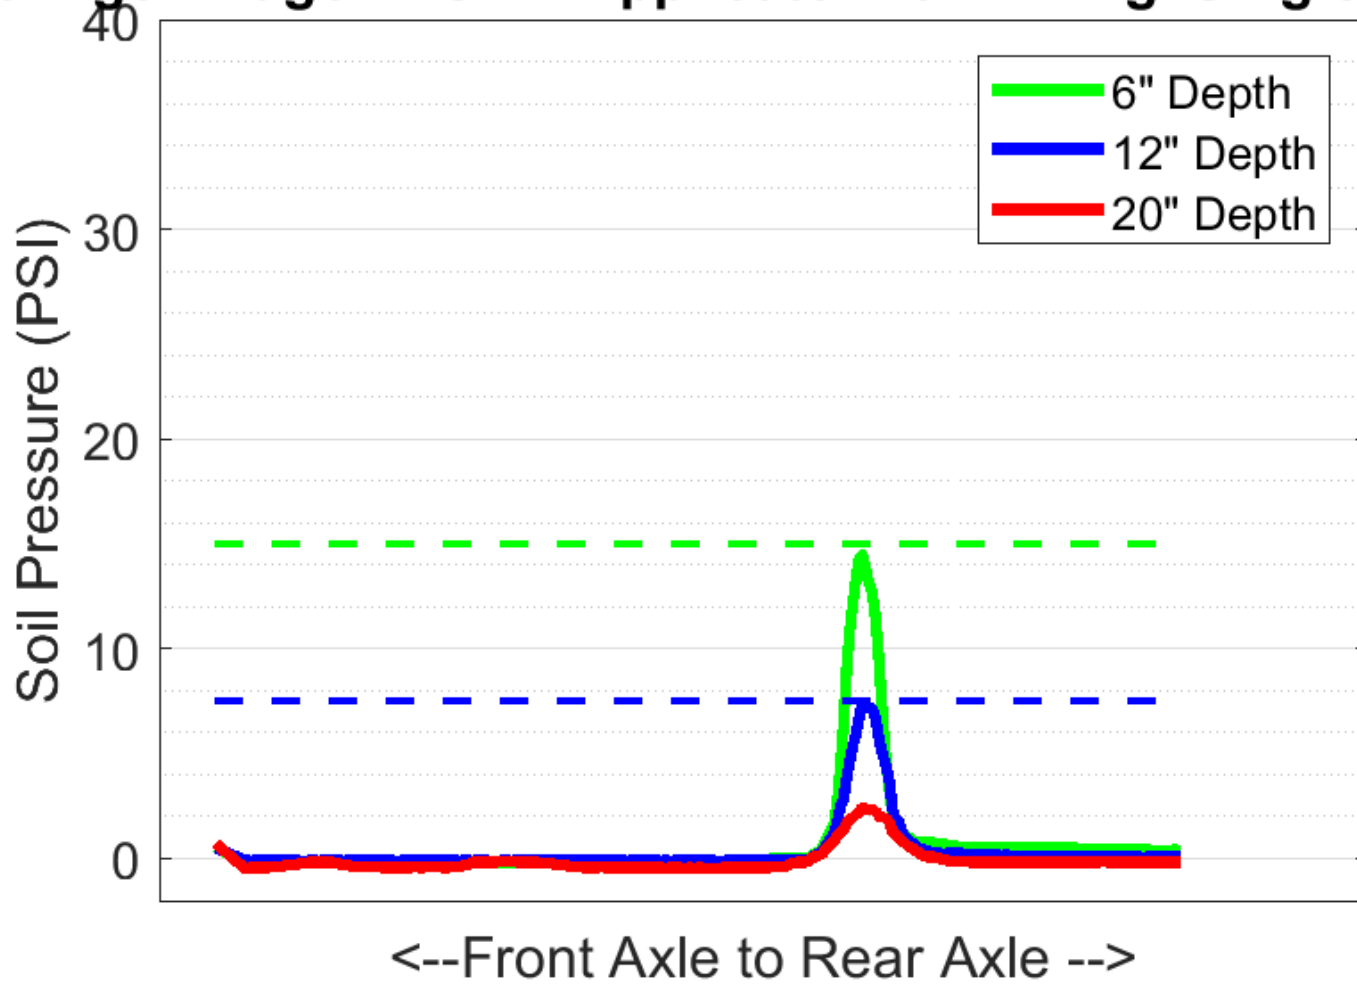
D38_1

Zolinger Wagon - UAN Applicator Farm King Singles - 320

- Moderate axle weight and high tire pressure with narrow tires are to be avoided if trying to reduce the load on the soil.
- Given the soil conditions at the time, this configuration was not as problematic as we might have anticipated although look at the blue line at 12” touching the theoretical threshold line.

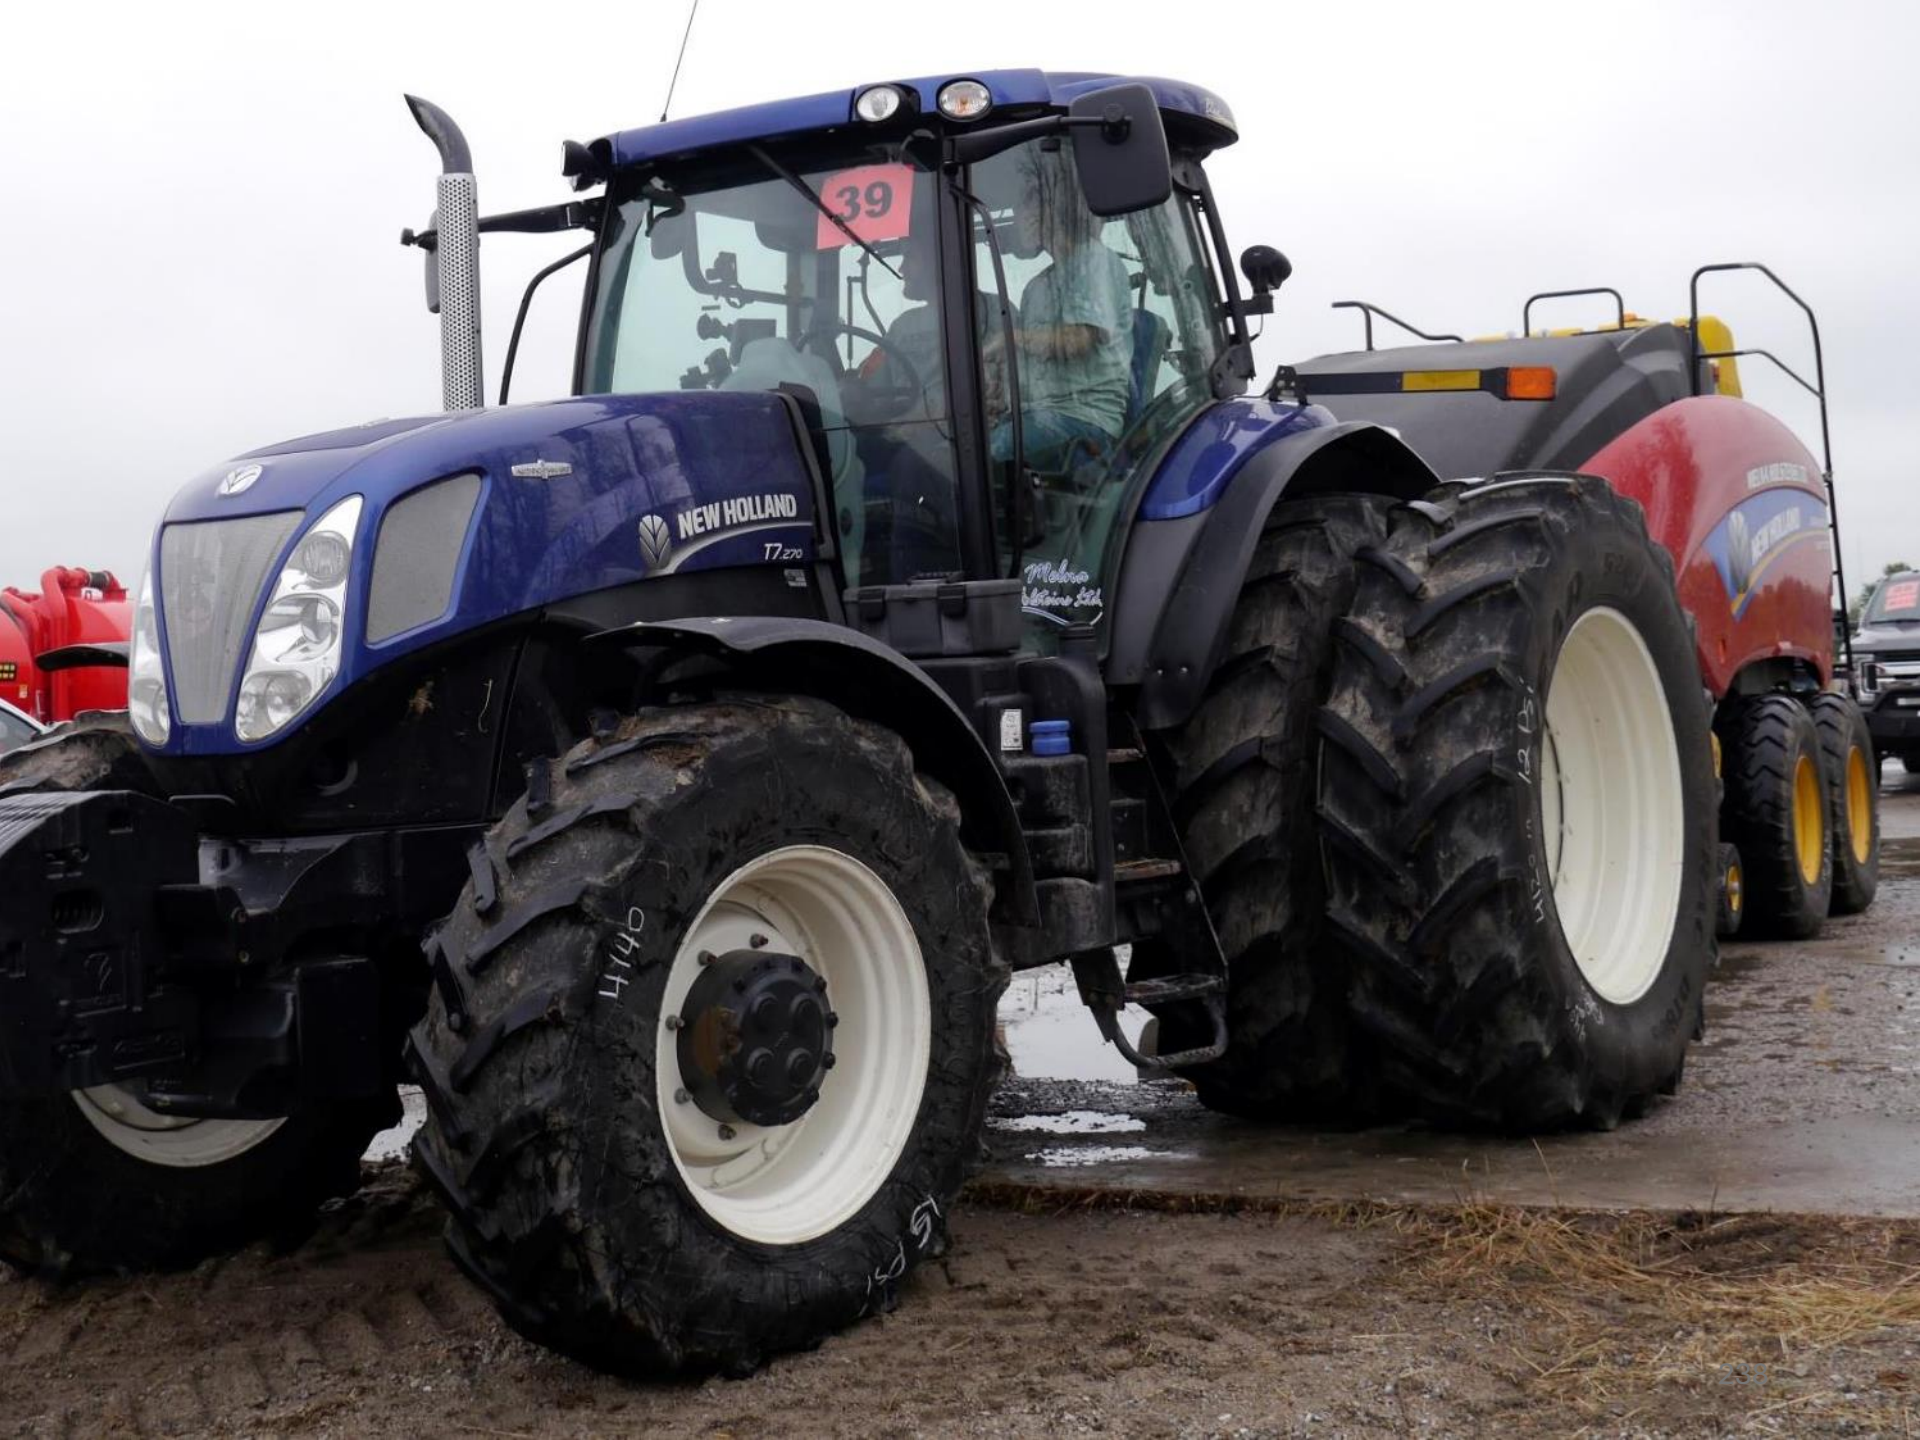
Exhibit: D39

**New Holland 330 Lrg Sq
Baler w 620s + New
Holland T7.270 Row Crop
Tractor w Dual 520s**

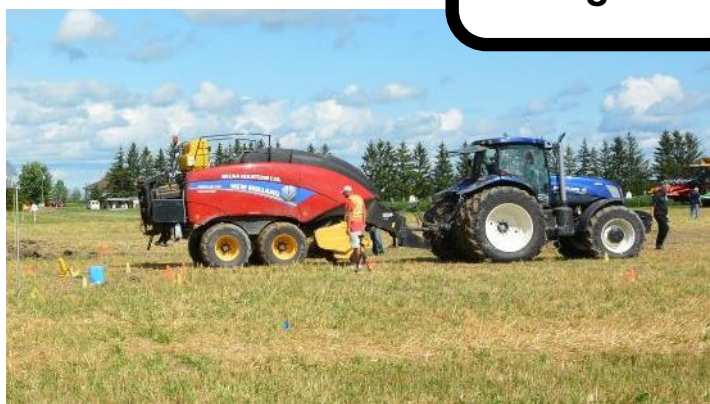
D39_baler_3

Melenhorst Baler - Large Sq NH Singles - Tandem

- This is a good example of the baler being a lighter machine than the tractor, but having a higher stress in the topsoil due to the tire configuration.
- This shows the impact of tire pressure when you look at the tire size relative to the psi for the baler vs tractor tires.
- Although its still a satisfactory configuration, caution in putting a baler like this in the hay field shortly after a significant rain could be problematic.

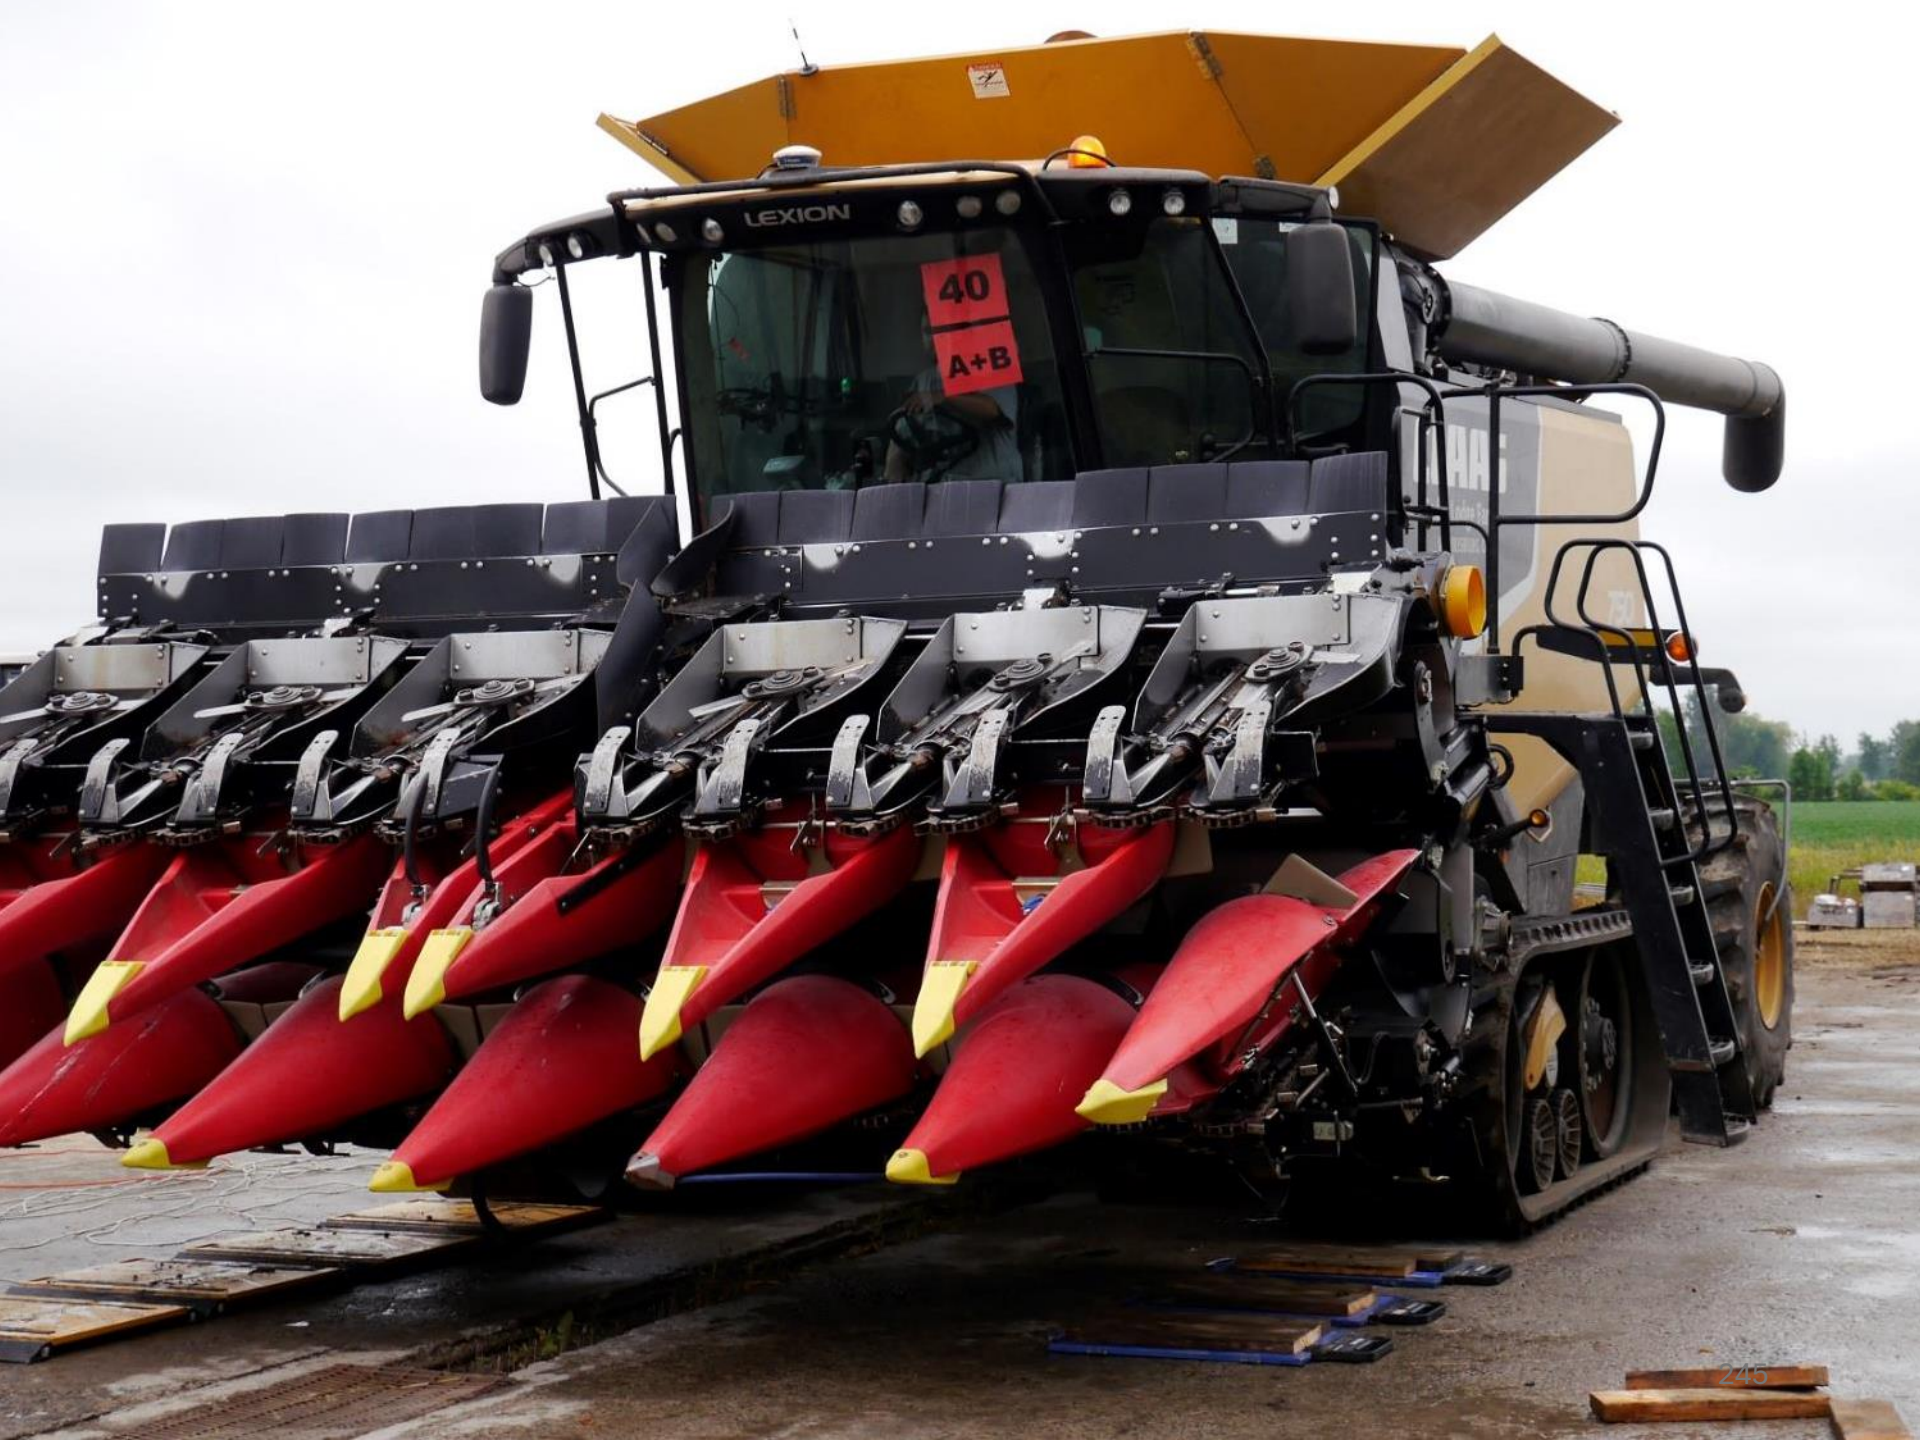
**Exhibit: D40
Class 750T Tracked Combine
with CTIS on Rear 28LR26
Tires**

Rear Tire 30 vs 10 psi

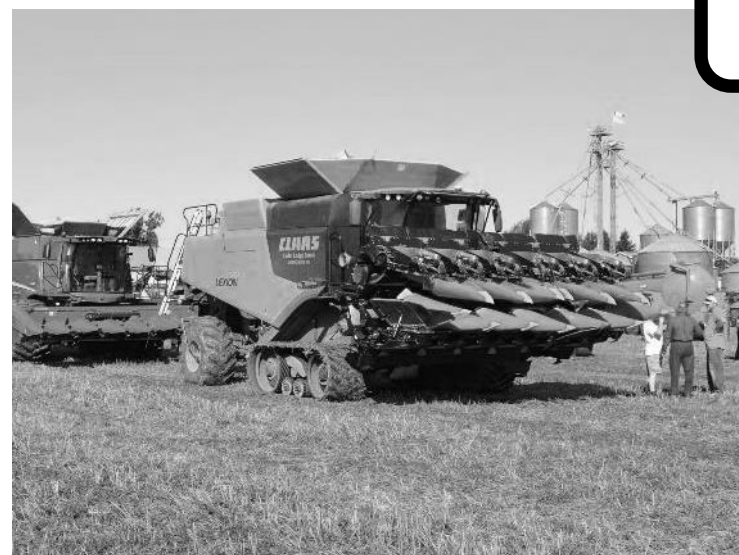
**Steering Tires
Equipped with CTIS to
manage PSI**

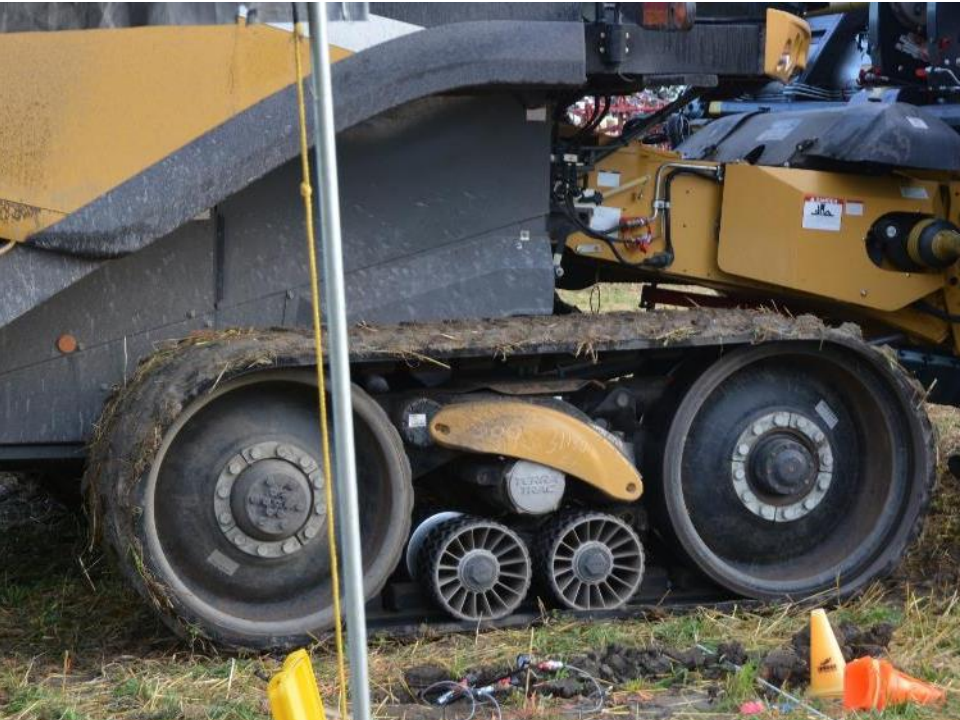
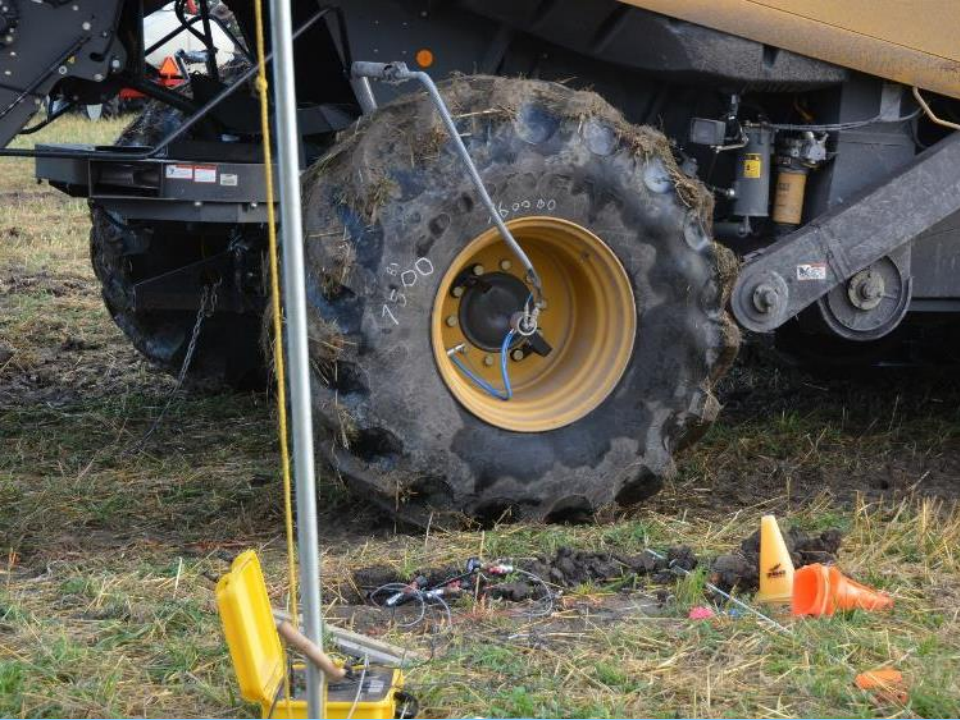
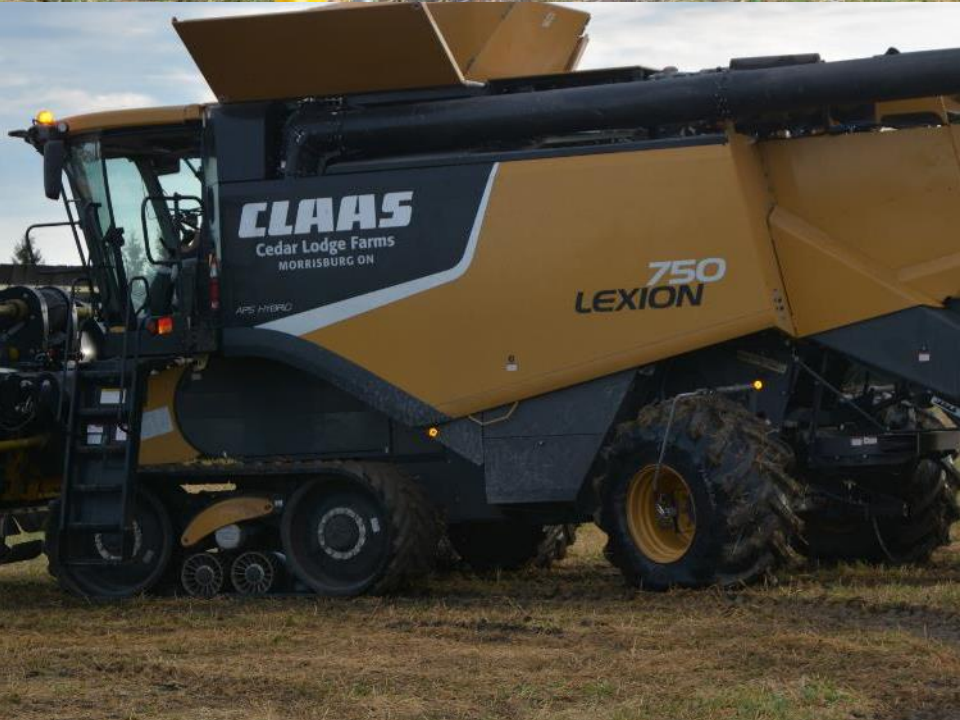
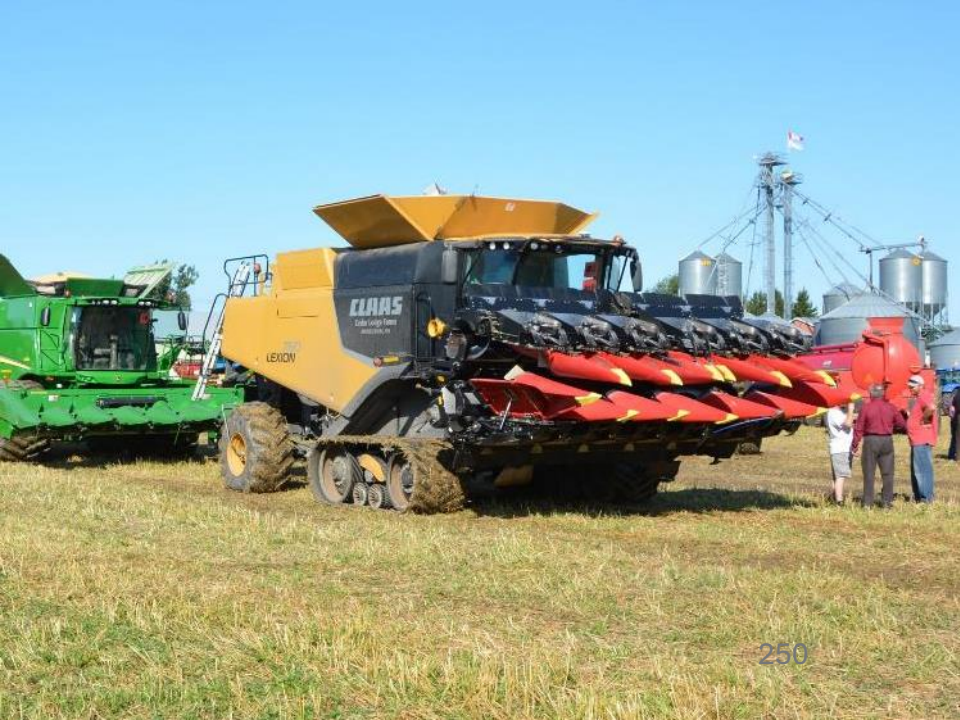
Plot Comments – D40

- This is a good configuration, comparable to dual and large signals.
- This is a very heavy corn head and when using other lighter heads, more weight may be put on the steering tires, which in previous events have shown to be more of a problem than the front wheels or tracks.
- Note that every track boggy wheel shows in the sensors.
- Even with a good configuration, the overall weight of a full combine is putting lots of weight down deep in the soil compared to other configurations tested, ie see the red (lower) line movement compared to many others where we don't see that line move much.

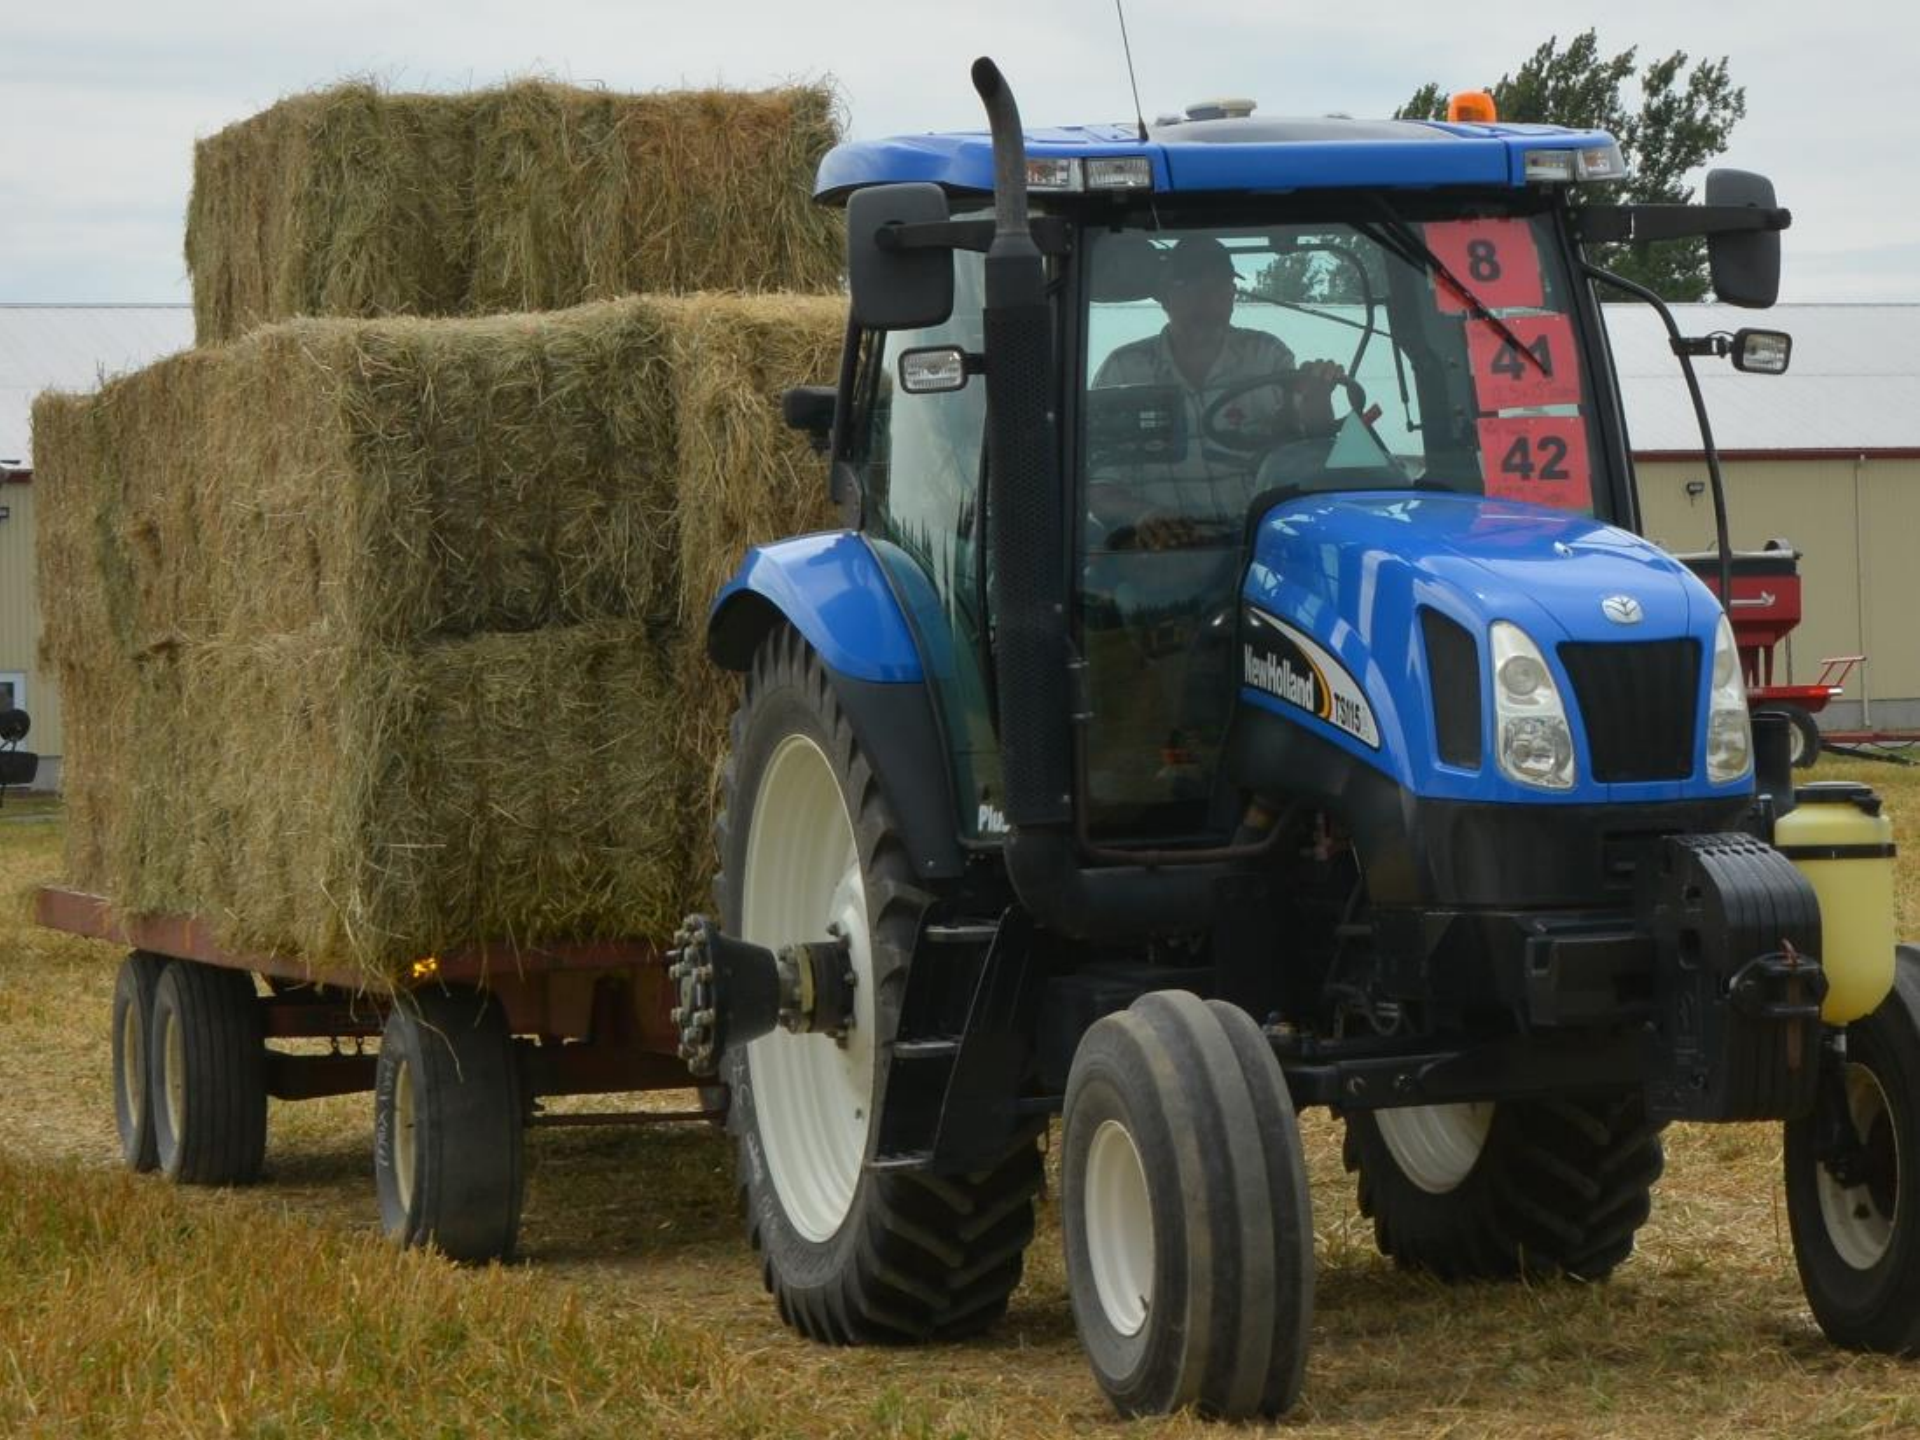
Exhibit: D41+D8

**Hay Wagon Tandem Rear w
12.5Ls + NH TS115A Singled
Row Crop Tractor**

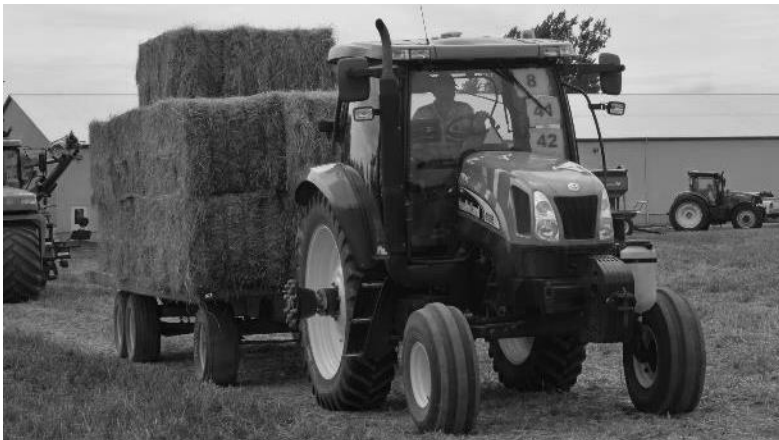
Exh: D 41

- Hay wagons, similar to the gravity wagons. High pressure bias ply tires creating high soil stress.
- Note the difference in the front vs back of the wagon between single vs tandem setup, tandems reduce the load on the soil.
- These tires as bias are quite round making it harder to centre the weigh on the sensor, we might have expected more load response here and rounded tires put more pressure into the soil as the contact area is reduced.
- Compared to D42 with larger radial tires, but single front and rear axles we would have expected high load at the sensors.
- The tractor in this instance was not measured based on tire position relative to the target wagon tires.

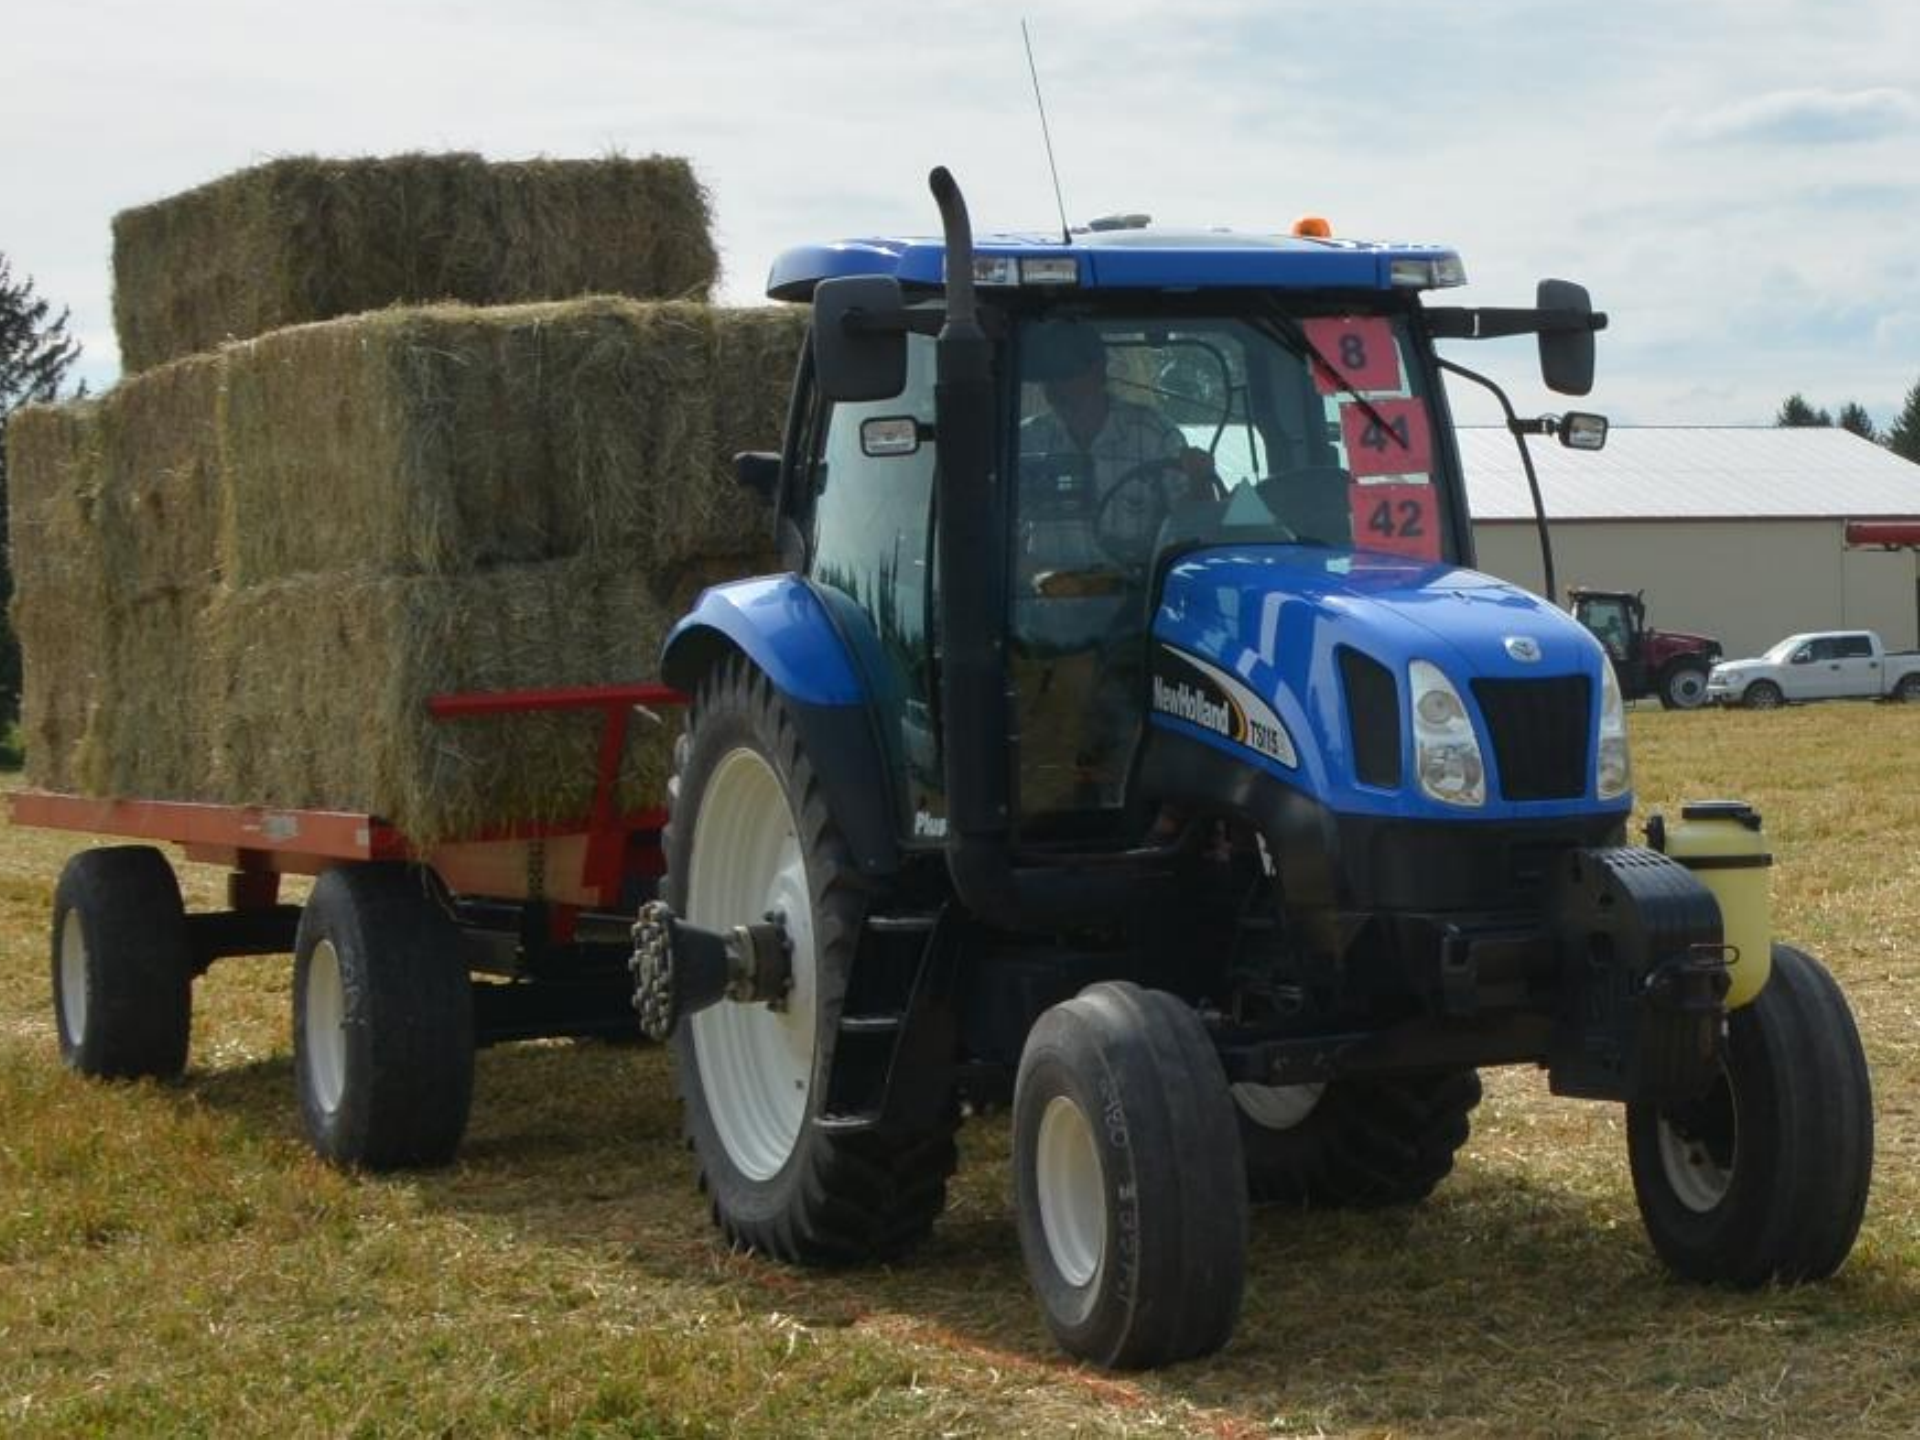
Exhibit: D42+D8

**Flat Rack Hay Wagon w 425s
Singles**

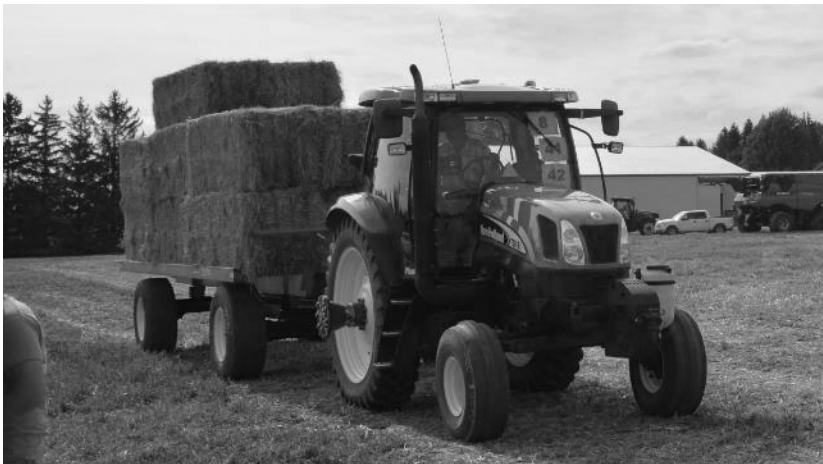
D42_2

Wagon - Bale 425 singles

- A large and radial tire compared to D41. High tire pressure causing high top soil stress but low load in the subsoil.
- Although good to keep deeper soil with less stress, the stress at the 6” depth might cause severe enough rutting to force removal of the forage stand early which can be costly.
