2019 Dundas SCIA Compaction Event

Winchester, Ontario

August 29th, 2019

Dundas SCIA Compaction Event

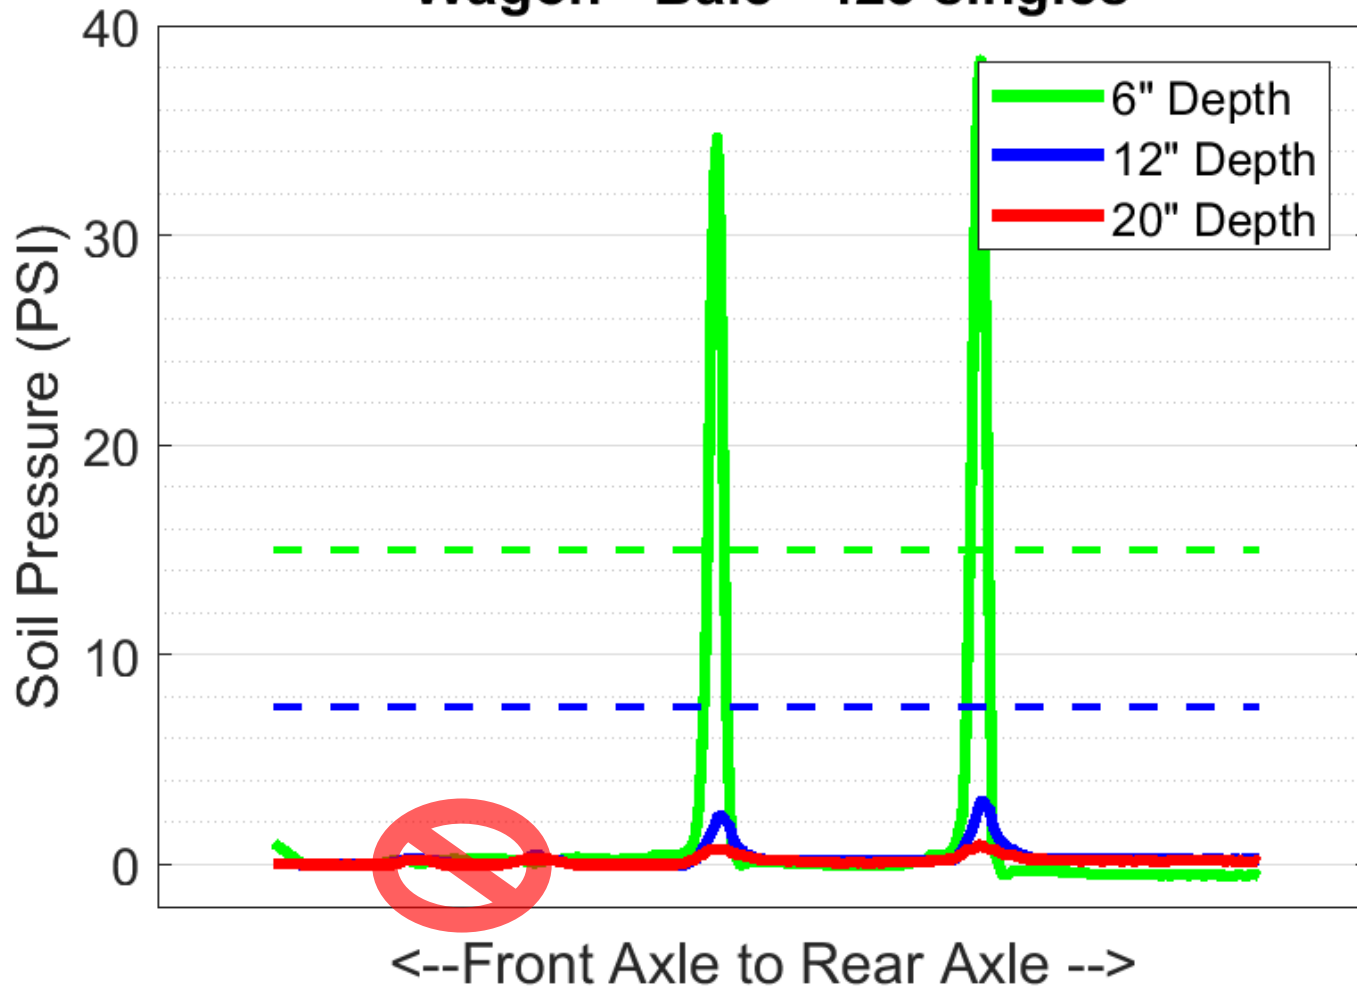
D42_2

Wagon - Bale 425 singles

- A large and radial tire compared to D41. High tire pressure causing high top soil stress but low load in the subsoil.
- Although good to keep deeper soil with less stress, the stress at the 6” depth might cause severe enough rutting to force removal of the forage stand early which can be costly.

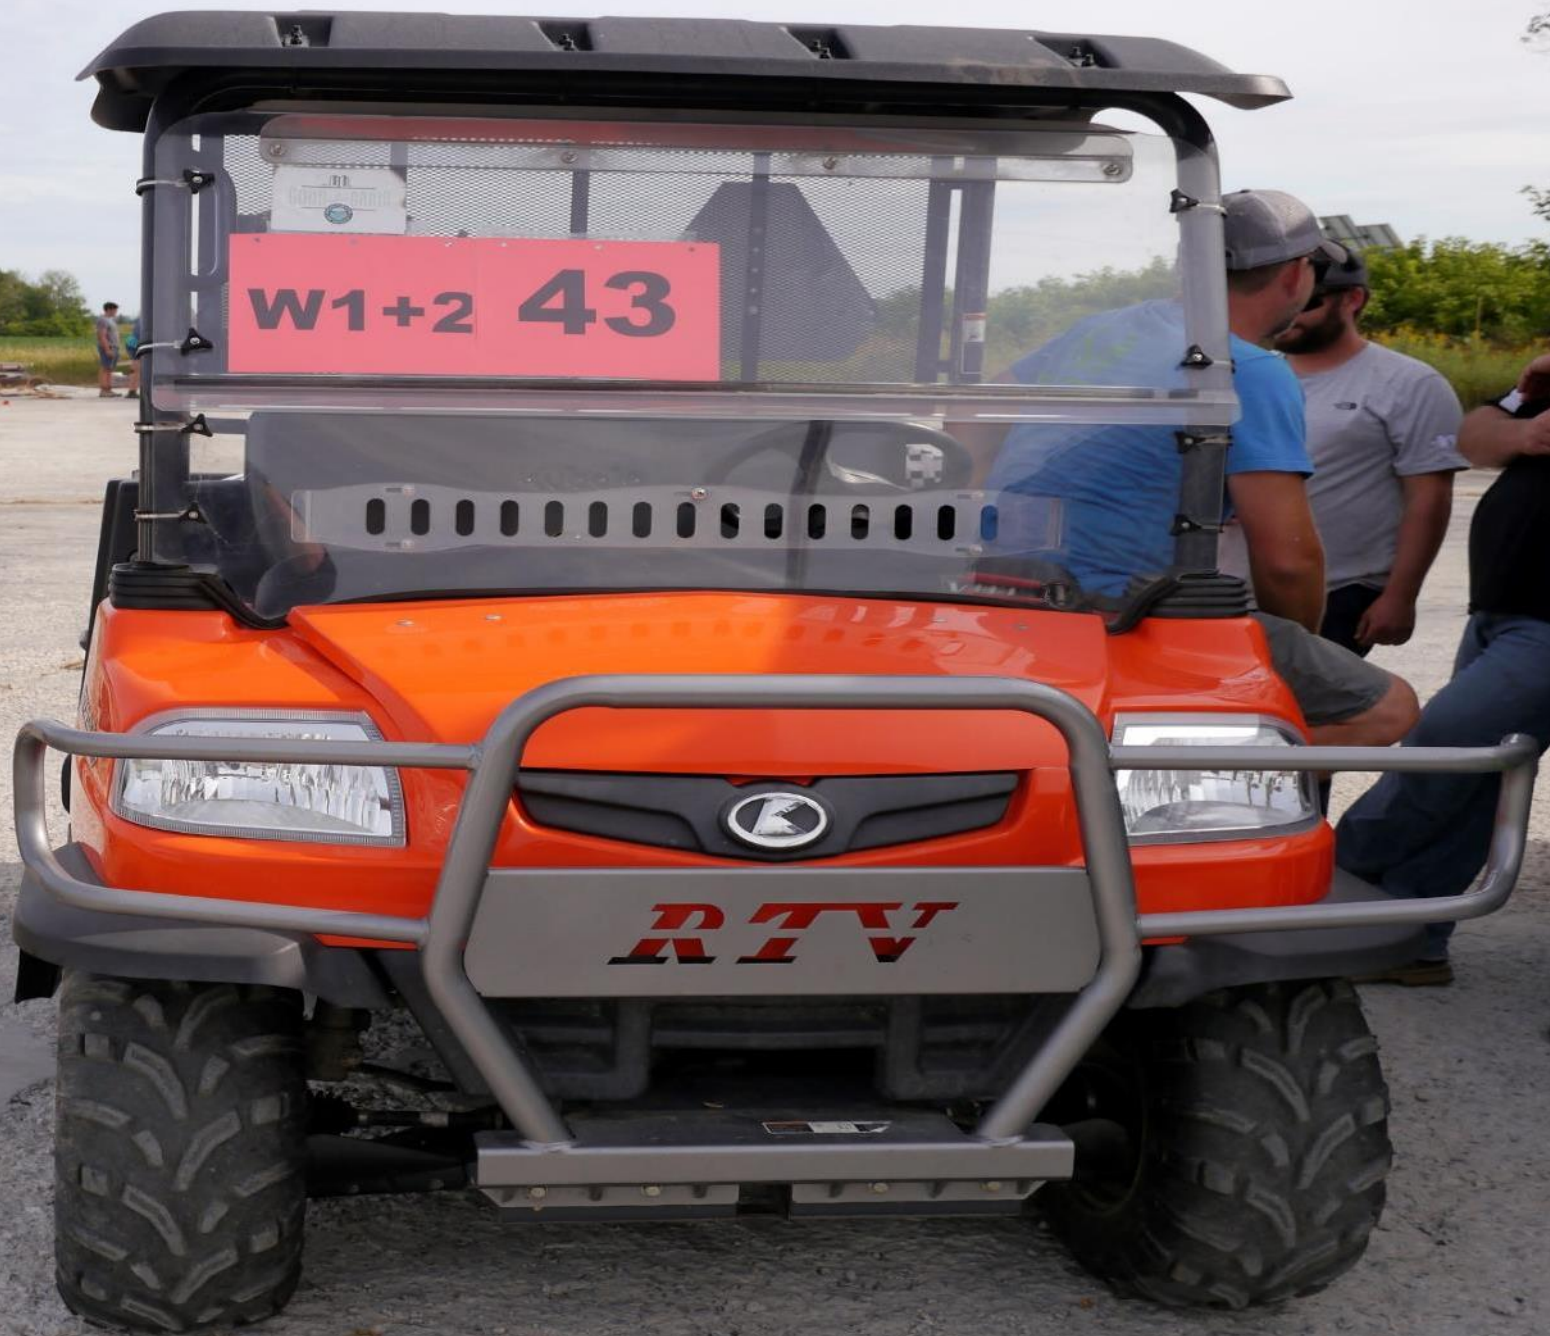
**Exhibit: D43
Kubota RTV 900XT Side by
Side**

**420/420
25X10X12
NHS**

8 PSI all Tires

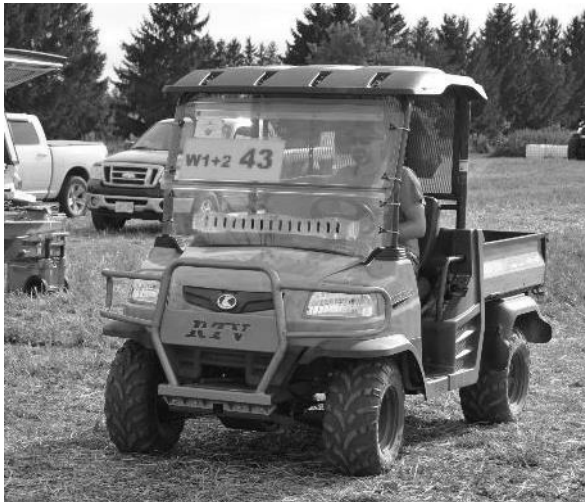
D43_W1_2
RTV Singles

- This is a good example of a light vehicle only causing stress in the topsoil, however due to the weight and small tire size it is almost comparable to a pickup truck.
- Note no response deeper down in the soil.
- It does speak to the aspect of low weight equals little threat even when soil conditions are poor.

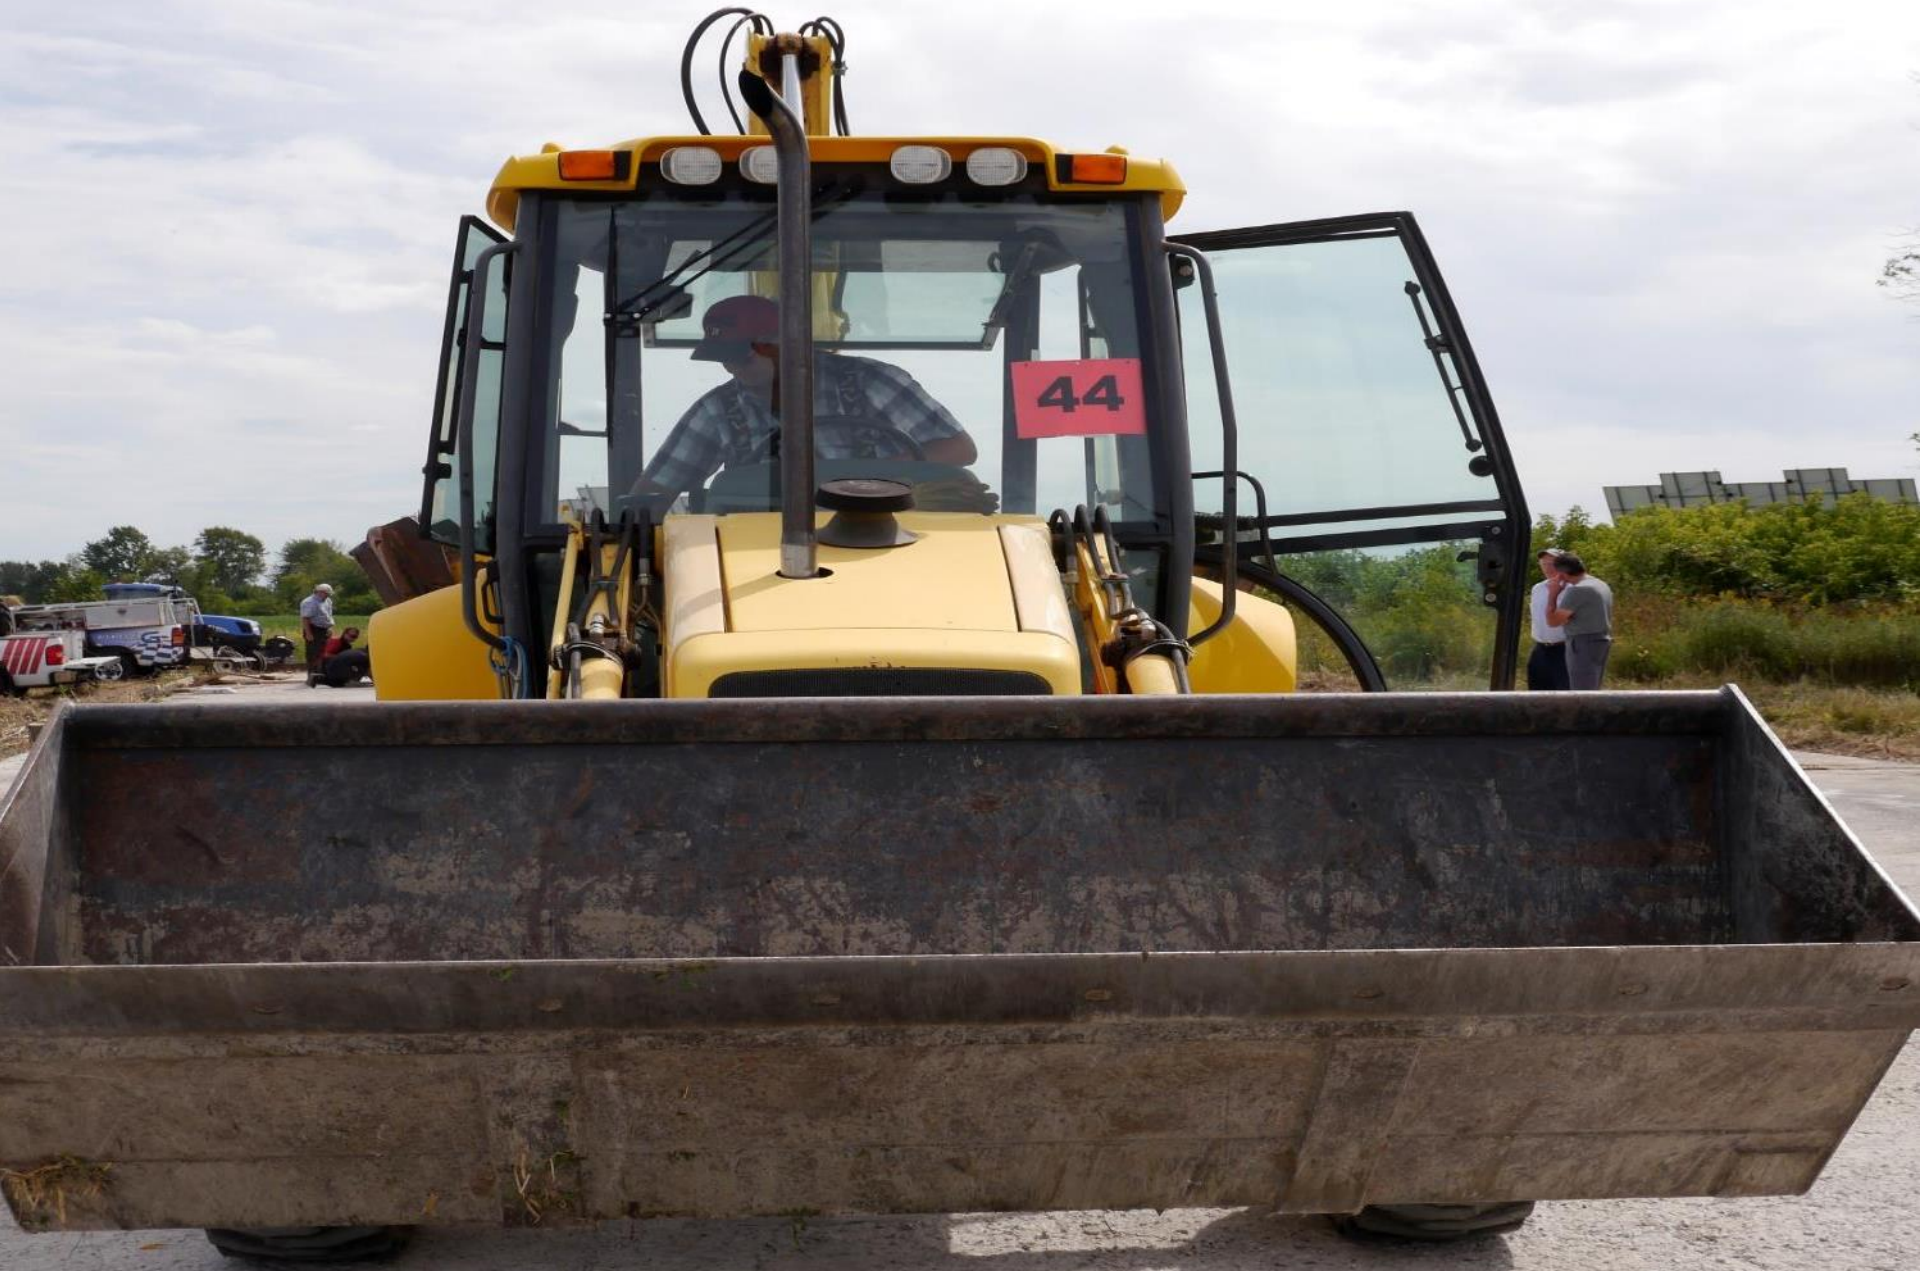
**New Holland Backhoe LB75.B w
19.5R and 12.0F Bias Tires**

5,920
19.5L/24

2,140
12-16.5

29 PSI all Tires

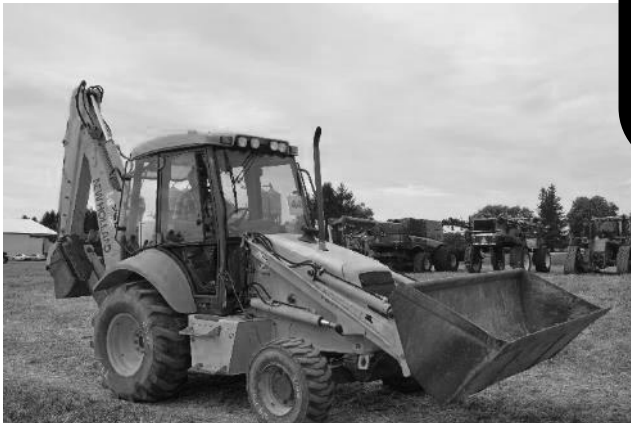
D44_1
Ray Homes Backhoe NH Singles

- The front and rear tires were somewhat misaligned. So each plot shows the peak of the tires individually.
- Construction equipment often has bias tires and this shows here where the shallow load is detected but the overall weight is low relative to seeing load detected at depth.

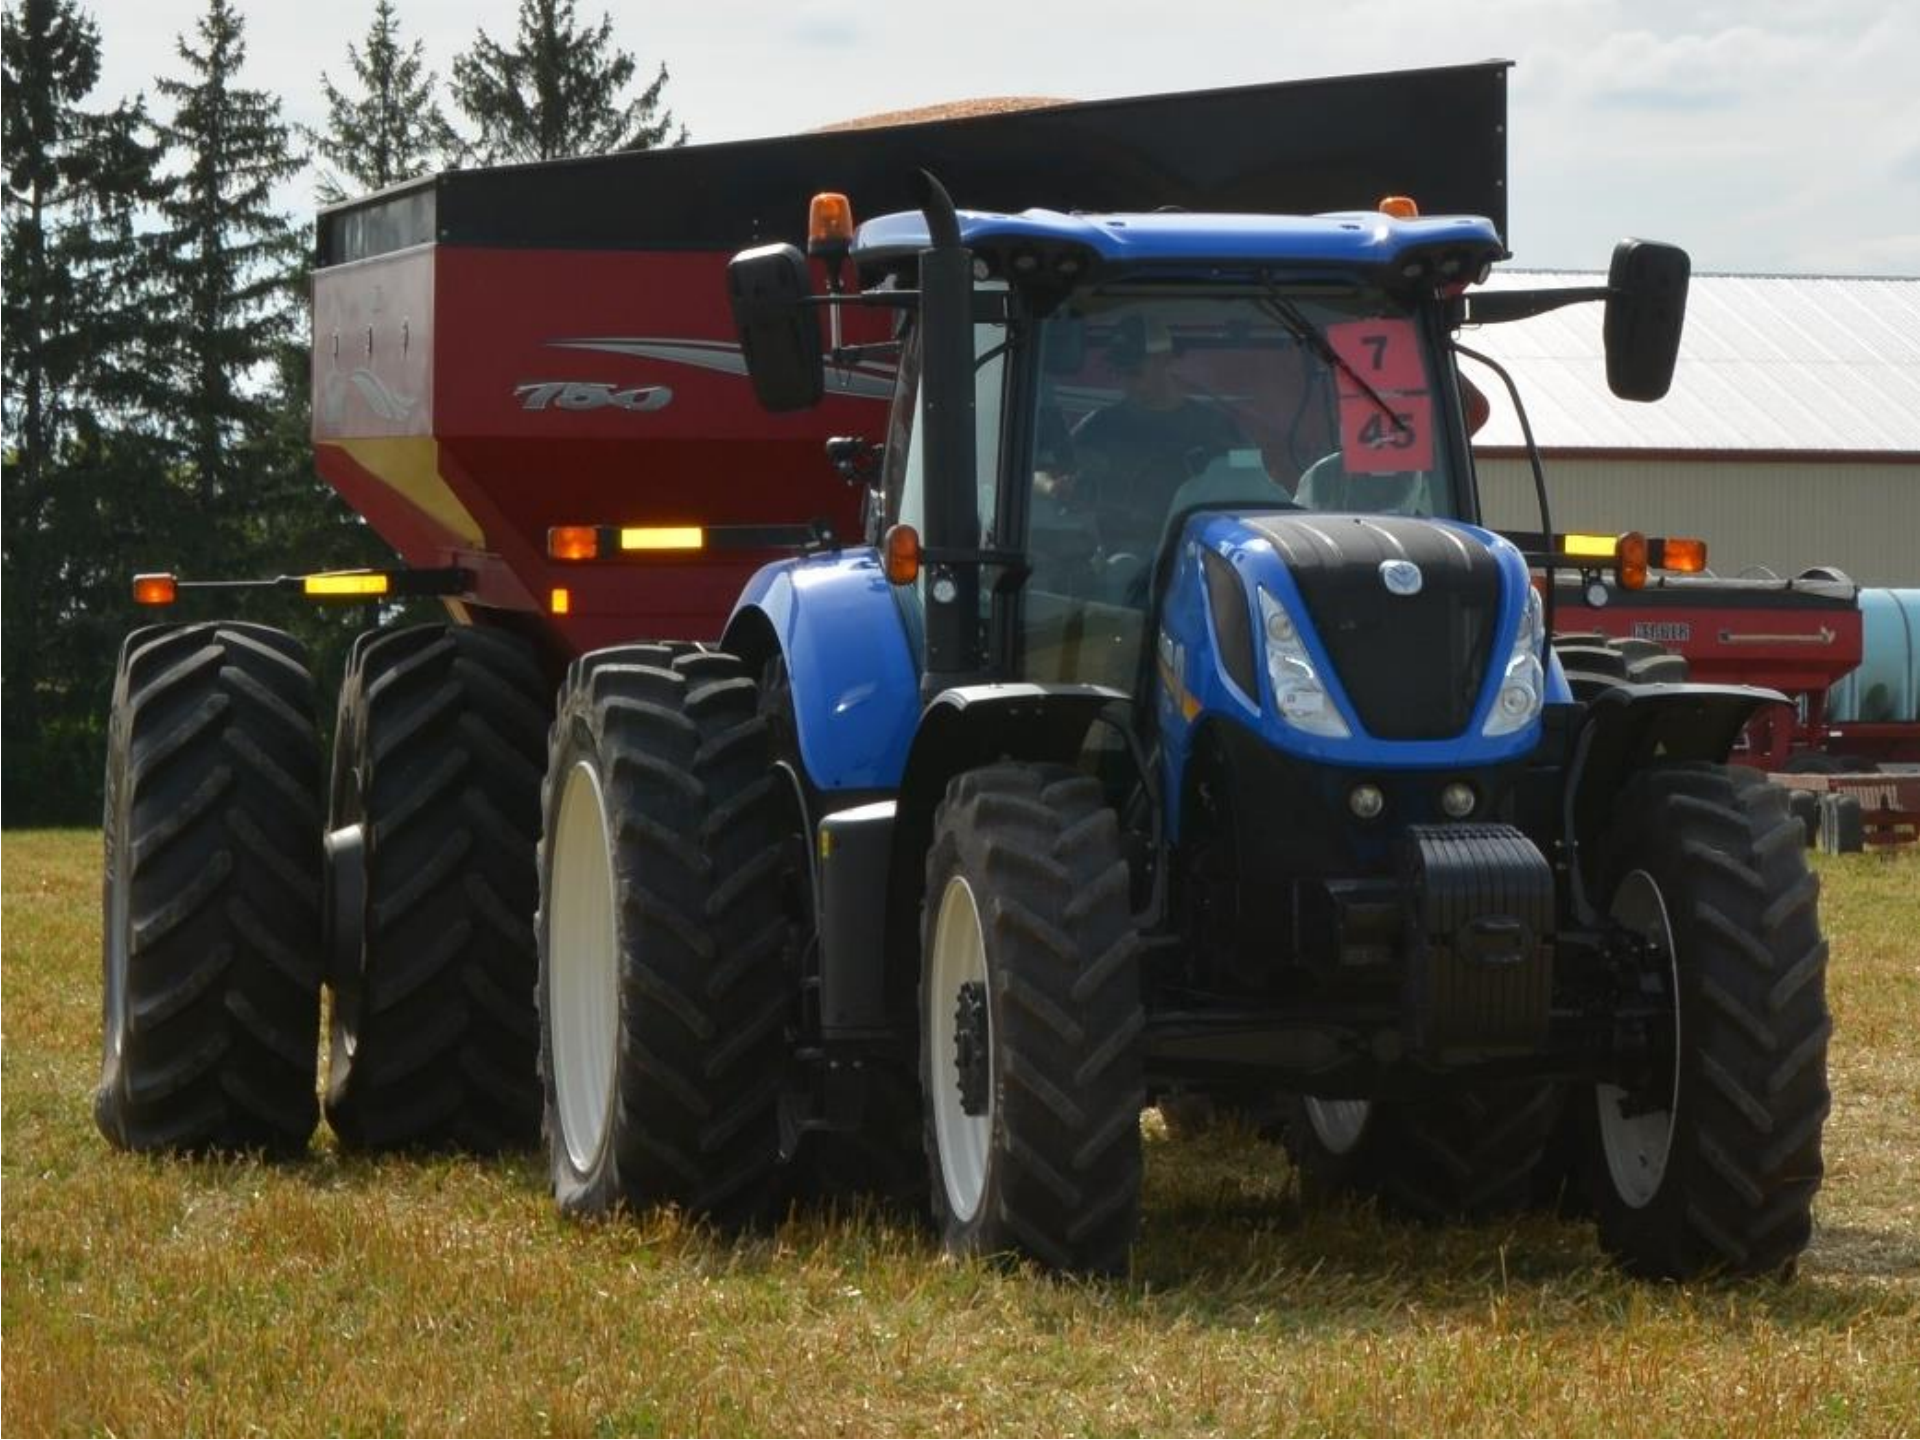
Exh: D45

Dualled Rear Row Crop

Tractor w 480s

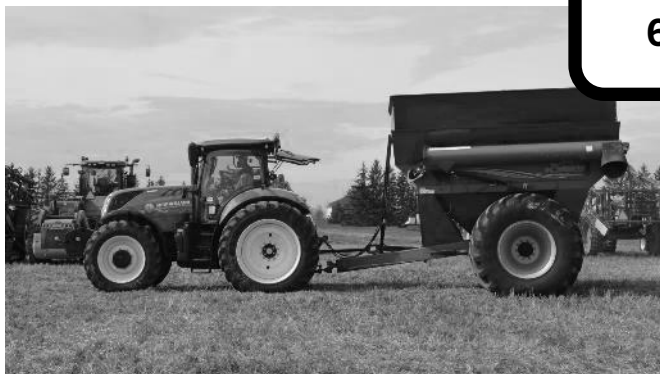
D45_outrdual_2
Demco T50

- High axle weight even on a 20 psi tire causing high stress shallow but dual configuration and overall load protecting deep threat.
- Dual wheel configuration spreads the load and lowers the threat of heavy weight load being driven deeper.
- In this configuration most of the load is detected shallow and while it might impact the crop this year, the freeze/thaw and time will eliminate it easily relative to when the weight is driven deeper in many other grain buggy configurations.

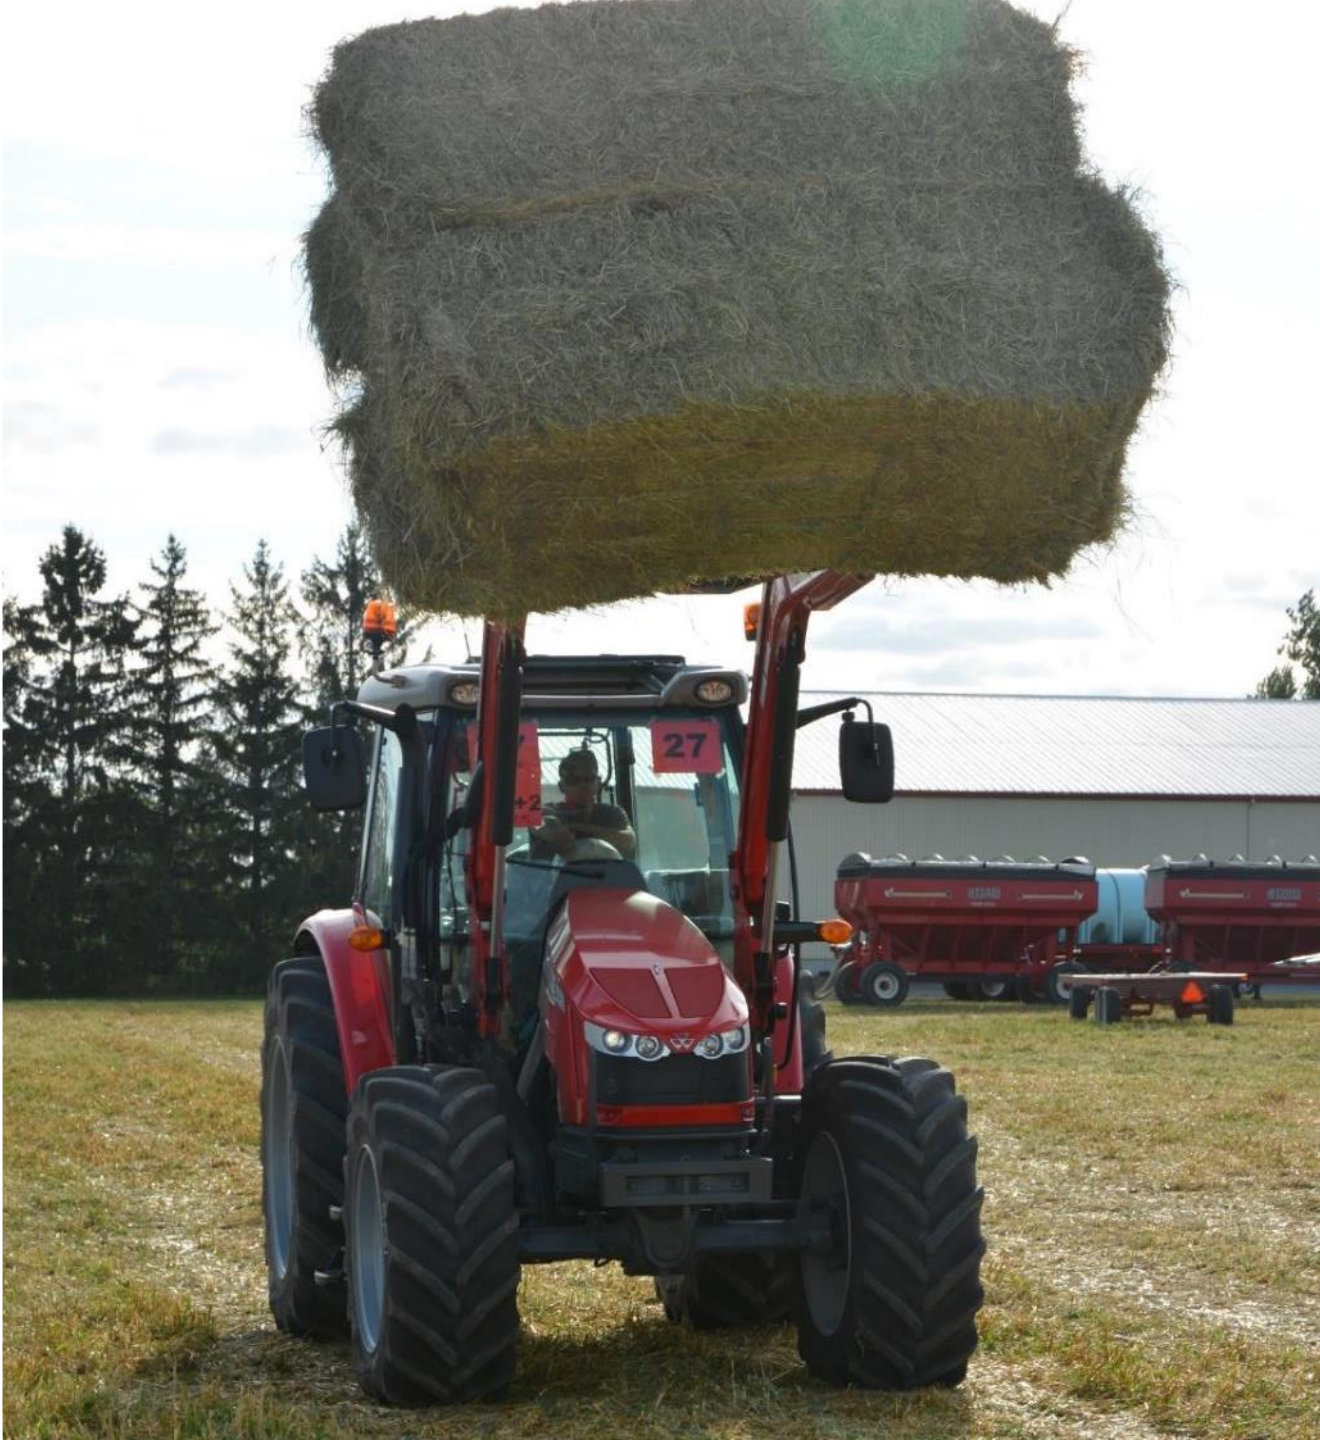
**Massy Ferguson 5711 Row
Crop Loader Tractor w
380/460's w & wo Load**

Weight: Loaded W 2
bales/Unloaded

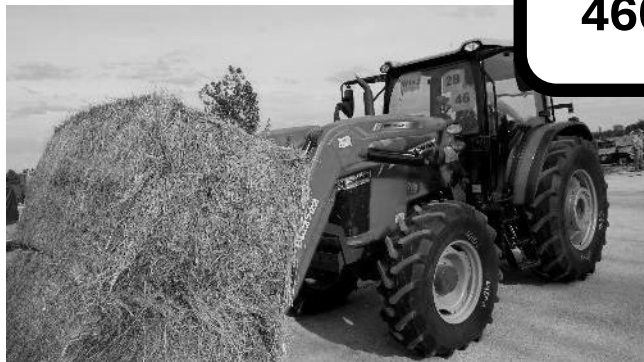
D46_W1_2

- Row crop loader tractors are often not configured to spread the load of on the front axle because of tire size leading to increased stress especially in the top soil area.
- The data in the two plots show how the same configuration can result in different responses due to changes in soil factors where the sensor pits are located, even when close to each other in what appears to be a uniform field. As well Wednesday rainfall could have dried more by Thursday pm vs am leading to different response levels.

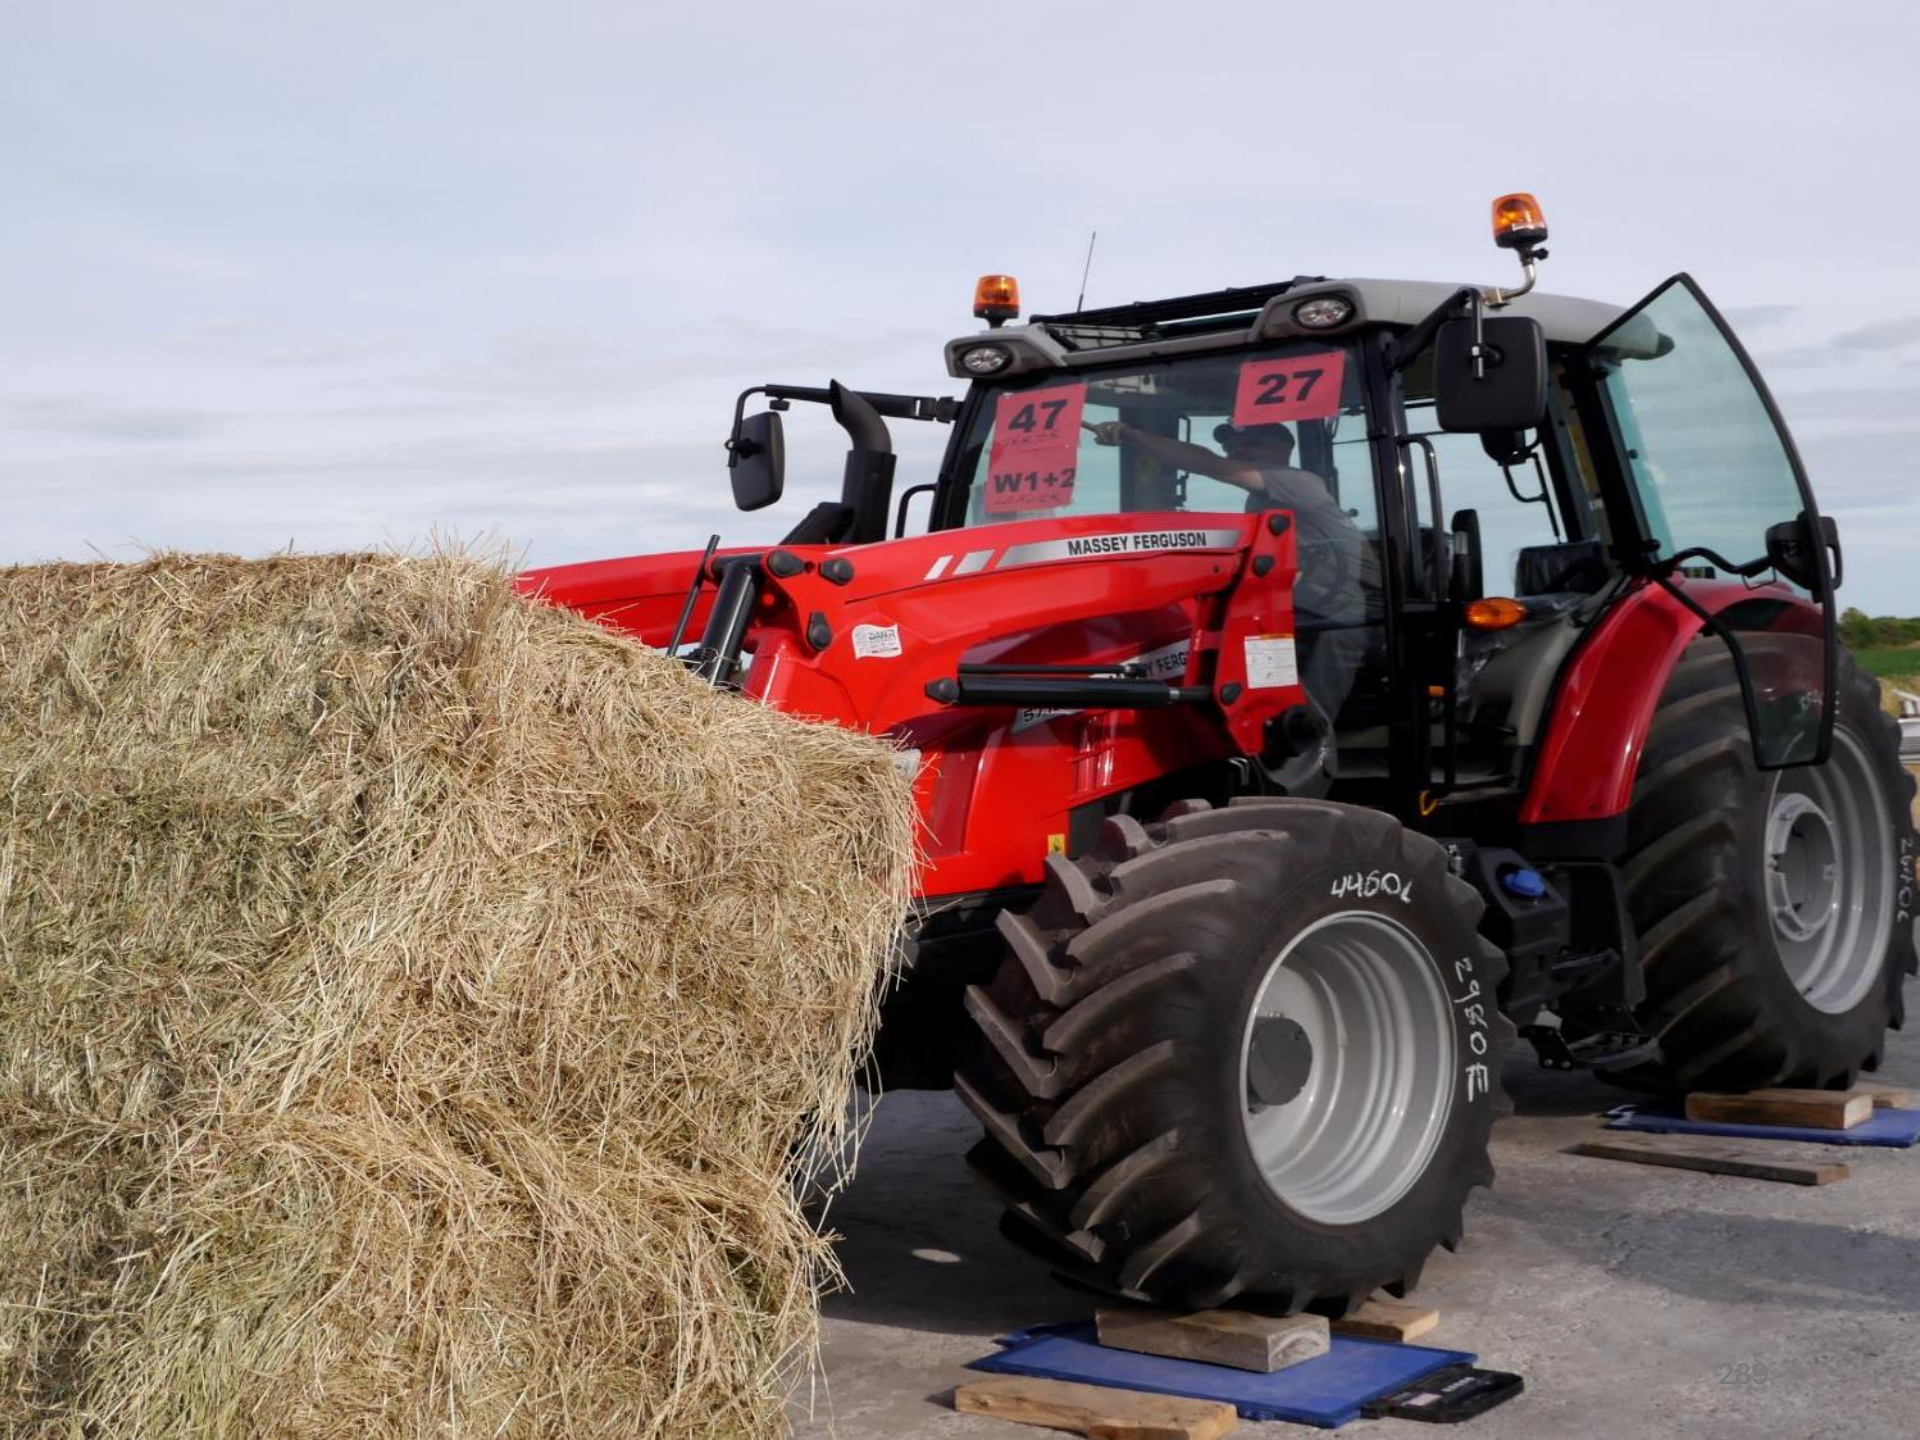
**Massy Ferguson 5713S Row
Crop Loader Tractor w
480/600s w & wo Load**

Weight: Loaded W 2
bales/Unloaded

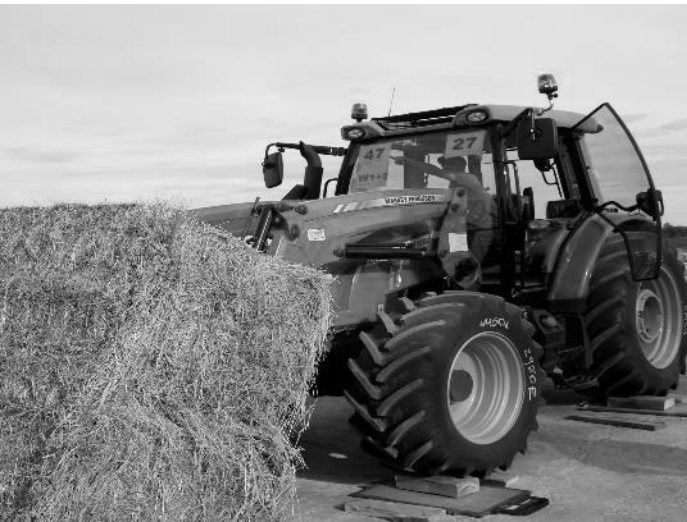
D47_W1_2

- This tractor of similar size to D46 has 480/600s at 15/6psi respectively.
- The response observed was similar although we were surprised the load on the front axle without the bales was still higher than expected.
- A rear weight may be a good consideration when loading bales in the field with a row crop tractor loader to prevent all the weight being moved forward onto the smaller, higher psi tires.

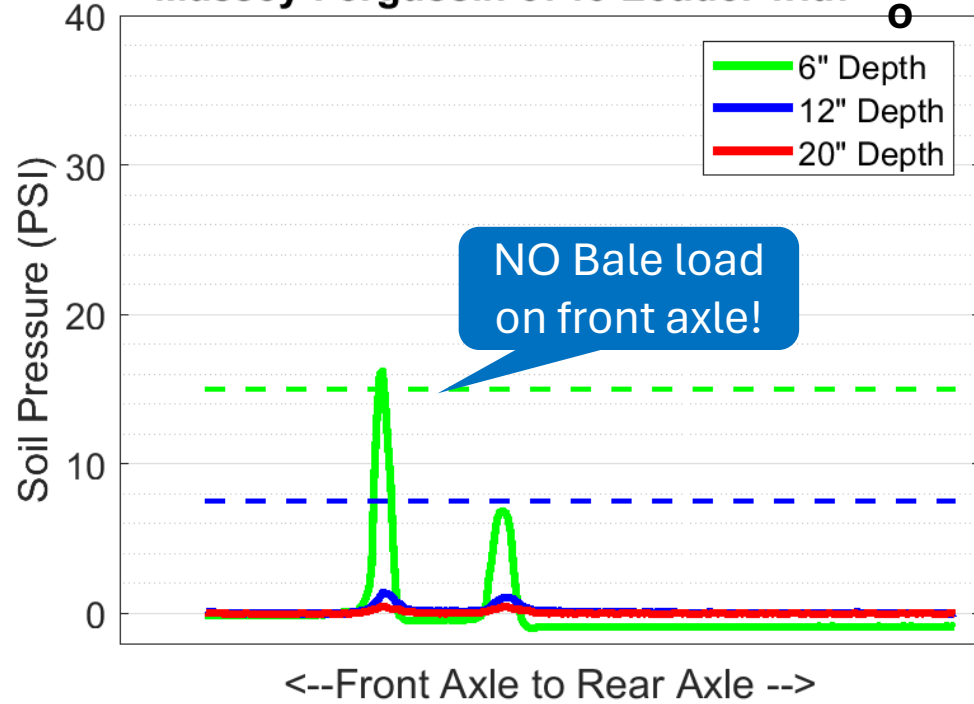
D47_W2nobale_2

Massey Ferguson 5713 Loader with
