2019 Elgin SCIA Compaction Event

Shedden, Ontario

August 8th, 2019

Elgin SCIA Compaction Event

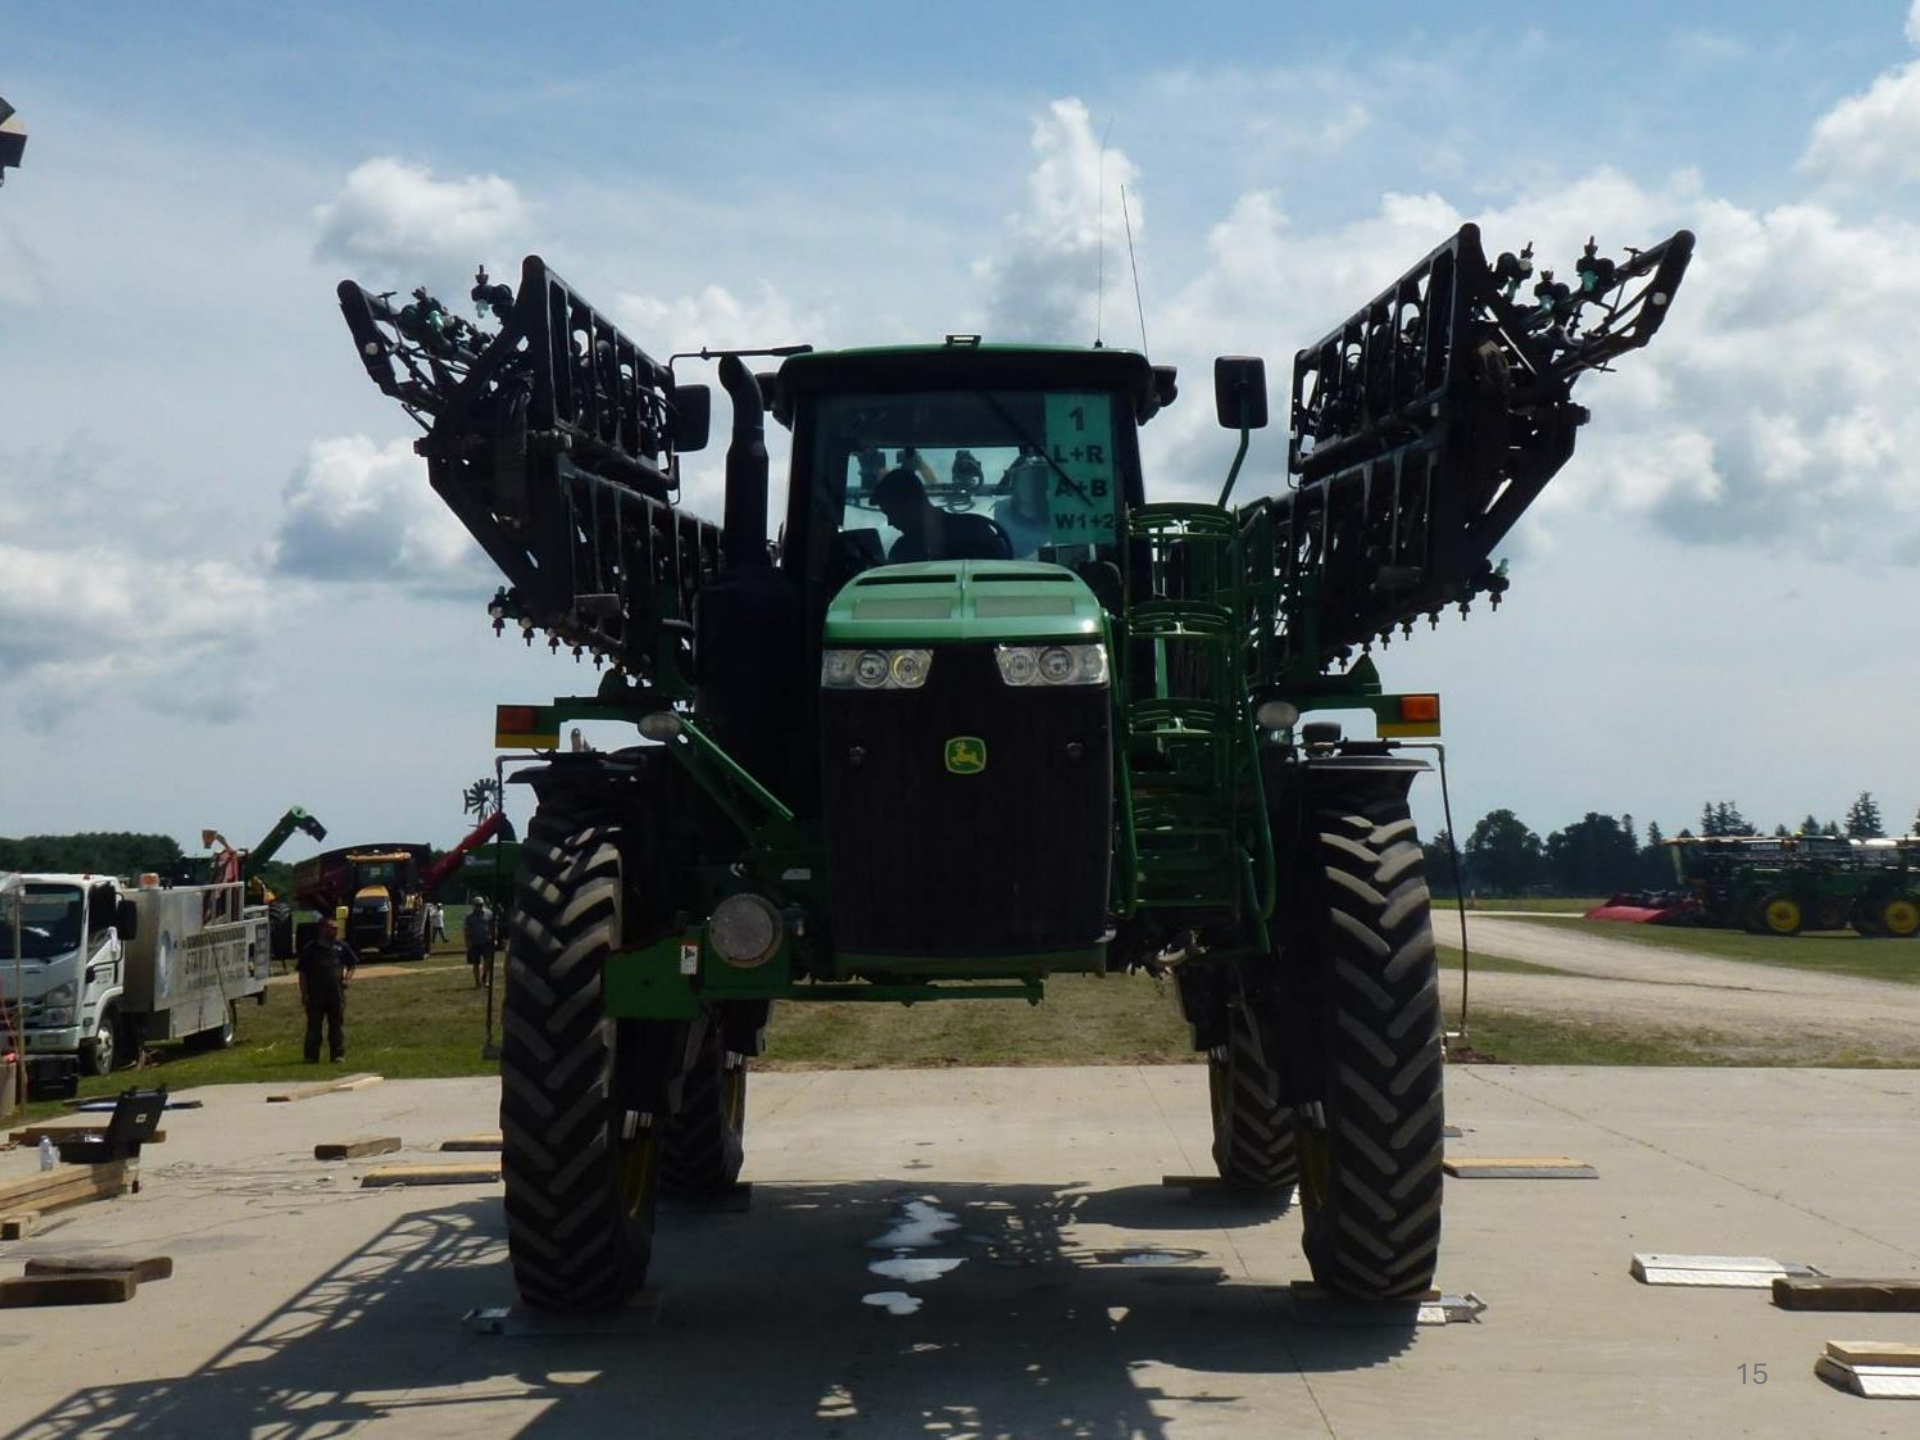
Exhibit: E1

**John Deere 4940 SP Sprayer
with VF420/95R50s vs 710/65
R46
and CTIS**

VF 420/95R50
Road 55 psi
Field 20 psi

710/65R46
Road 32 psi
Field 10/14 psi

- The narrow tires resulted in greater stress detected at each depth and each psi setting compared to the wider tires although given the dry soil conditions the load and configuration did not put damaging load into the soil.
- Lowering tire pressure reduces stress from equipment weight regardless of tire choice, but has greater impact with larger tires because of the volume of air that can be changed.
- The weight of the vehicle means that the stress at the 20 inch depth is not as effectively reduced by lowering the tire pressure.
- Lowering the axle weight would reduce the stress at the 20 inch depth.
- The machine was not able to be tested with the boom out due to a technical problem.

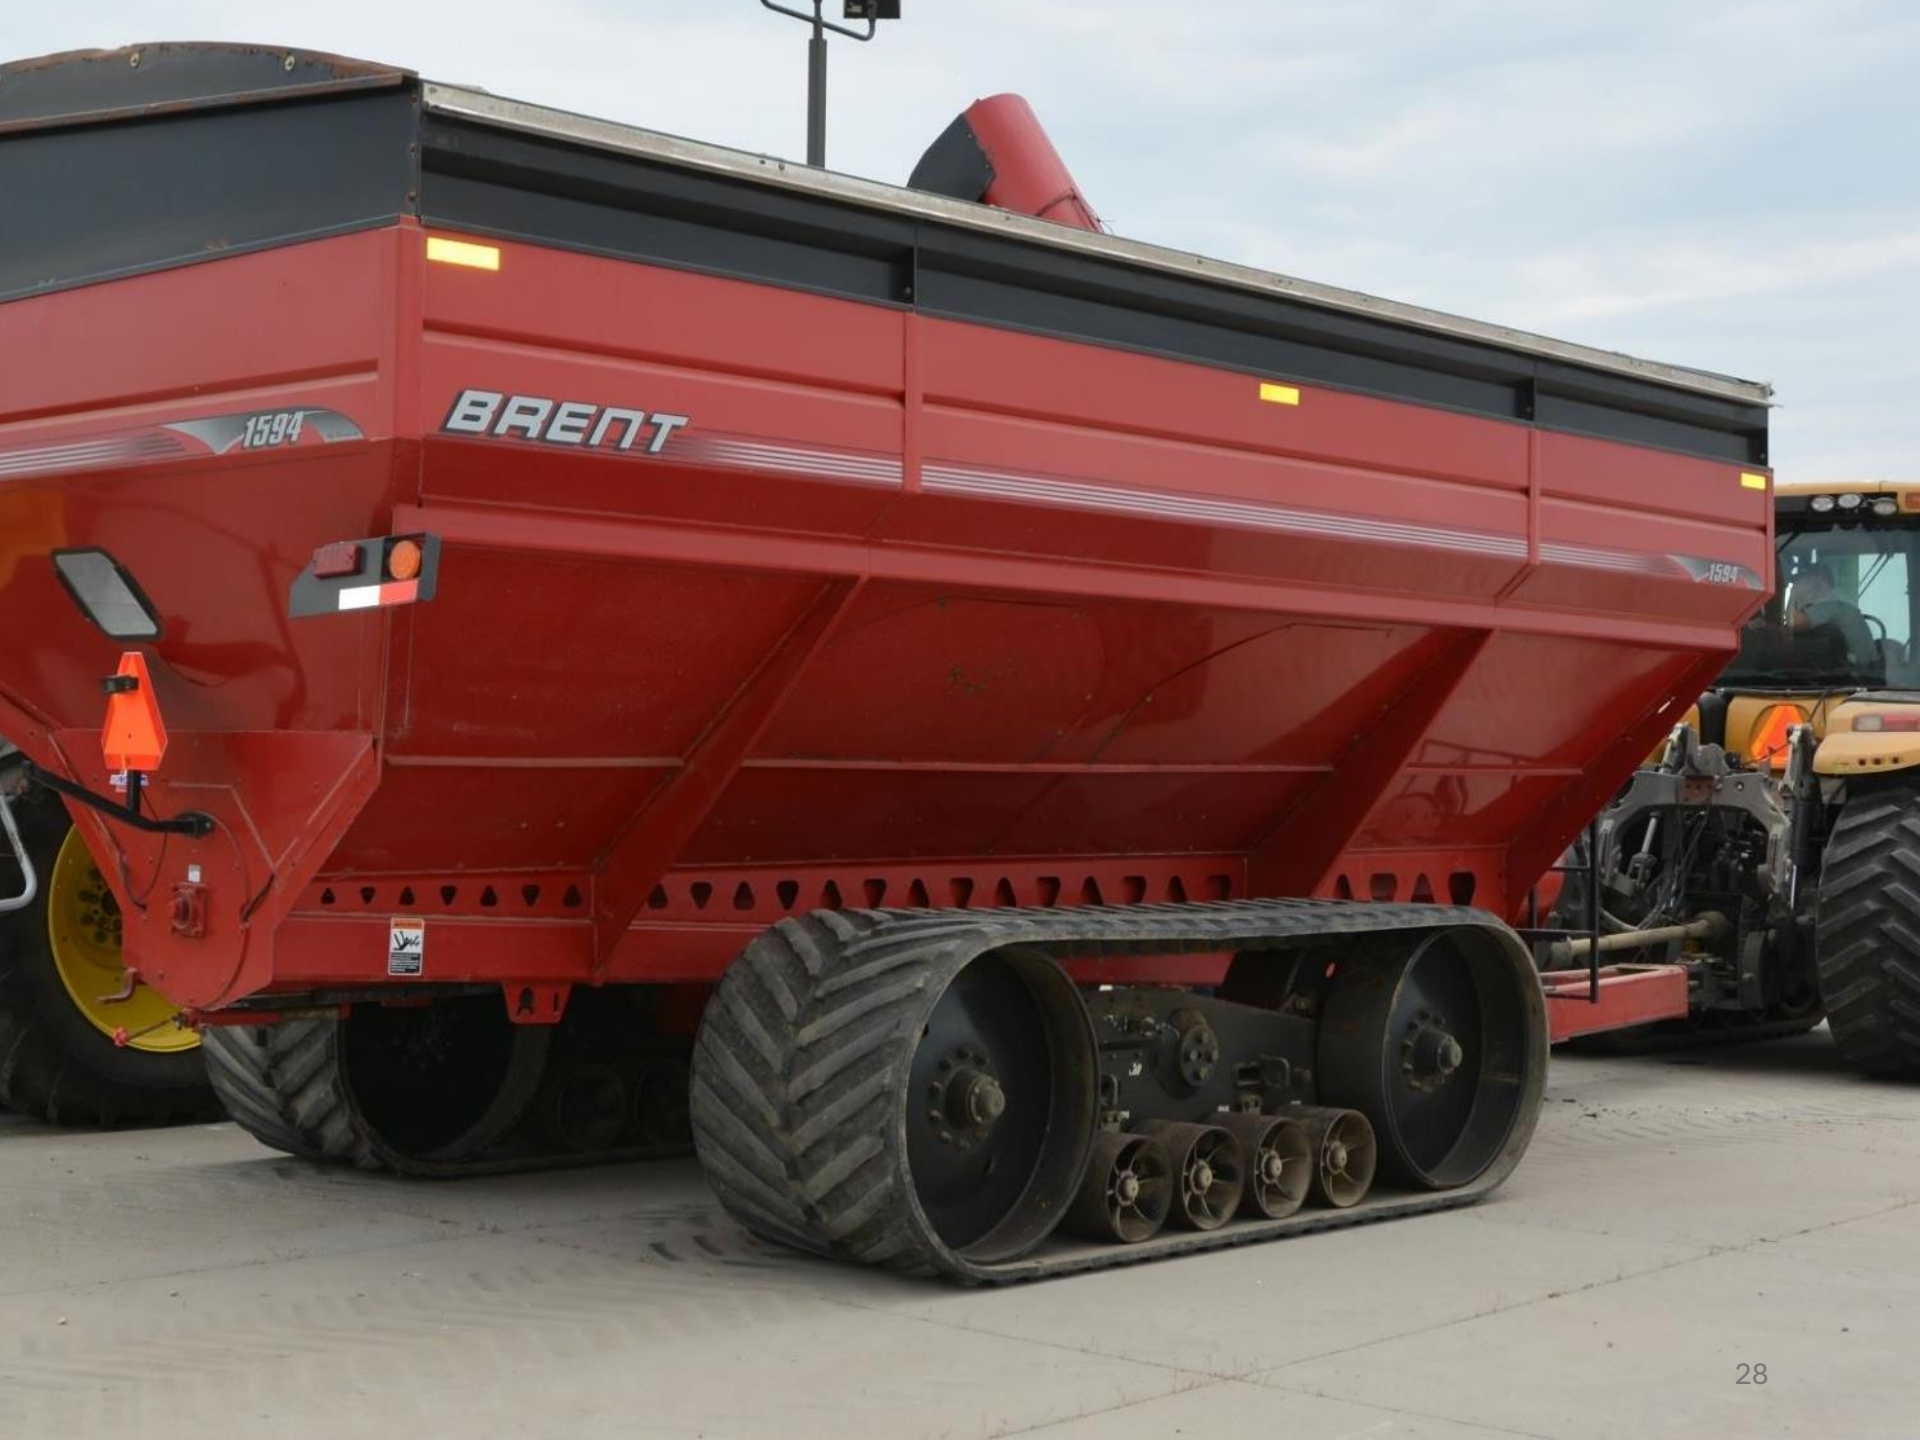
Exhibit: E4 + E31

**Challenger M775E Two Track
Row Crop Tractor and Tracked
Brent Avalanche 1594 Grain
Buggy**

- This unit tested the grain cart tracks the first two plots were aligned over the center of the track face which shows a lower soil pressure for the buggy.
- The second two plots show the pressure under the outside third of the track face, directly under the track rollers. These plots did not record the track of the tractor since it was off the sensor.
- This shows that the pressure distribution across the face of the track is non uniform.

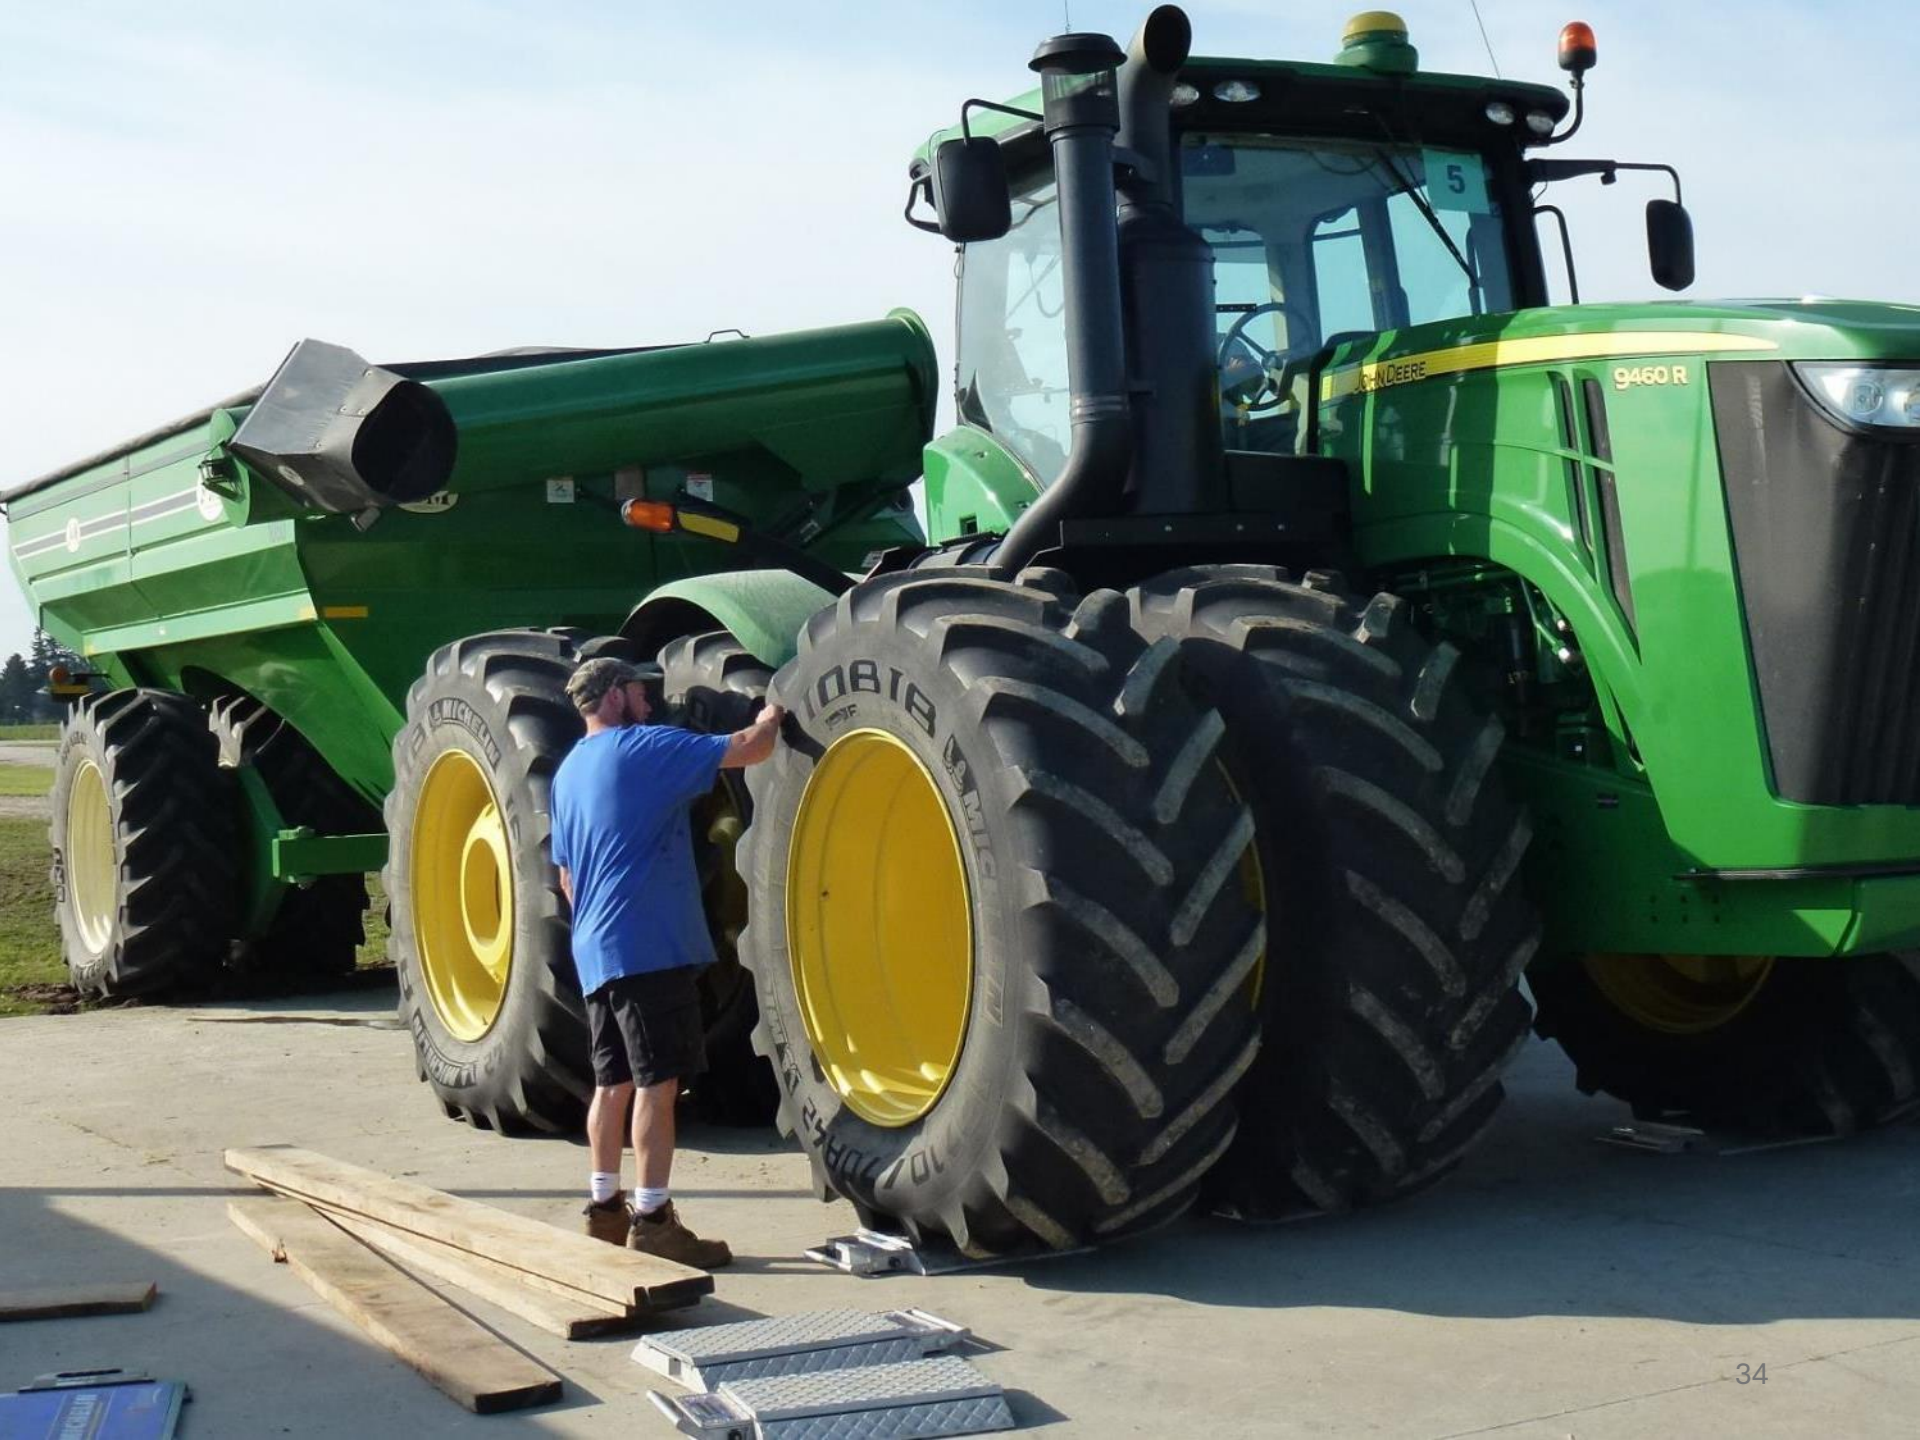
Exhibit: E5

**JD 9460R Articulated Dualled
520s + J&M 1050 Grain Buggy with
Offset Tandem 650s at two PSI
Levels**

- This vehicle compared high inflation pressure and low inflation pressure for the grain cart
- Notice also the high inflation tire was ~3000 lbs heavier
- Notice the last peak on the plots is slightly higher for the plots names E5_1 and E5_2
- Also notice the much higher overall response for the plots for the first sensor installation E5L_1 and E5_1. This may be explained due to differences in soil properties.
- The first two peaks on all plots were the tractor tires but do not account for the peak pressure so should be ignored as the tires were not centred on the sensors.

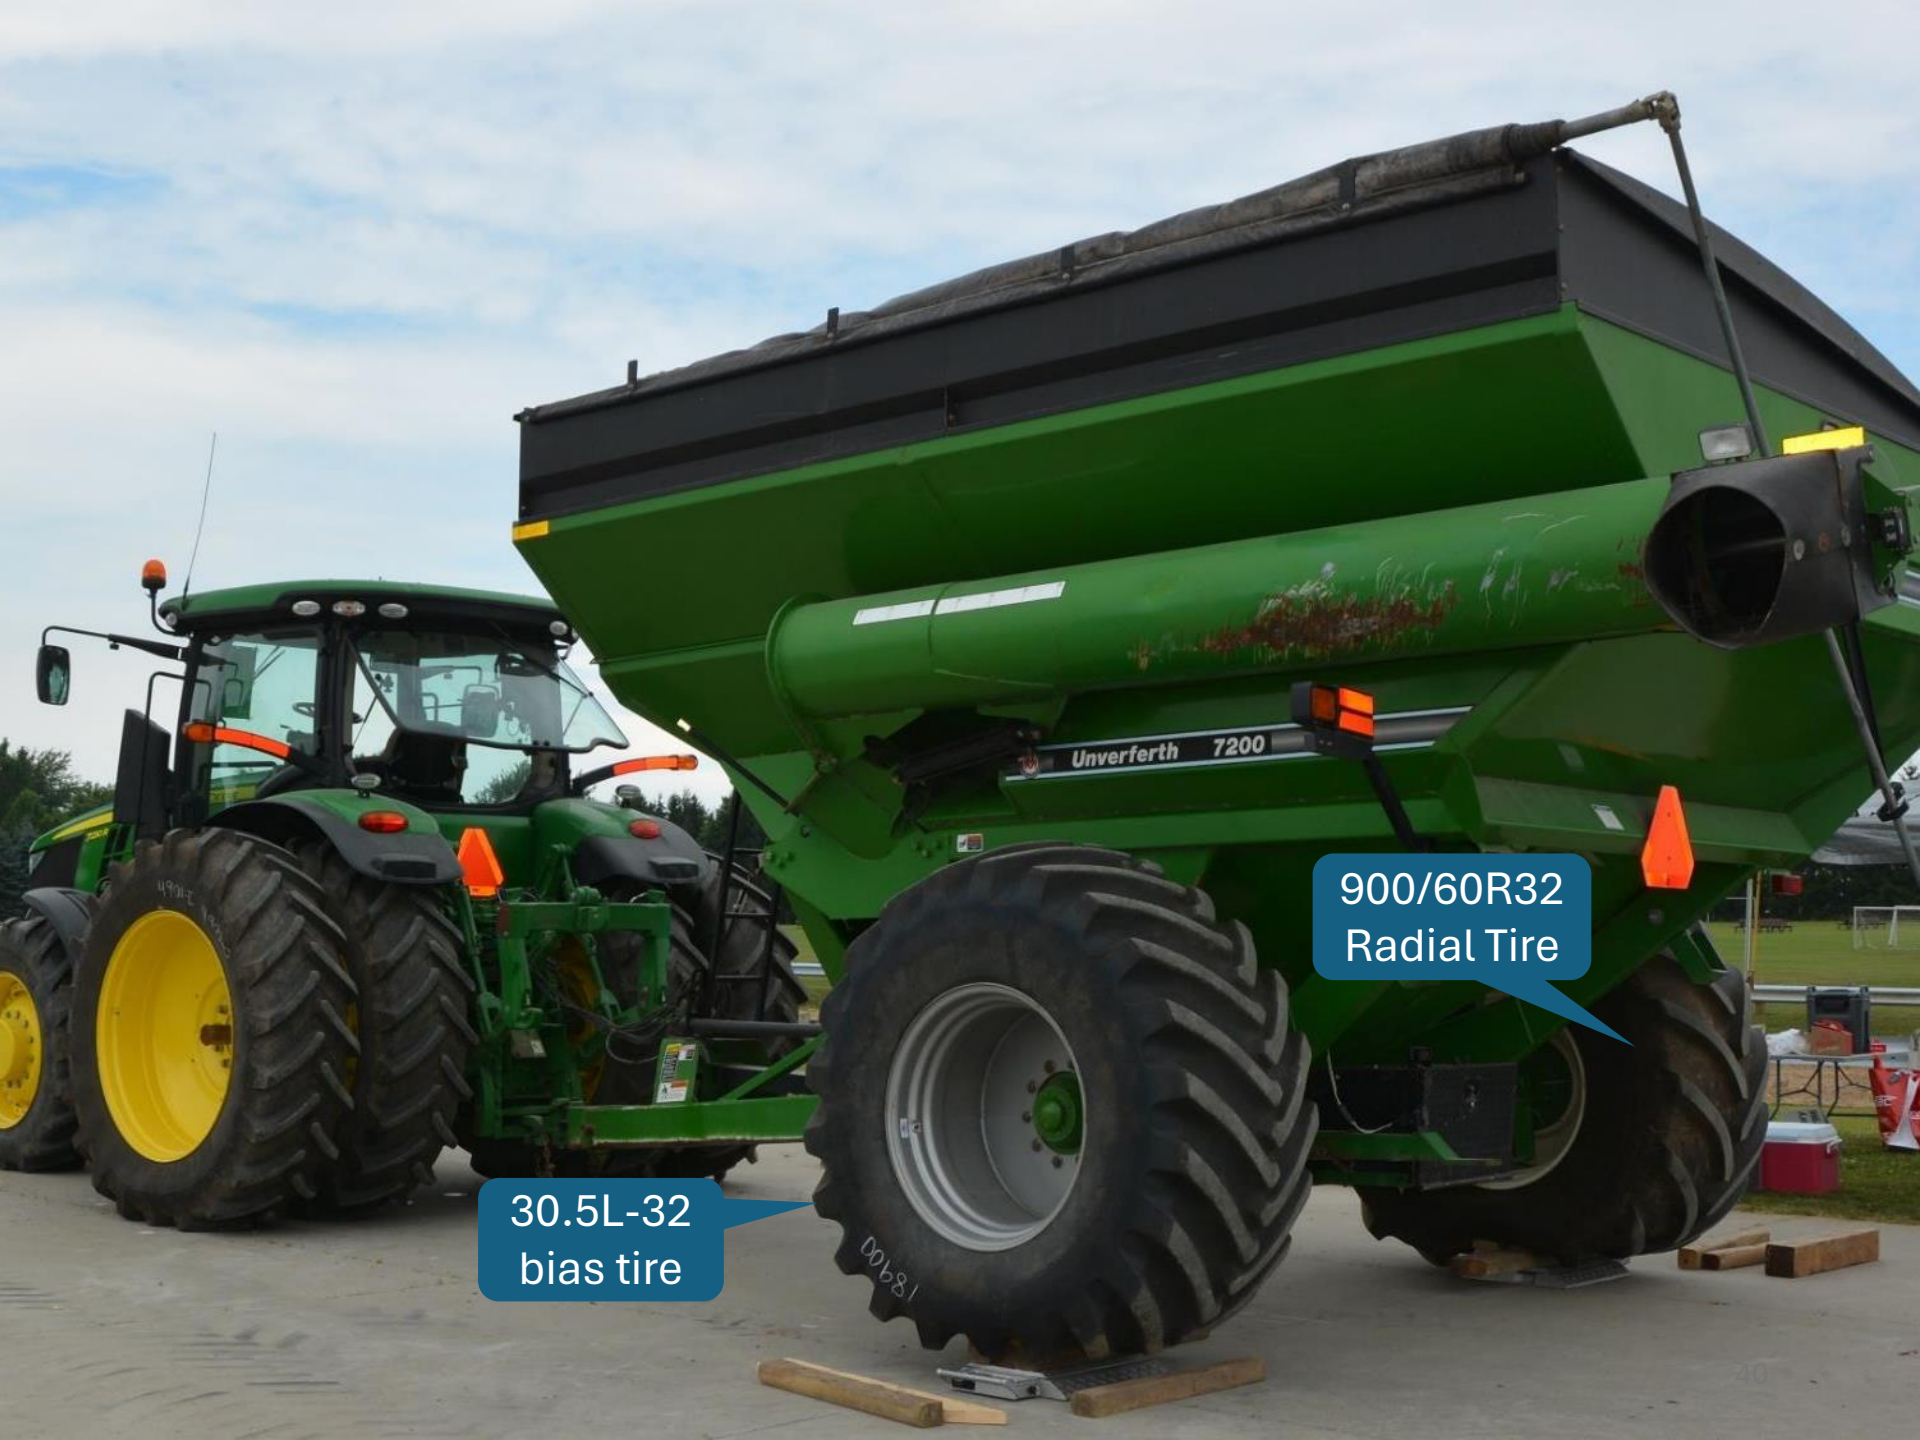
Exhibit: E6

**JD 7230R RC Tractor w Dualled
520s + Unverferth 7200 Grain
Buggy with 30.5L-32 vs
900/60R32 Tires**

30.5L-32
bias tire

900/60R32
Radial Tire

- The response curve to the left is partially the rear tire of tractor and right curve is the grain cart.
- This unit compares two common tires for a grain cart a 30.5L-32 bias tire and a much wider 900/60R32 radial. The bias tire is associated with the plots titled E6_L_1 and E6_L_2. The bias tire had a higher inflation pressure with approximately the same load.

- Plots named E6_L_1 and E6_R_1 had some issues hitting the sensor in both attempts. We later found out that this installation of sensors was misaligned.

- The plots E6_L_2 and E6_R_2 show that the bias ply tire had a slightly higher soil pressure response.
- There is a slight advantage to the radial tire for lowering soil stress but note that the load is very large and the benefits from larger volume tires or wider tires may not be as prominent as they would be with a lighter load or more axles. ie, this unit is too heavy for the tires used!

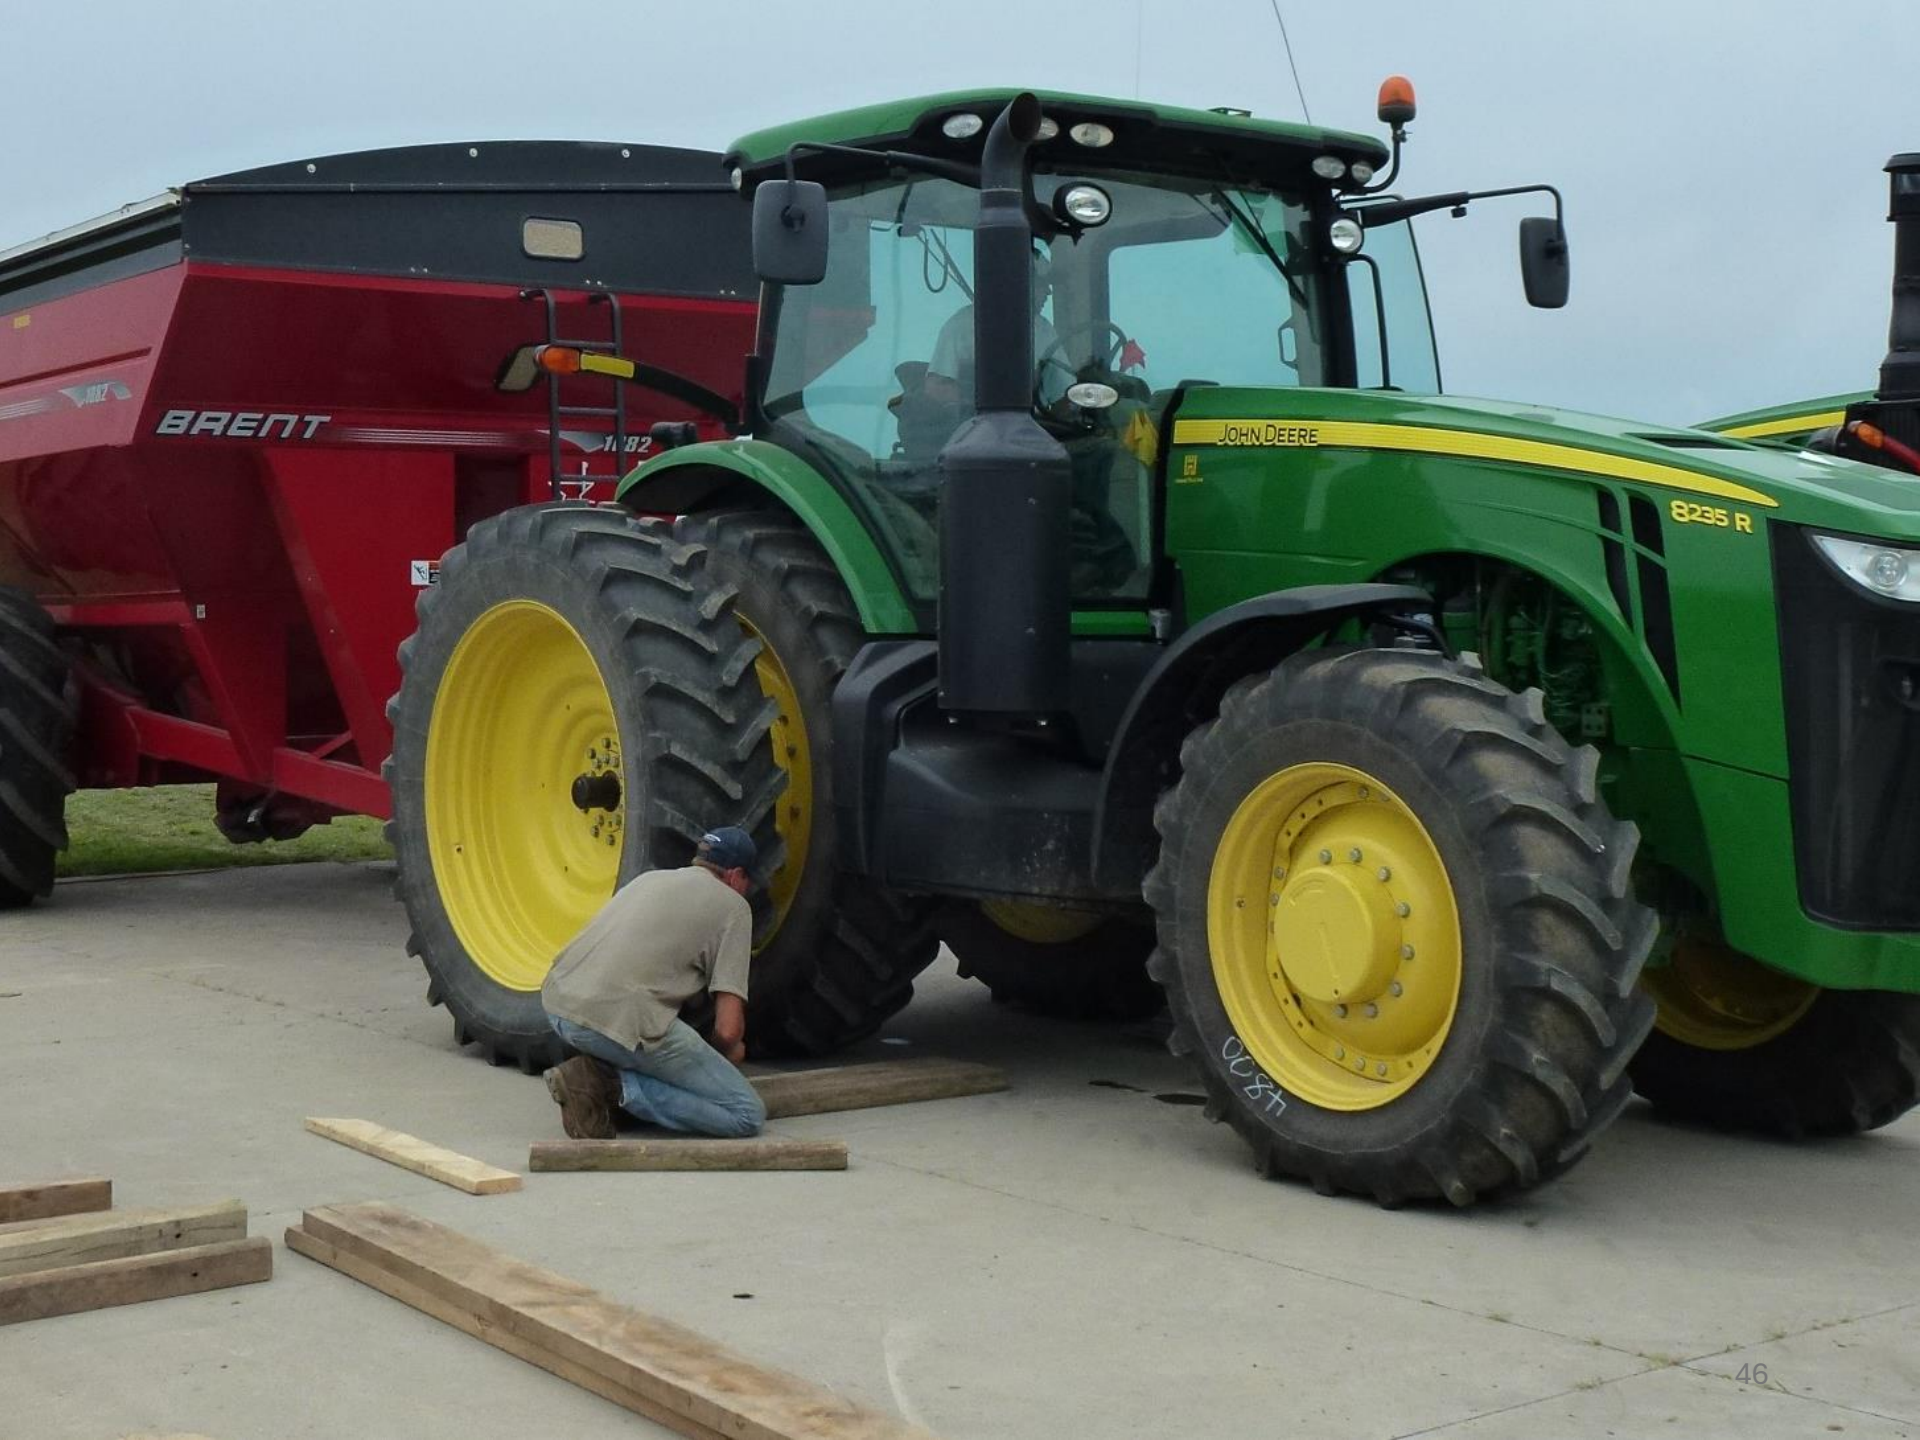
Exhibit: E7

**JD 8235R RC Tractor w
Dualled 420s + Brent 1082
Grain Buggy w 900 Big
Singles**

- This vehicle has the same radial tire that was seen on Unit E6.
- The plot E7_1 shows the left side and an overall larger response due in part to a wetter soil profile.
- The plot E7_2 shows the left side again with a similar response to the same tire on Unit E6.
- The soil pressure is slightly higher in this test due to a higher load and pressure (4300 lbs. increase) compared to the Unit E6.
- This load and configuration is good given the soil conditions at sampling time.

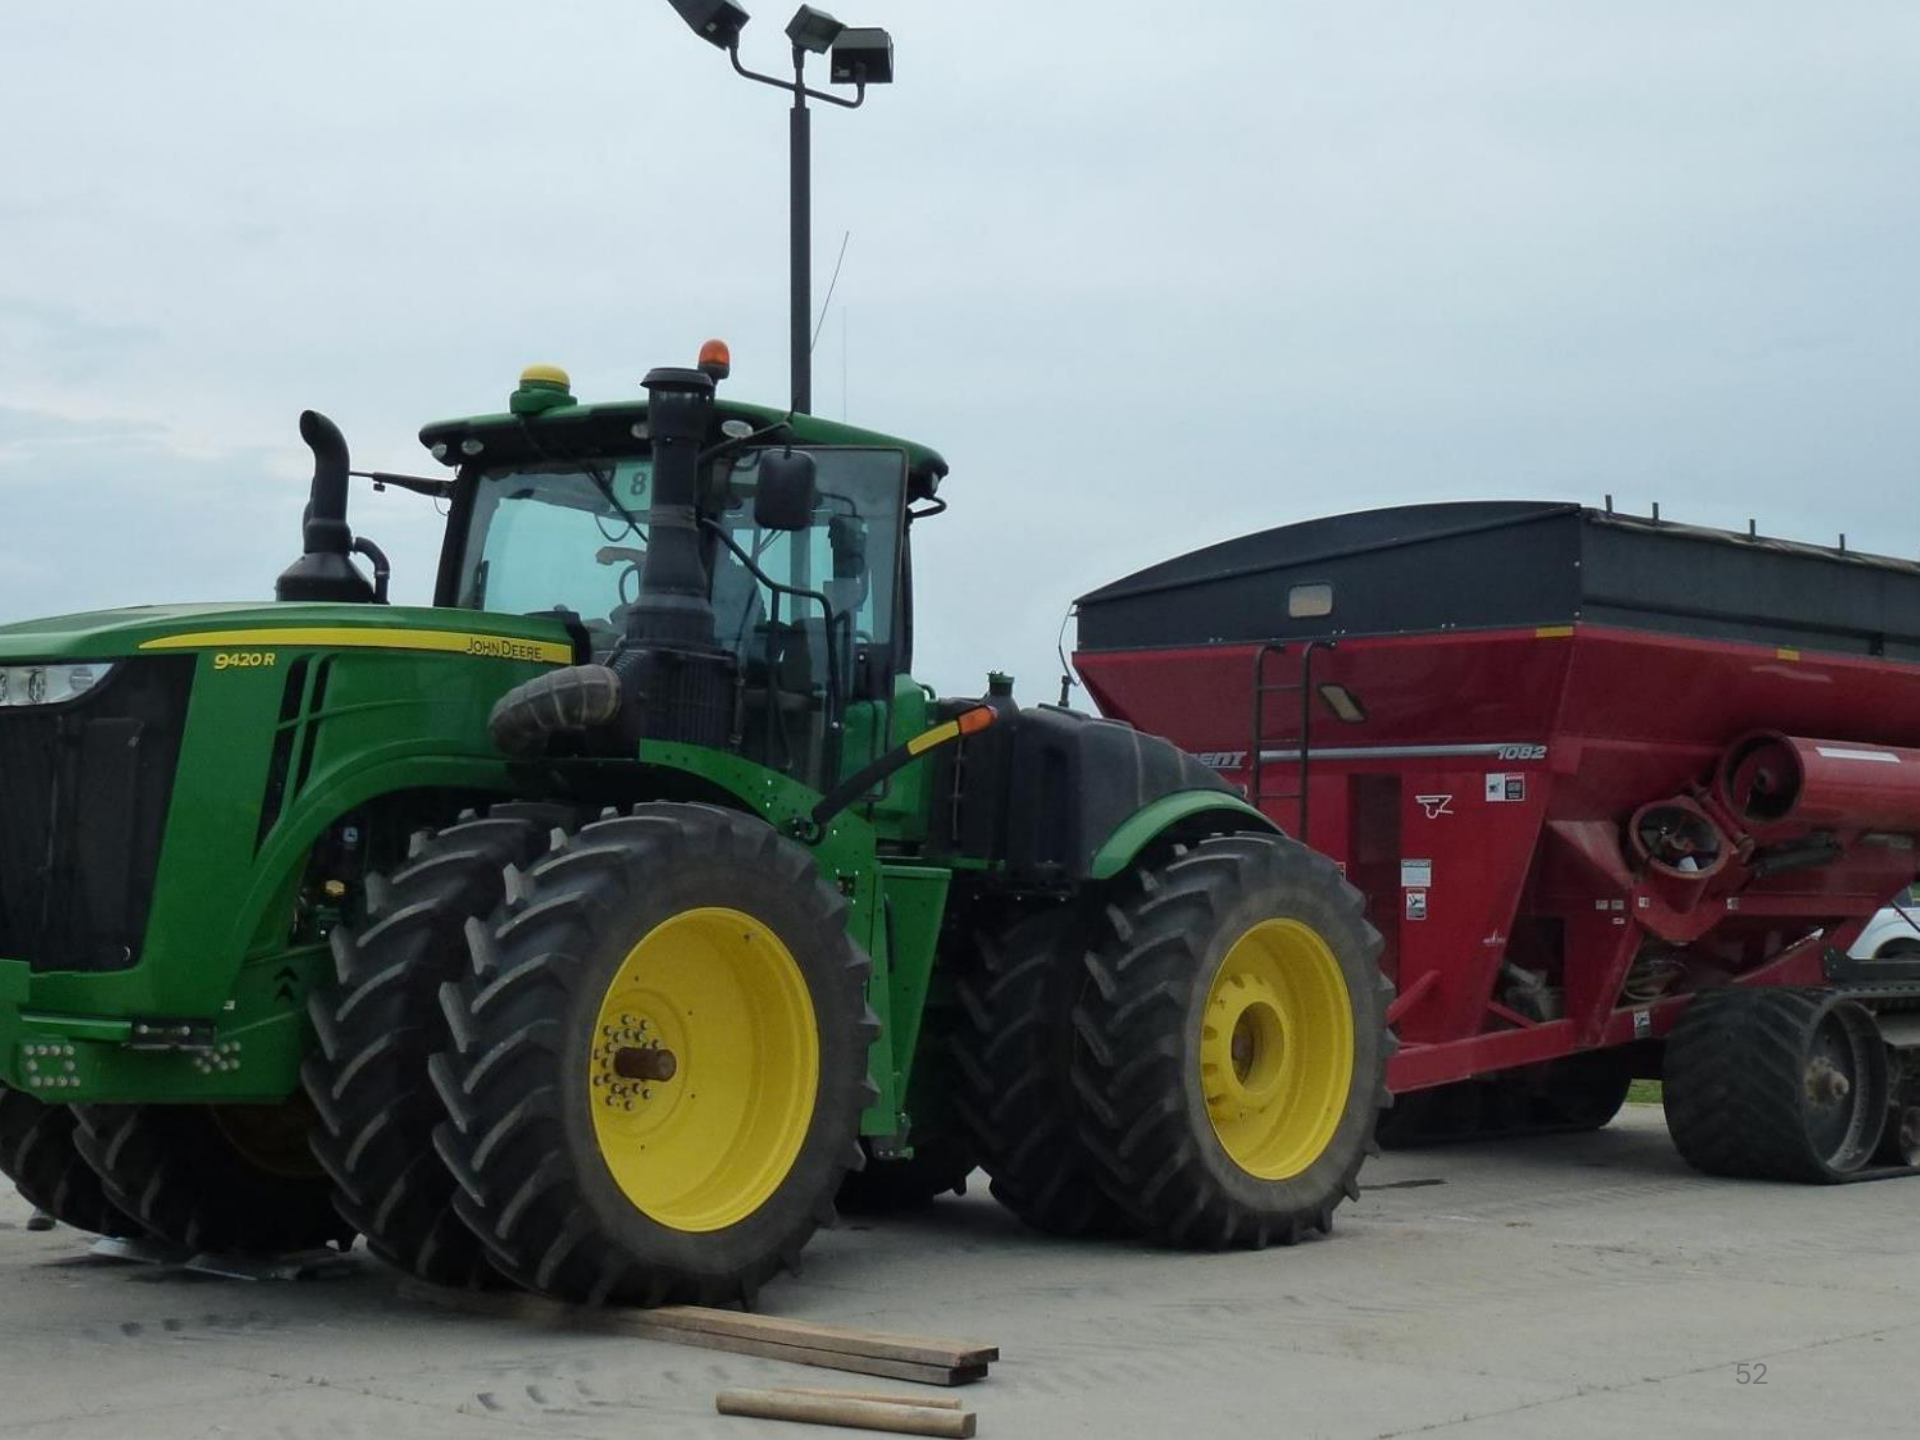
Exhibit: E8

**JD 9420 R Articulated
Tractor w Dual 520s +
Brent 1082 Tracked Grain
Buggy 34" Wide Track**

- The combination is a tracked grain cart with a similar weight to Unit E7.
- The track unit on this machine appears much better suited to carrying this amount of weight.
- The two response curves are slightly different because they are different sensor installations showing soil differences in close proximity.
- The configuration would be substantially safer than a single tire for carrying this amount of weight.
- The outside dual on the tractor was almost in line with the rollers on the track unit. Notice that the tractor is exerting a lot more load on the soil compared (first two peaks on the plots) to the cart.
- Also note the characteristic spiked shape for the track response. Each little spike corresponds to a roller on the track unit.

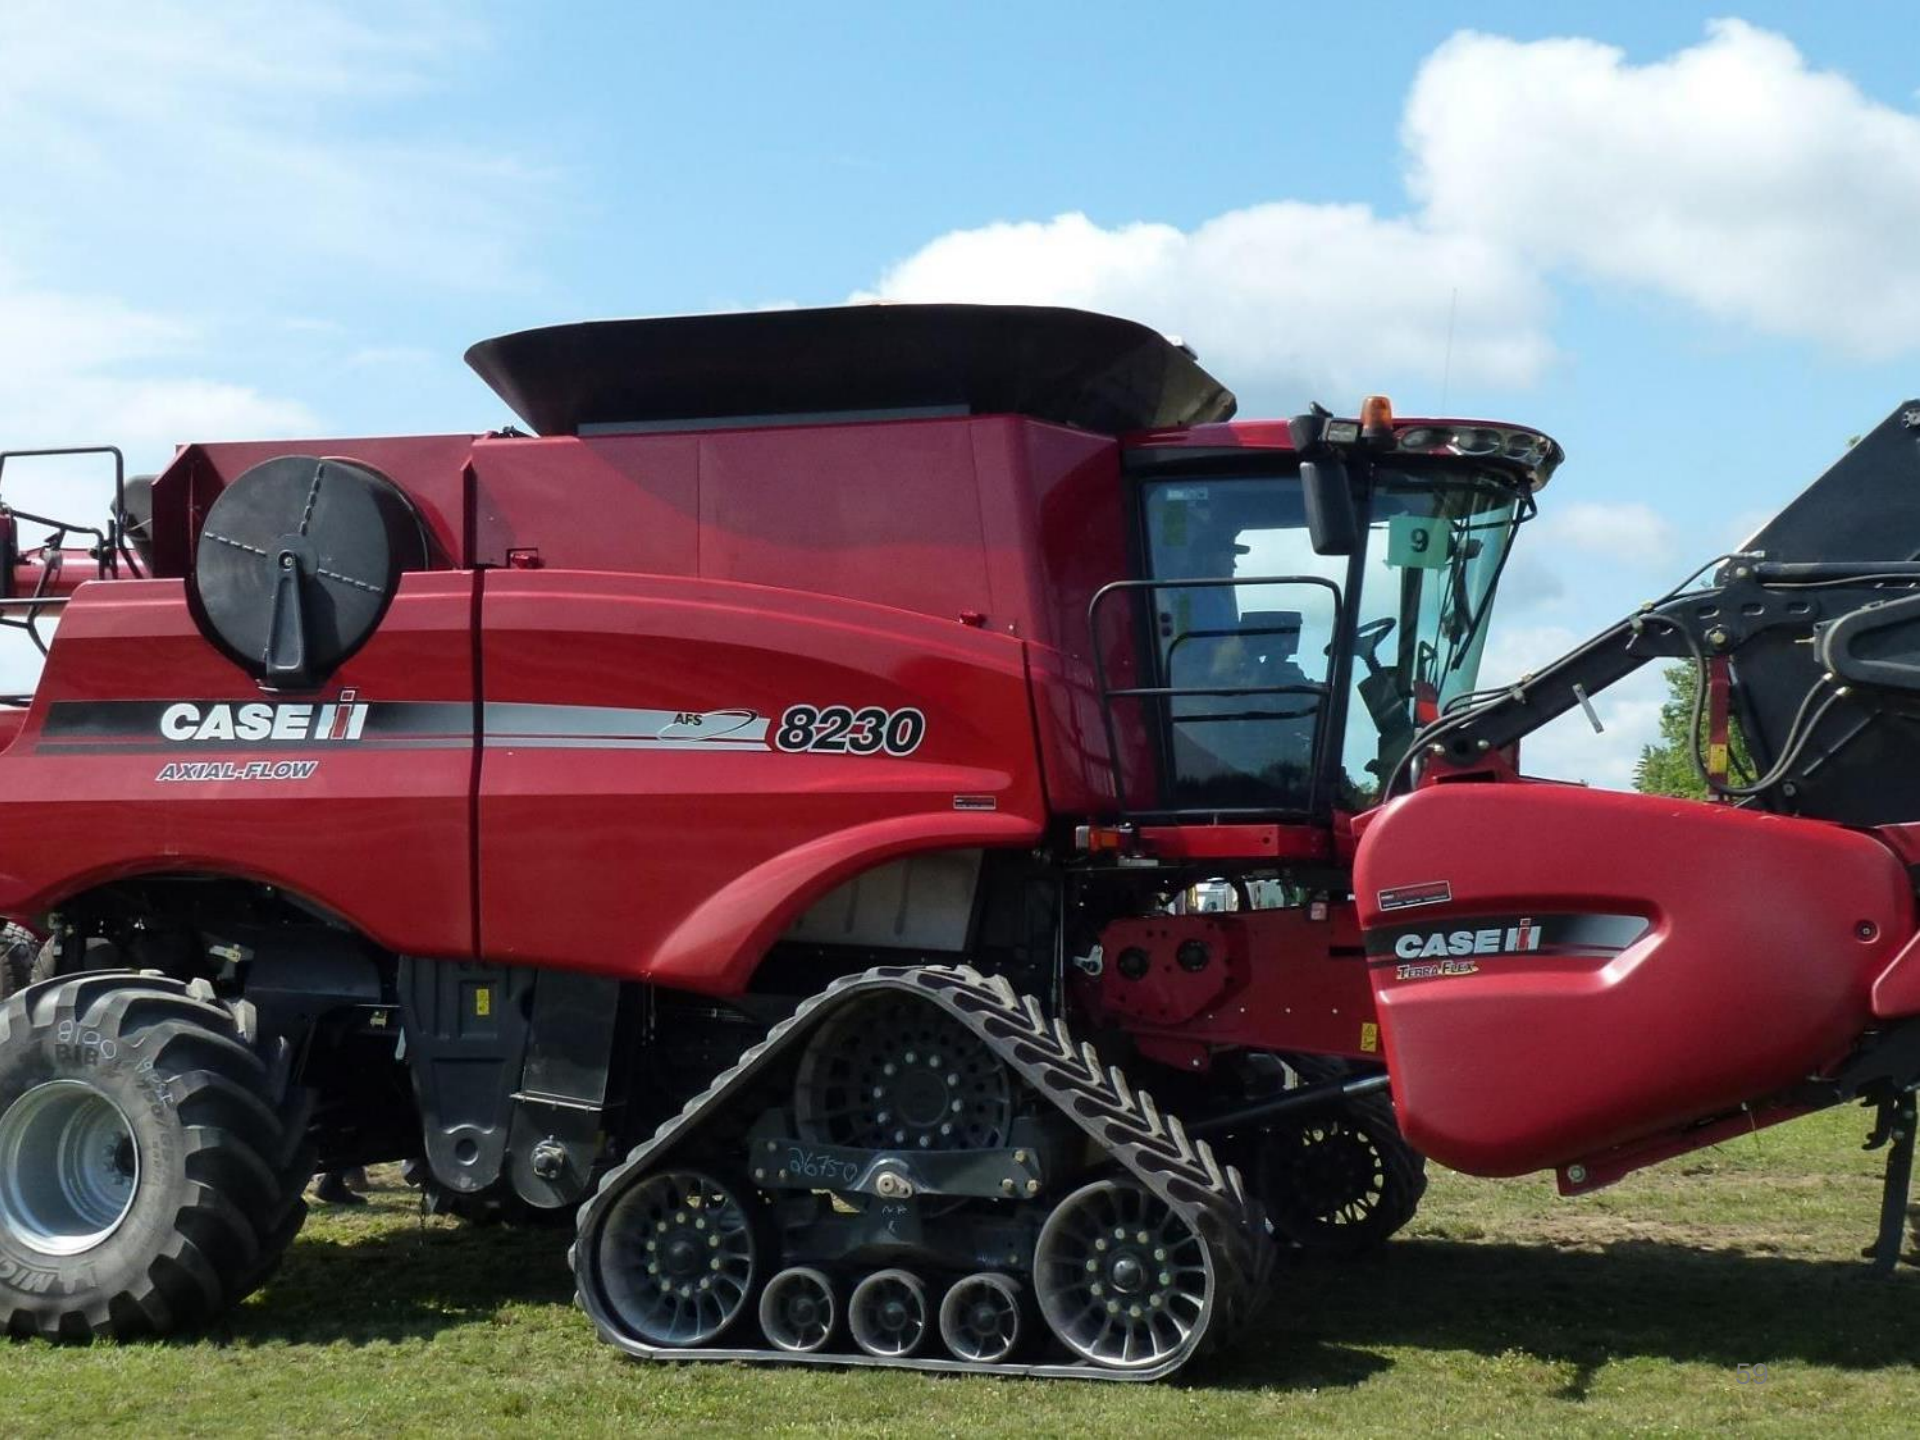
Exhibit: E9

**CaseIH 8230 Tracked
Combine w 750 Rears**

750/65R26

29,700
Track 36 X 80''

19 PSI

CIH 8230
(72,730 LBS/33.3 T)

26,750
Track 36 X 80''

- This combine with tracks was tested on the second installation only.
- The plot titled E9_2 was measured down the center of the track face, between the sets of rollers.
- The plot titled E9_offset_2 was the same track aligned with the outside set of rollers. The stress at the 6 inch depth is increased under these rollers showing that the pressure distribution is not uniform across the face of the track.
- Also notice that the 12 inch and 20 inch depths are similar in both cases. The stress at these depths is more associated with the weight of the vehicle and not the amount of flotation that the track or tire provides.
