2019 Elgin SCIA Compaction Event

Shedden, Ontario

August 8th, 2019

Elgin SCIA Compaction Event

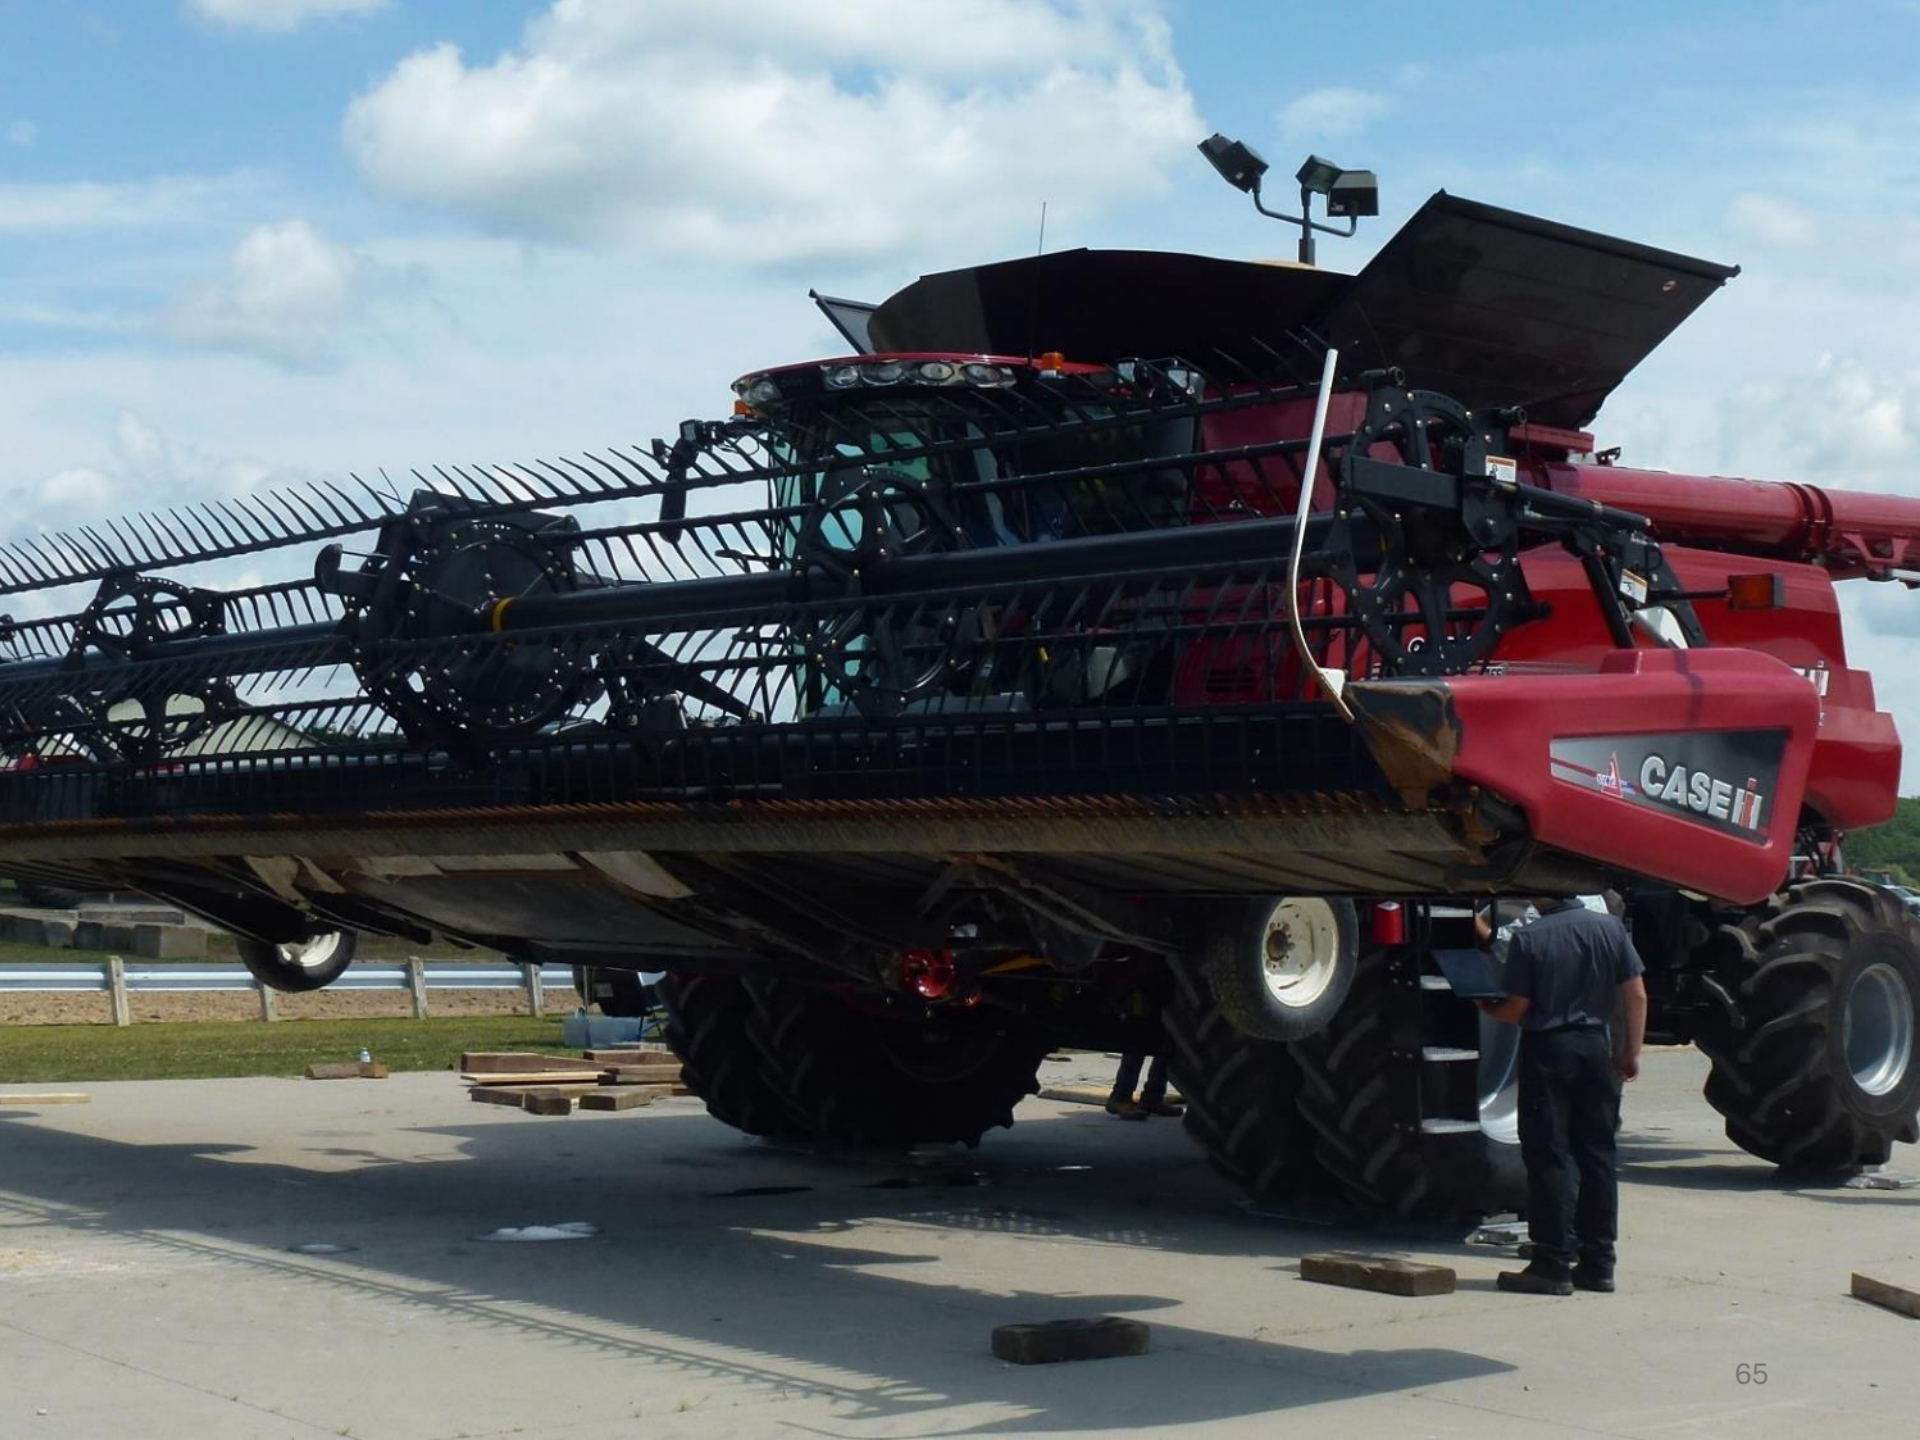
Exhibit: E10

**CaselH 8250 Combine Dualled
IF580/85 R42 w
VF 710 Rears**

- This unit is a good example of a combine set up.
- The IF (front) and VF (rear) tires are allowing for a much lower tire pressure than one might normally expect on a combine.
- Overall the small footprint of these tires may mean that the stress is not as small as one would expect with a low tire pressure.
- The stress on the left rear (E10_LRear_3) is roughly the same as the front dual tire.
- The right rear tire (E10_RRear_3) appears to be much lower. This could be explained by the relatively large spacing between the lugs on this tire. The tire lugs were not sinking into the soil during this event and therefore the weight was being carried by the lugs. The measured soil pressure would have been higher if the sensor was directly below the lug on the tire.

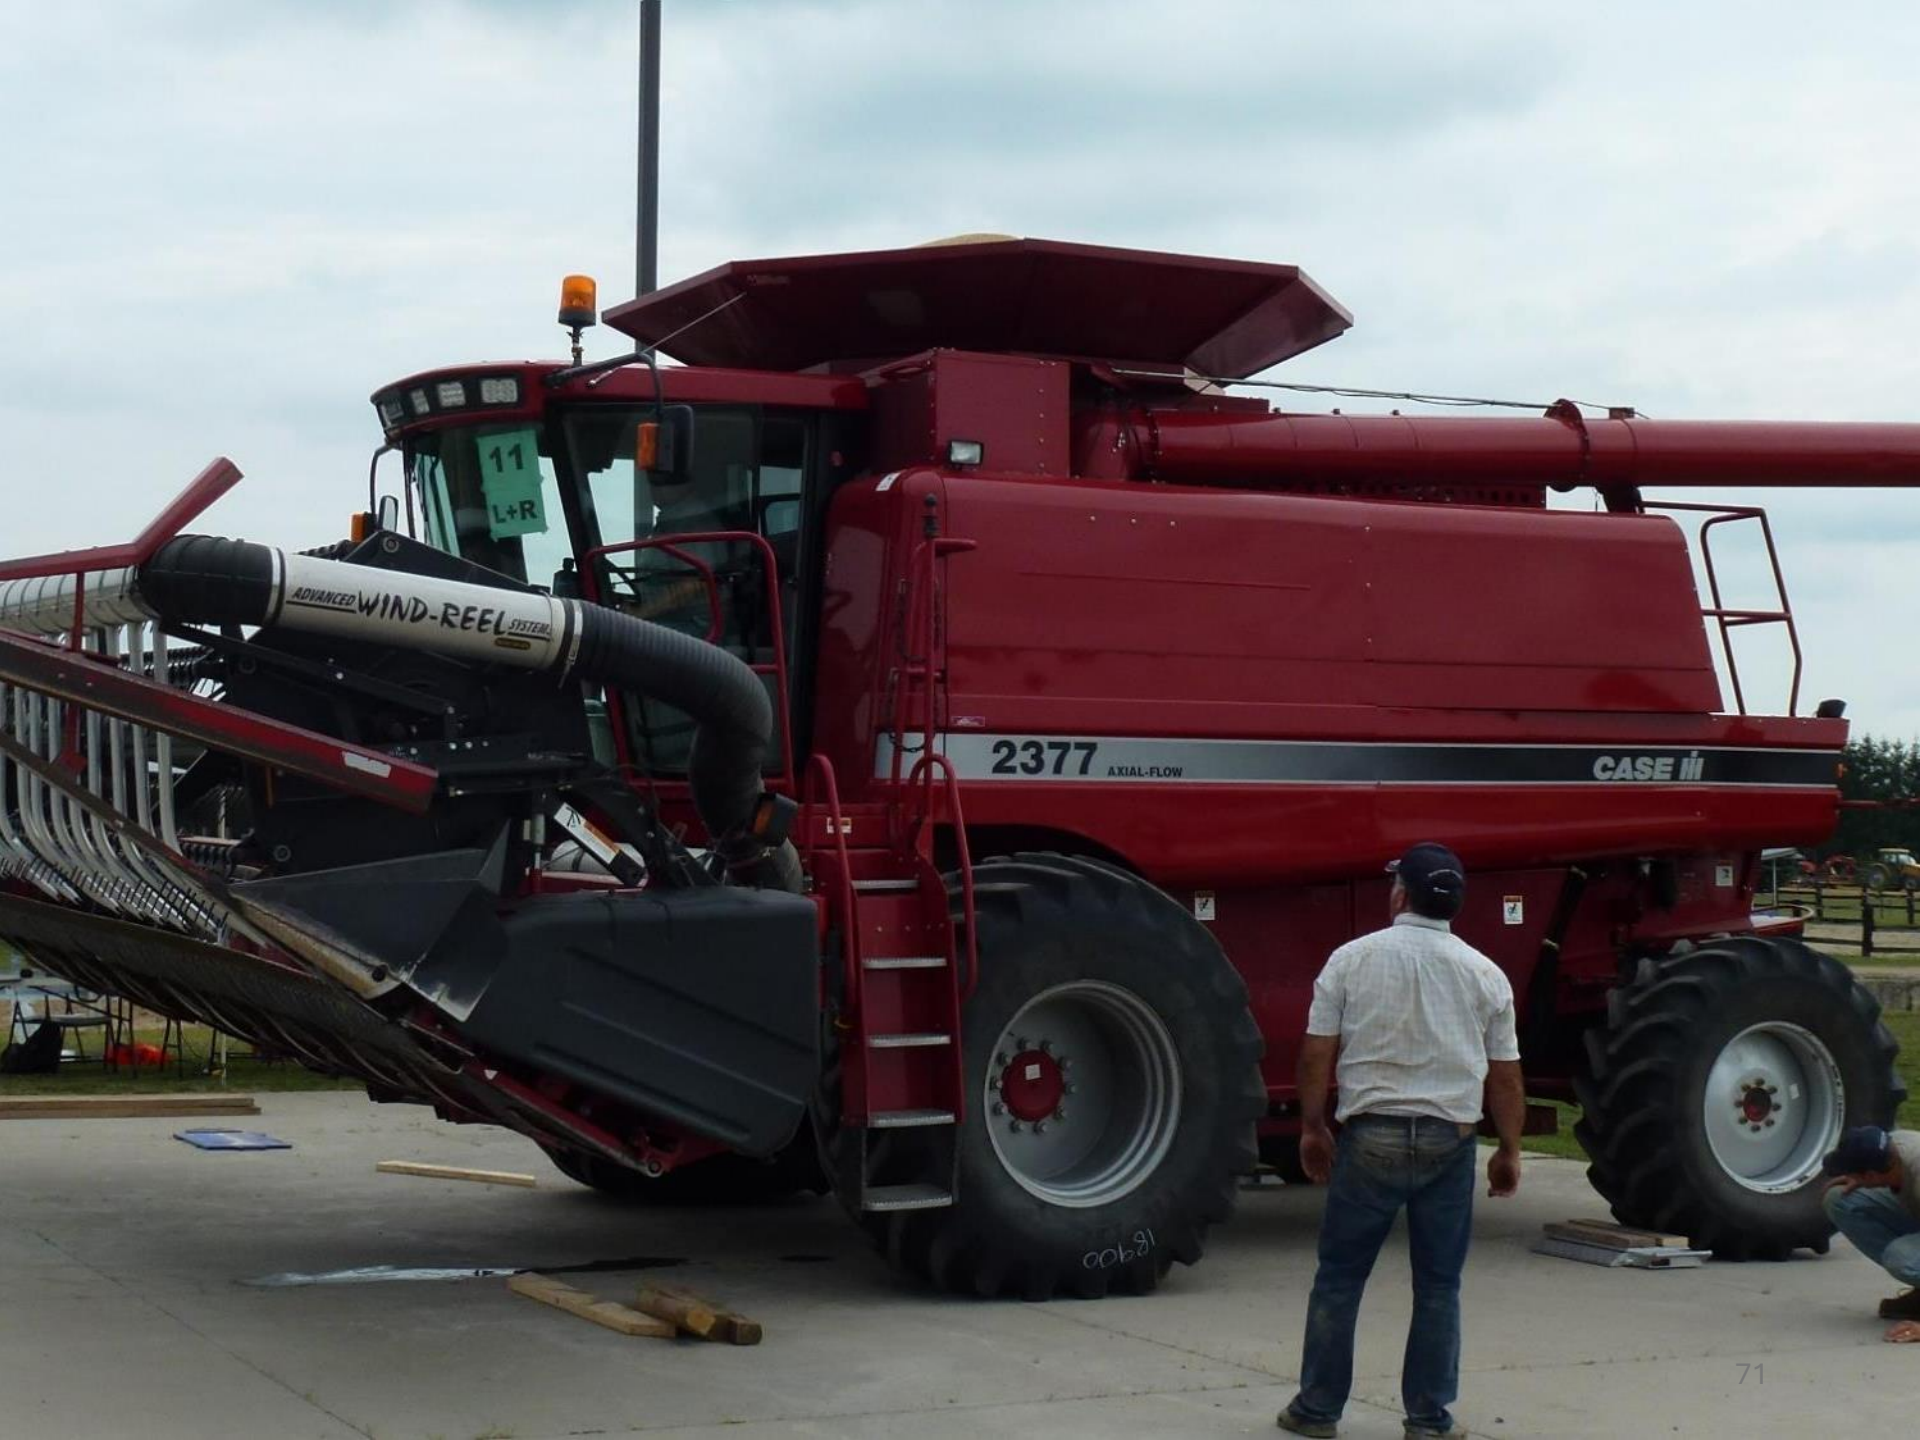
Exhibit: E11

CaselH 2377 Combine

30.5L-32 vs VF900/60 R32

Bias/Radial

Singles w 600 Rears

- This combine compares a bias tire to a VF radial tire.
- For both sensor locations 1 and 2, the bias ply tire (E11_L_1 and E11_L_2) exerted a higher force on the soil than the VF tire (E11_R_1 and E11_R_2) although given the soil conditions, both were acceptable.
- The rear tires in both test were measured approximately the same giving good confidence in the measurement setup as the rear tires were set up equally.
- Note: This Unit did not test on the same location as the tracked combine. Comparison between E10 and E11 should not be made.

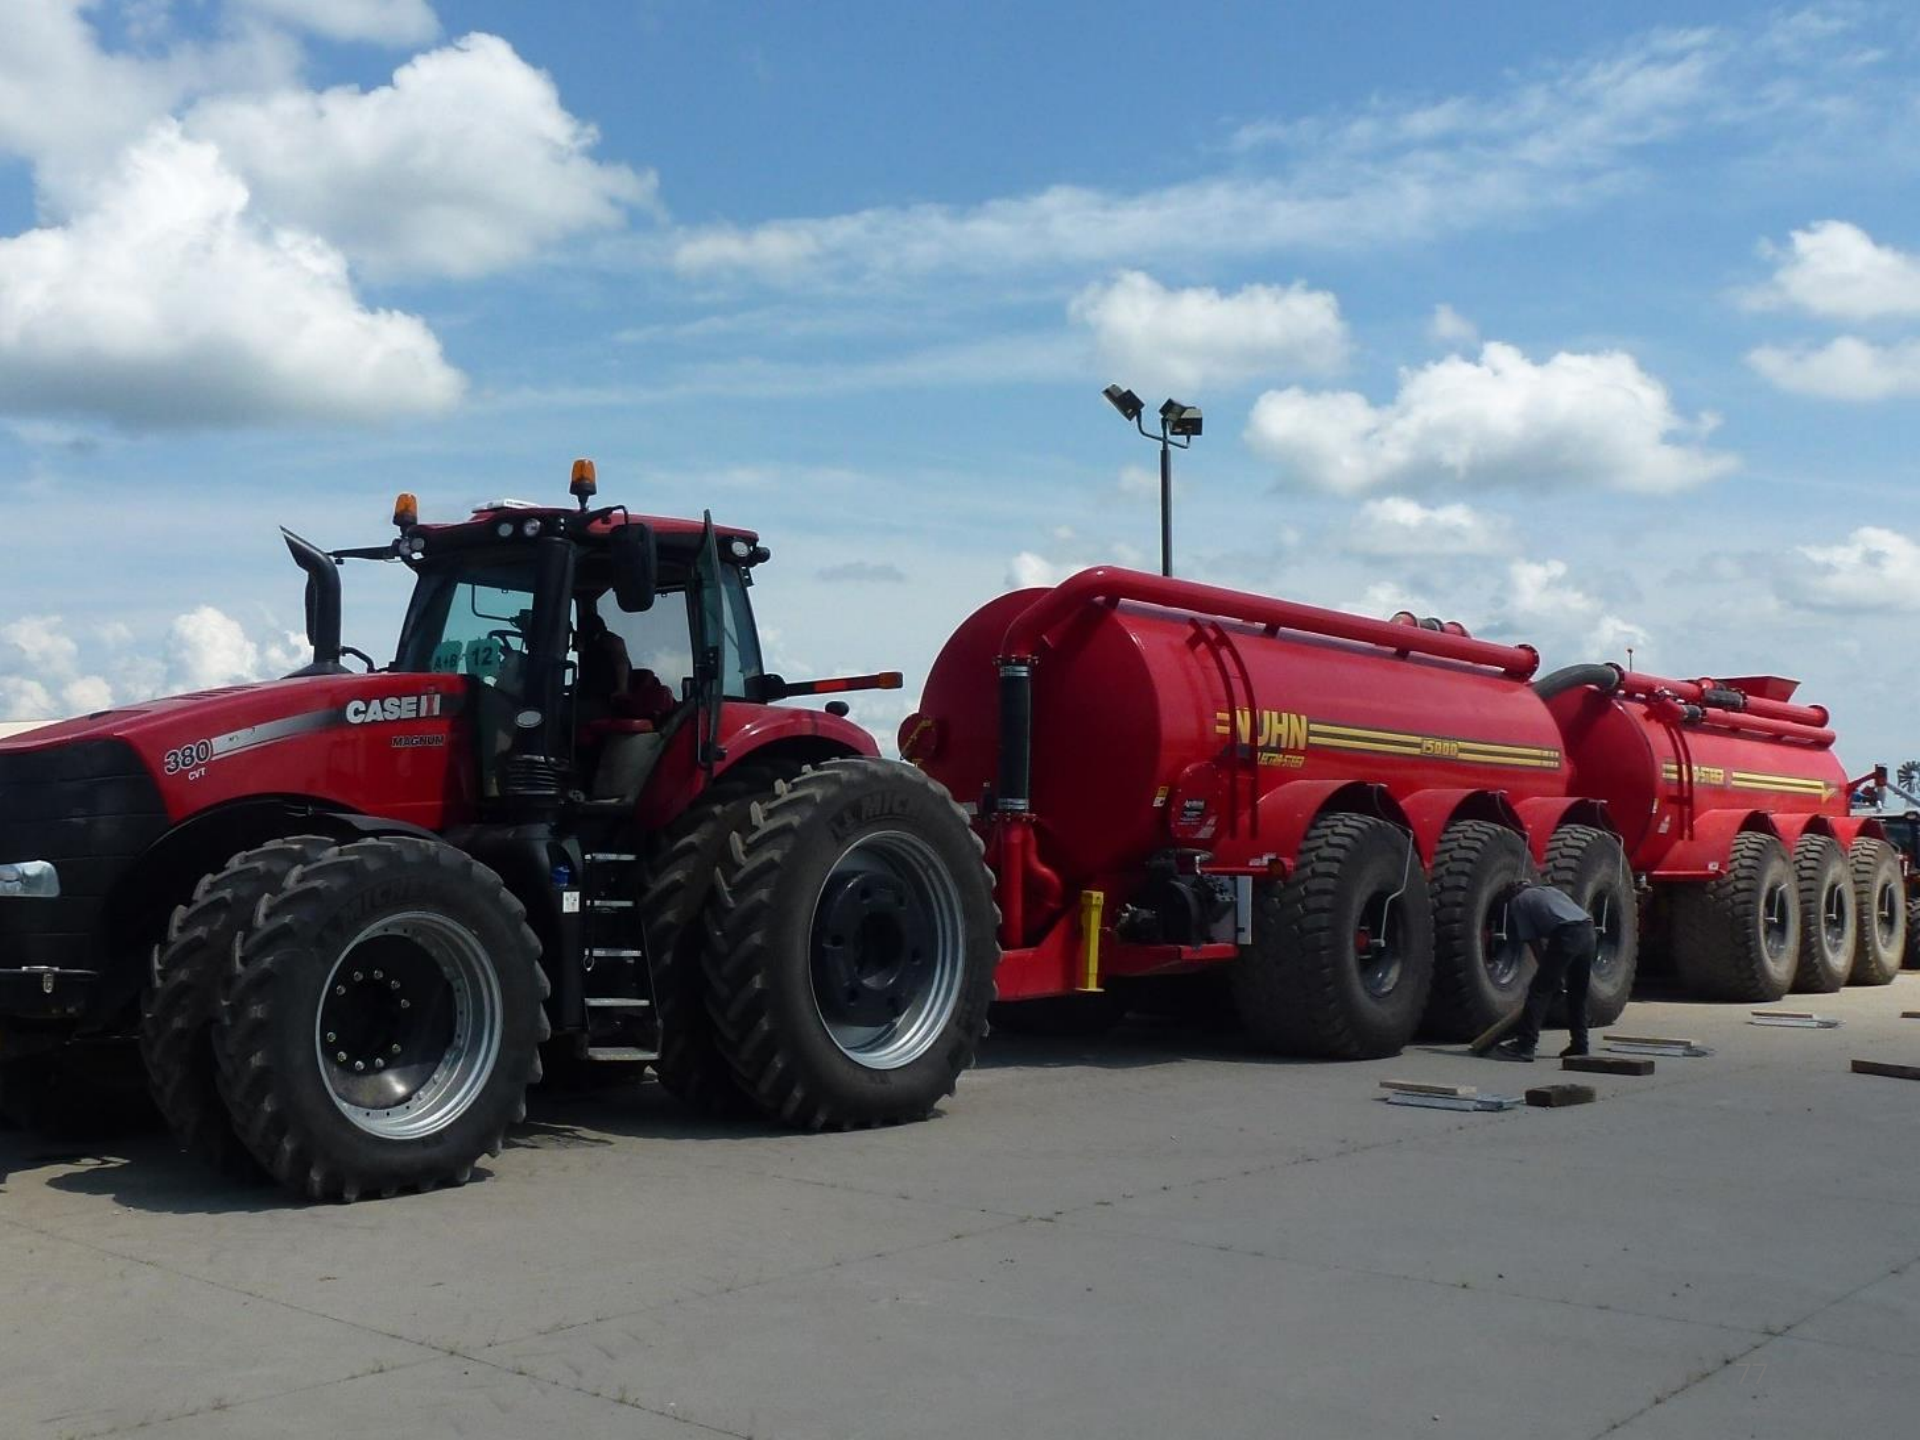
Exhibit: E12

**CaseIH Magnum 380 + Nuhn
15000 gal Quad Steer
Manure Tanker with VF 900s
and CTIS**

**CTIS: Road @40 and Field @15
psi**

- This Unit was equipped with a central tire inflation system (CTIS).
- This is a good example of the impact of high and low pressure tires.
- The load on the soil is reduce for the 6 inch depth when the tire pressure is reduced.
- The load at the 12” and 20” depth is not reduced by the same magnitude since the total weight of the machine did not change and this needs to be considered in terms of the risk to deep compaction.
- The tractor tires were not centred on sensors and should be ignored.

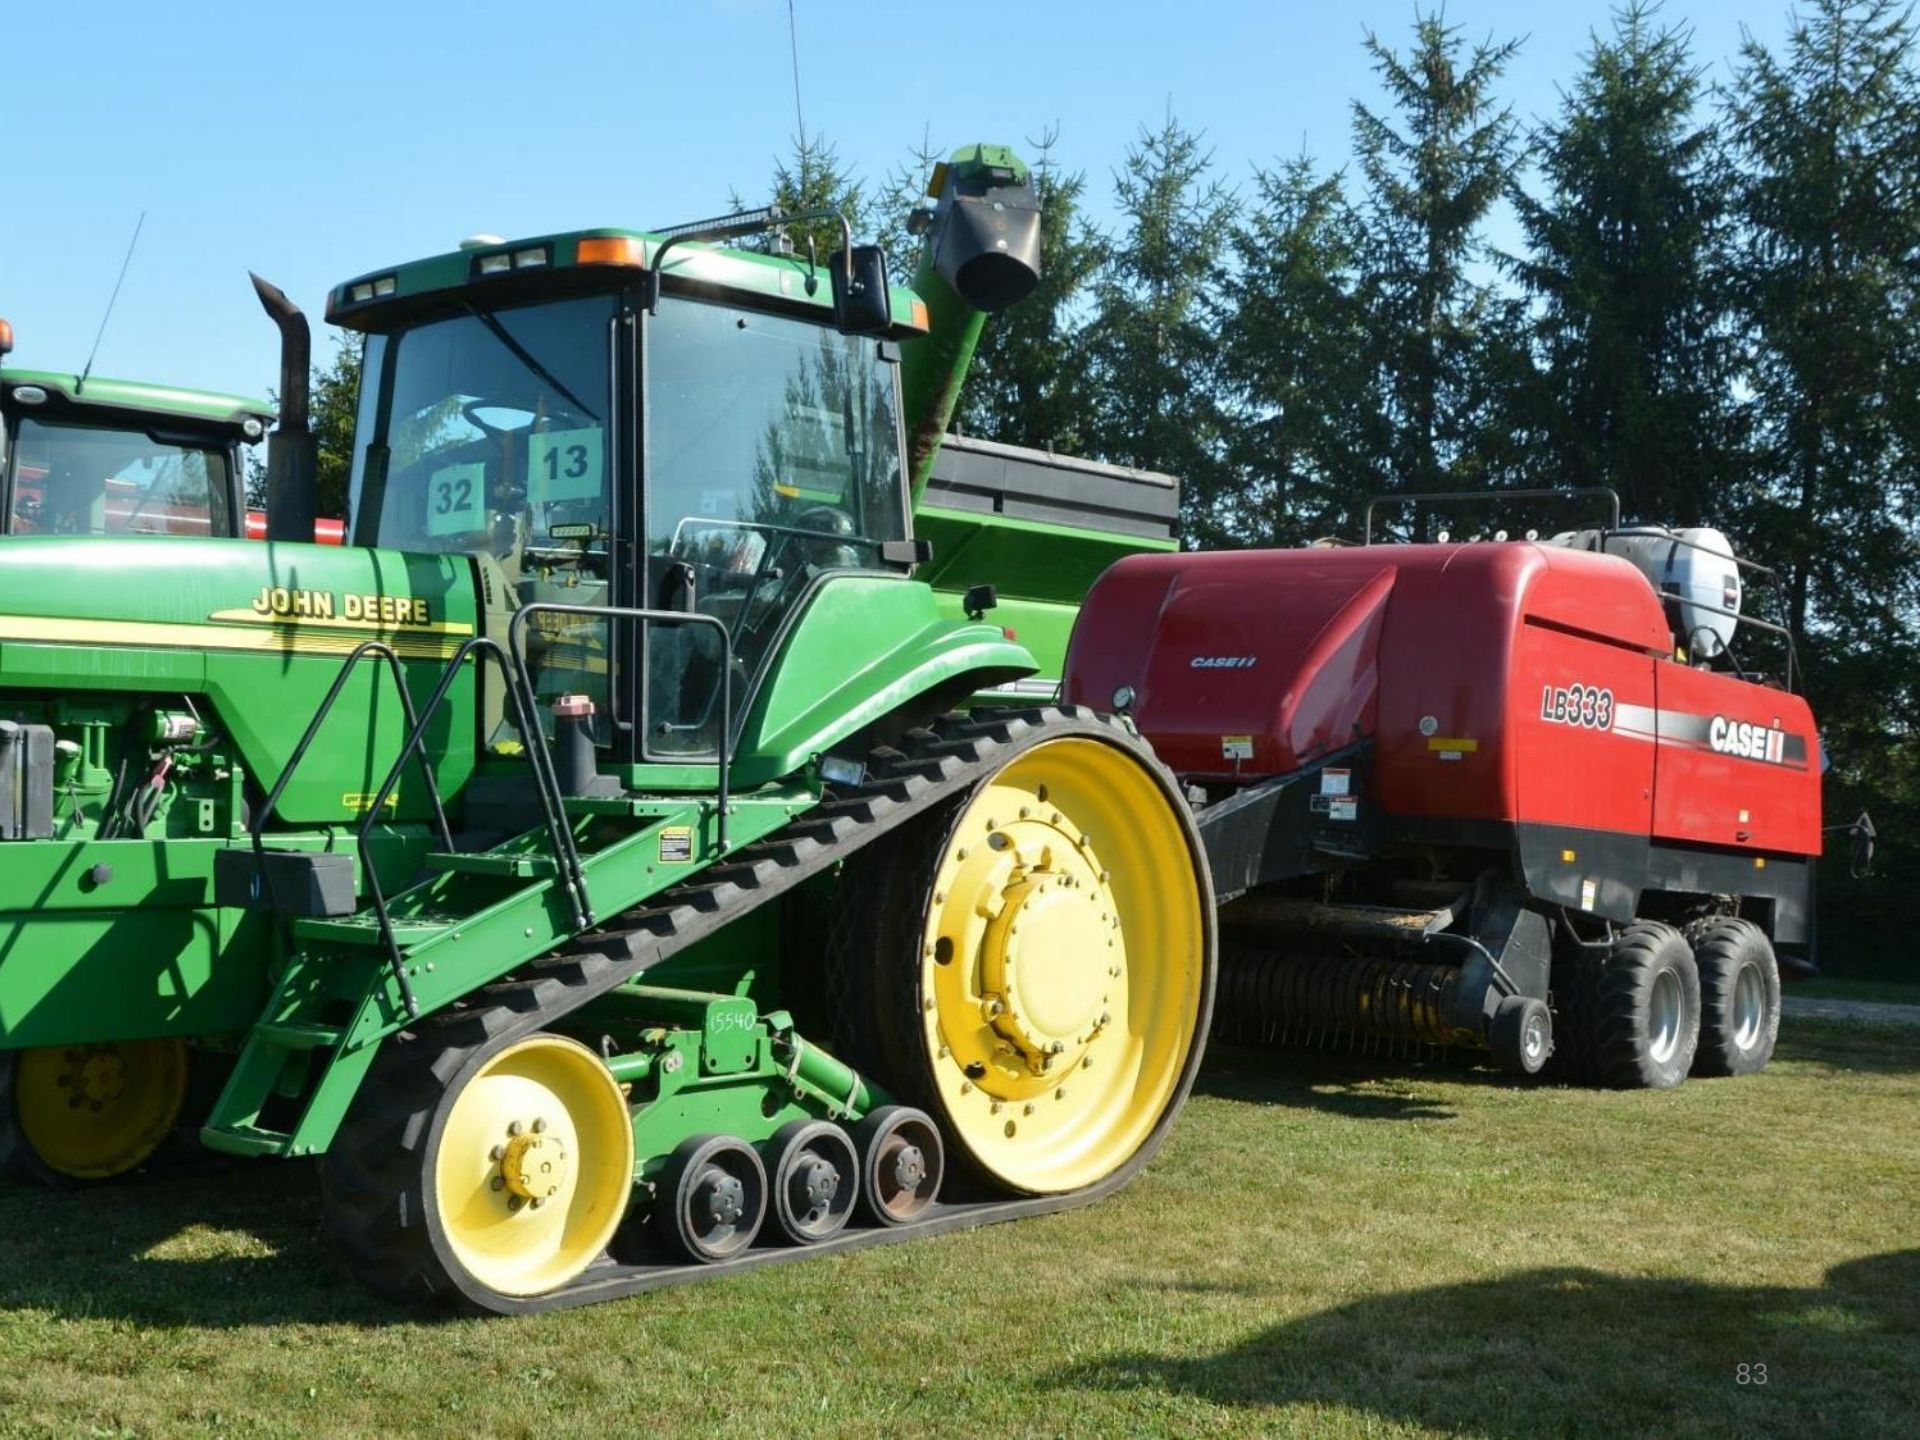
Exhibit: E13+E32

**CaseIH LB333 Large Square
Baler with Bias 500/50-17 +
Tracked JD 8410T Tractor
24” Left vs 18” Right Track**

Left chart centered tire sensing on the tractor track, while right chart centered sensing on the tandem axle of the baler.

- This set of plots shows the tractor and baler tires centred and off centre (opposite charts) between the two implements
- The right two peaks of each chart show the baler tire response while the left peaks of each chart are the tractor (18" vs 24" track width).
- These baler tires are well balanced and equally loaded. However notice the increase in soil pressure in the center of the face of the tire. The pressure is reduced when measured about 1/3 across the face of the tire where the 18" track was aligned with the sensors.
- A tire with a flatter tread face may be better at distributing the soil pressure across the full tread.

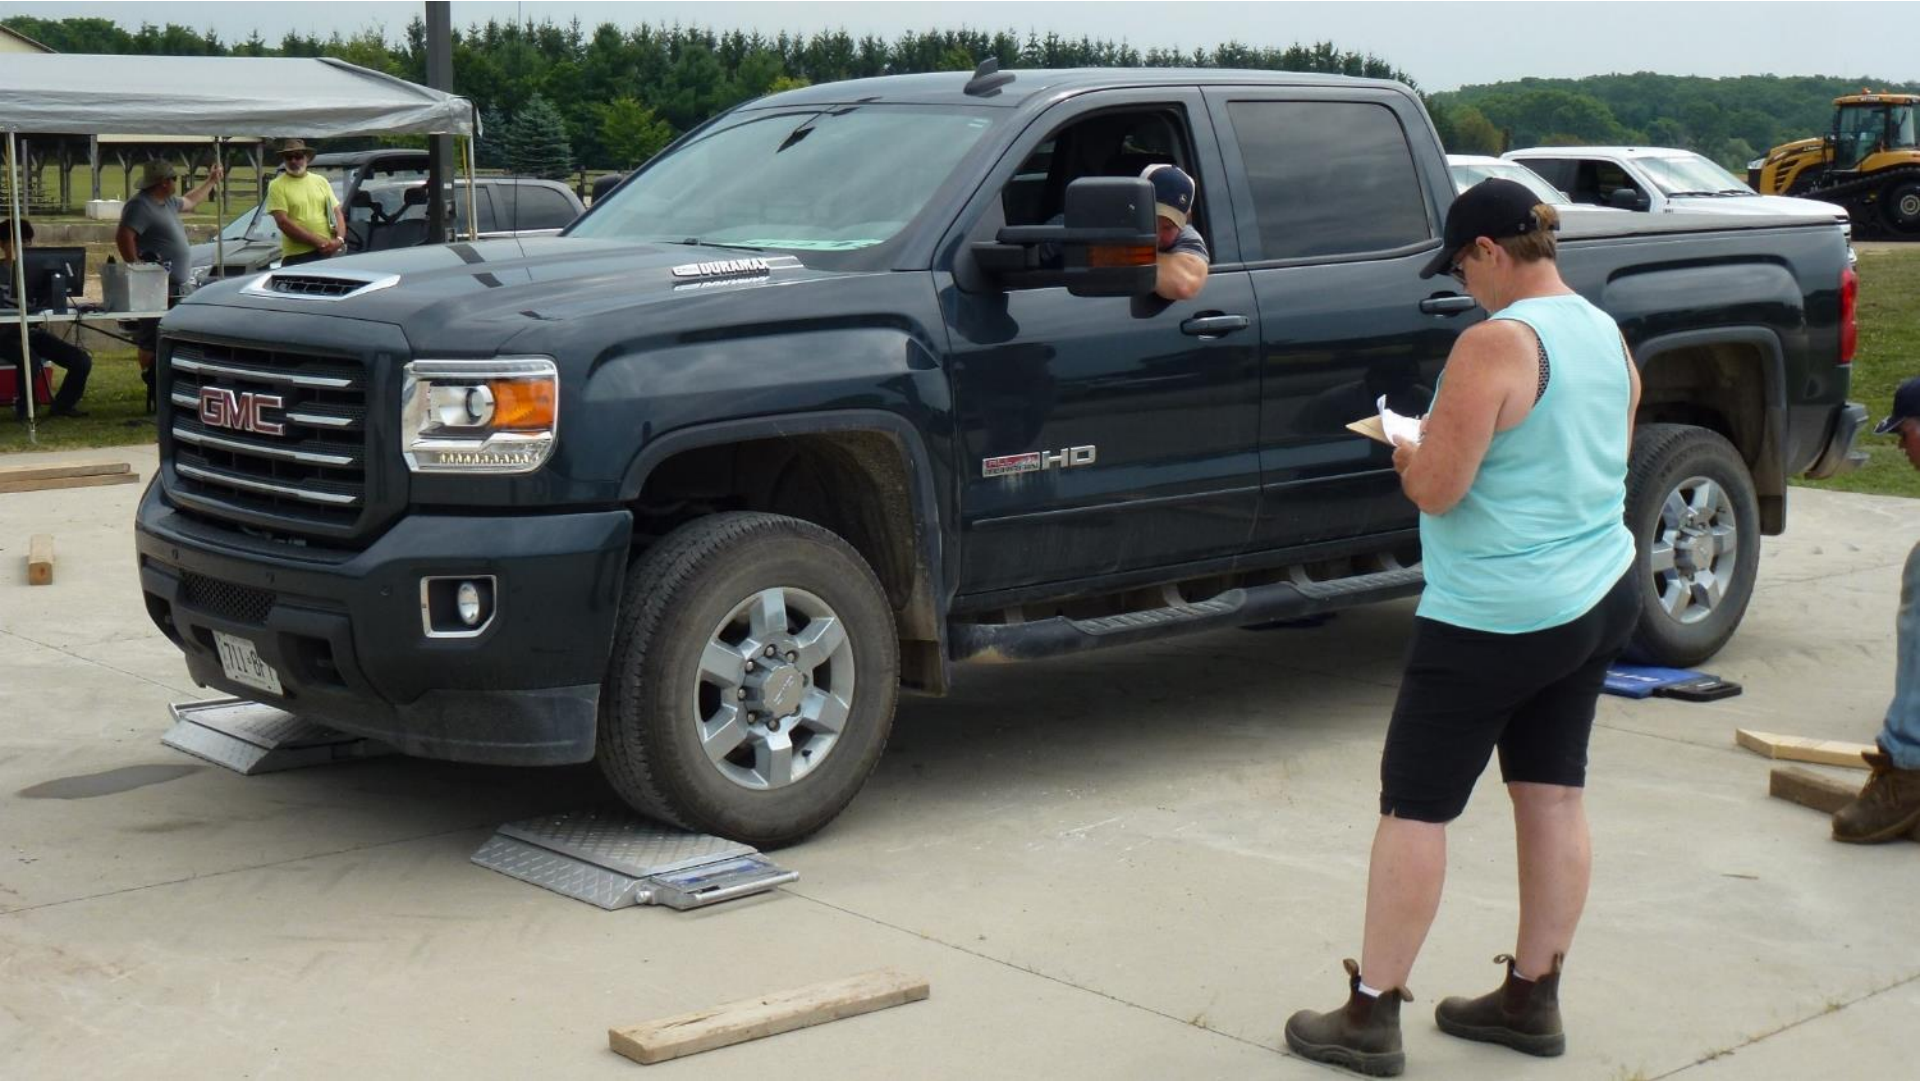
E15

**$\frac{3}{4}$ Ton Pickup Empty vs
Loaded**

Empty (E) – 8120 lbs
Loaded (L) – 9500
lbs

Tires - LT265/70R18

- Unfortunately, data for the load picture was not obtained.
- However, notice that the truck loads the soil on the front tires more than the rear in the empty condition.
- The rear peak would have been slightly higher if the loaded test was collected.
- Also note that a lot of the stress is measured in the 6 inch depth and less so in the deeper sensors. The total weight of the pickup is generally not enough weight to generate much stress at depth. Consider that the total weight of the truck is less than the weight on the average dual of a combine or grain cart.

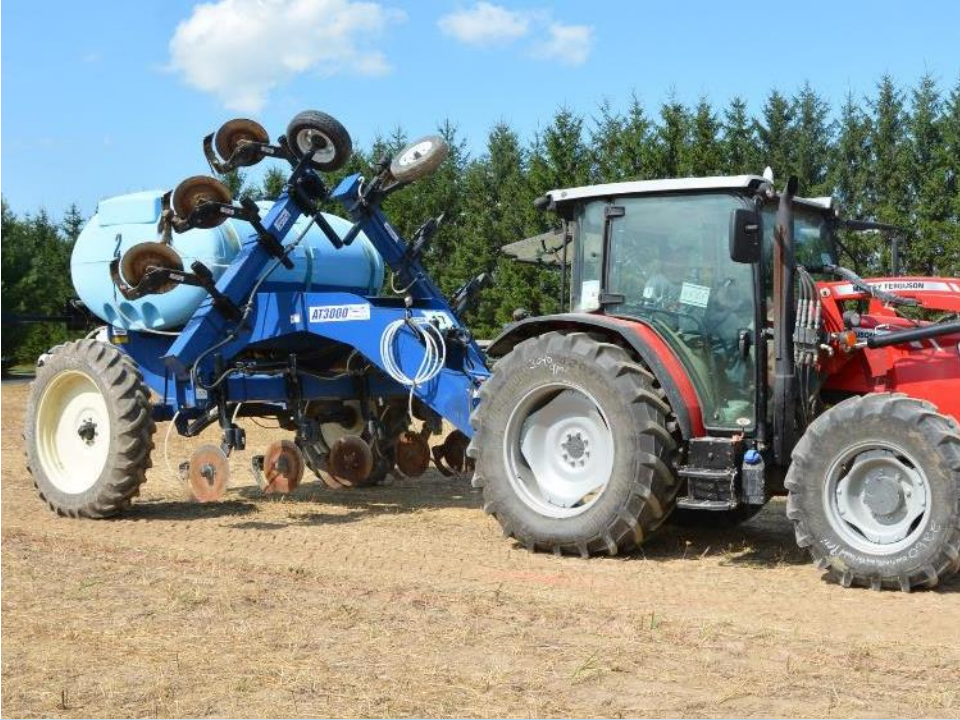
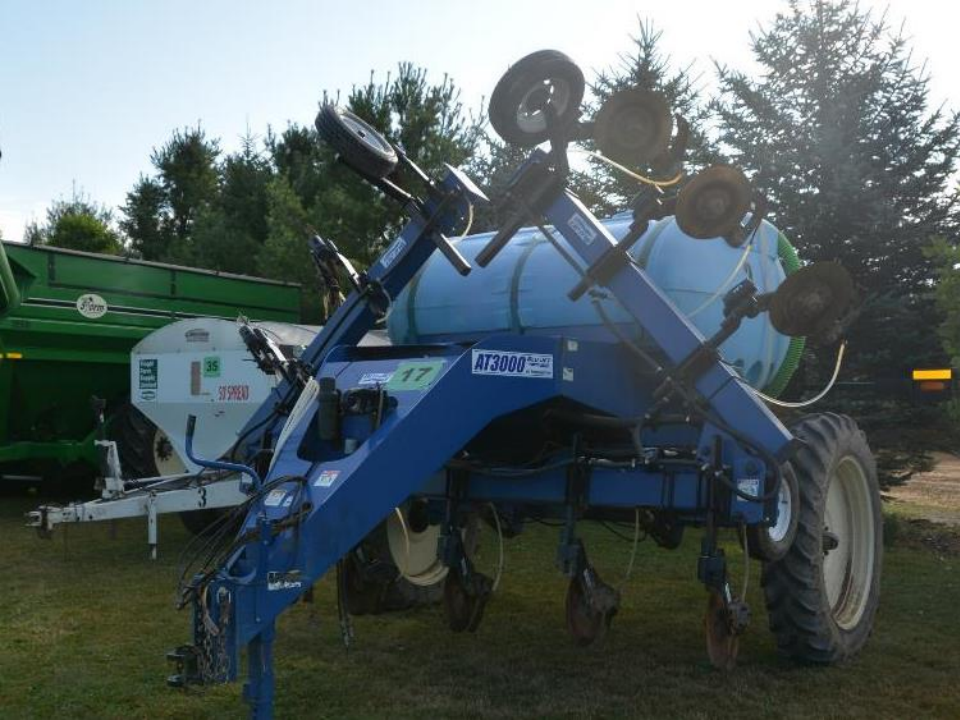
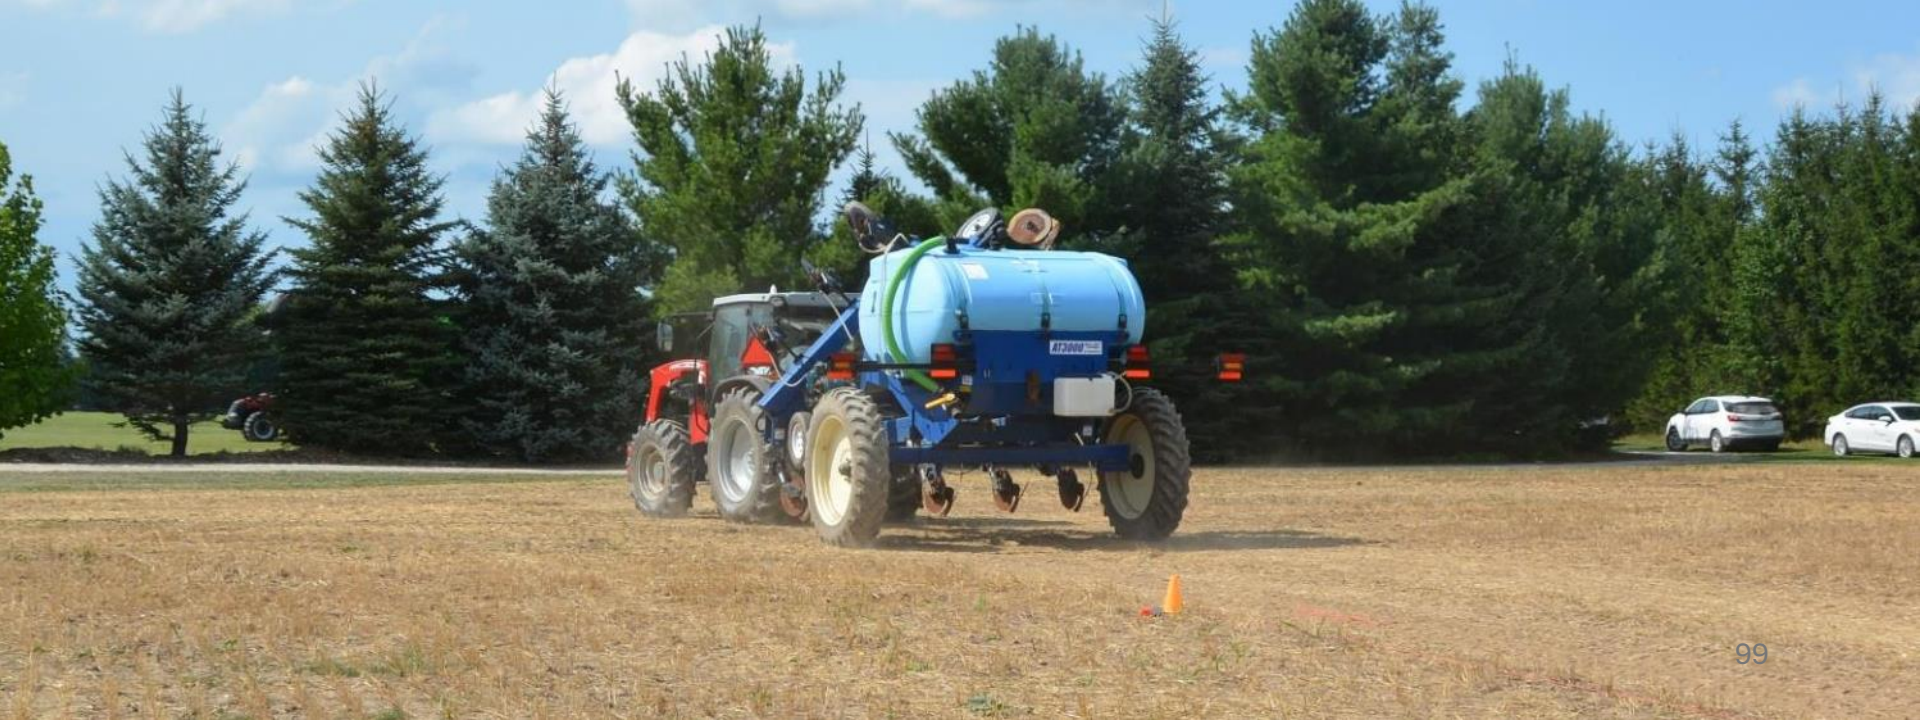
- This Unit had a high load on very narrow bias ply tires with high pressure.
- The plots show the variability in pressure across the face of the tread as it was difficult to consistently hit the sensor with the center of the tire.

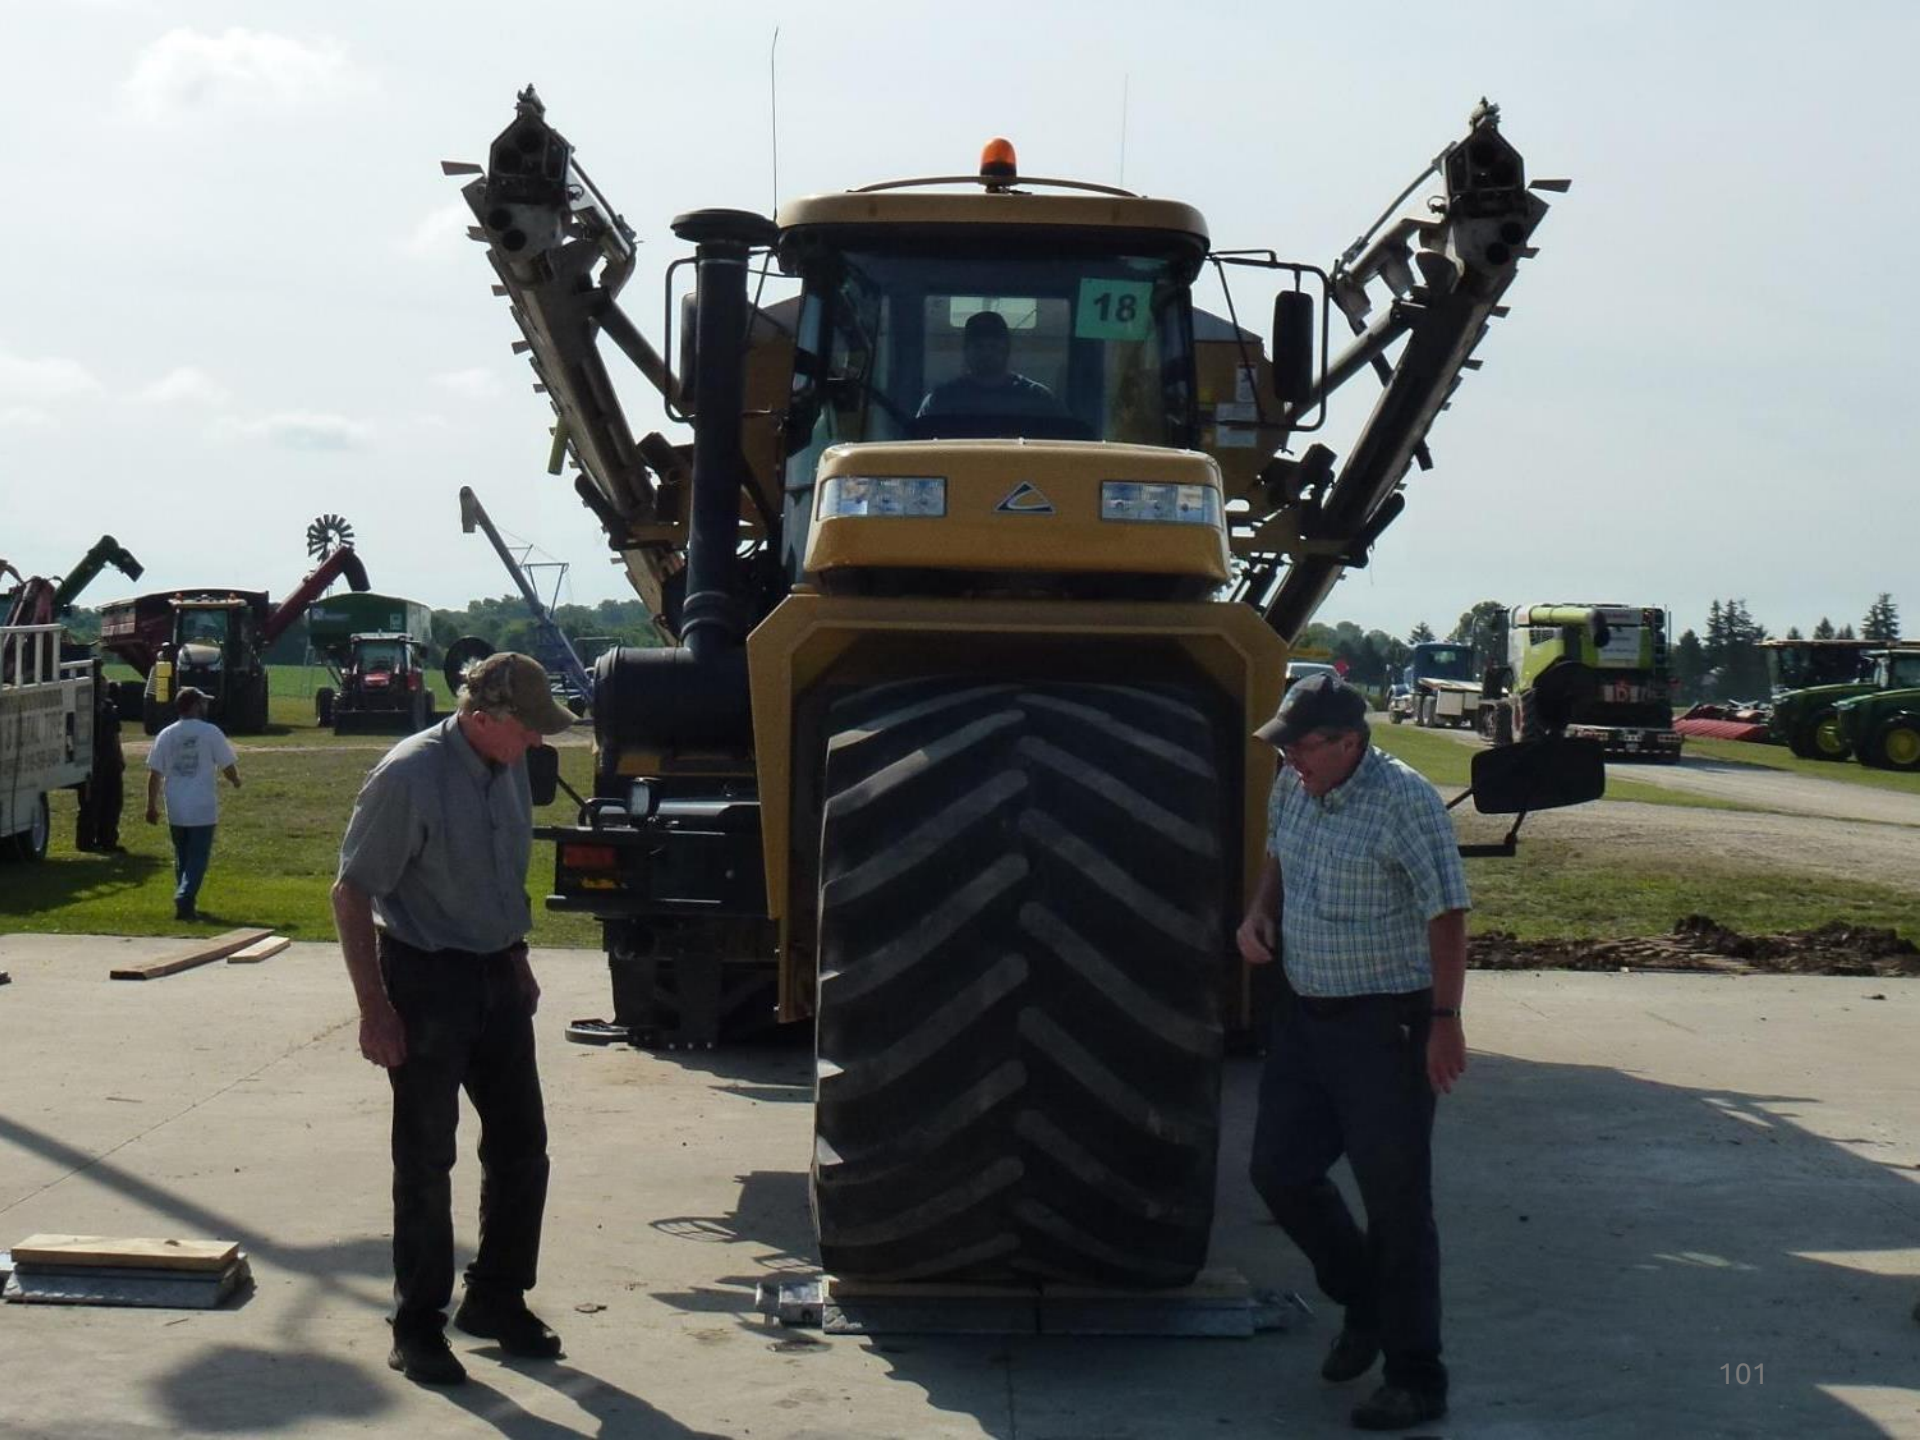
Exhibit 18

**Terragator 3 Wheel Dry
Fertilizer Applicator w
1000/50R25**

44 PSI

16,620
1000/50R25

AGCO Terragator CVT
(45,400 LBS / 20.5T)

11,040
1000/50R25

22 PSI

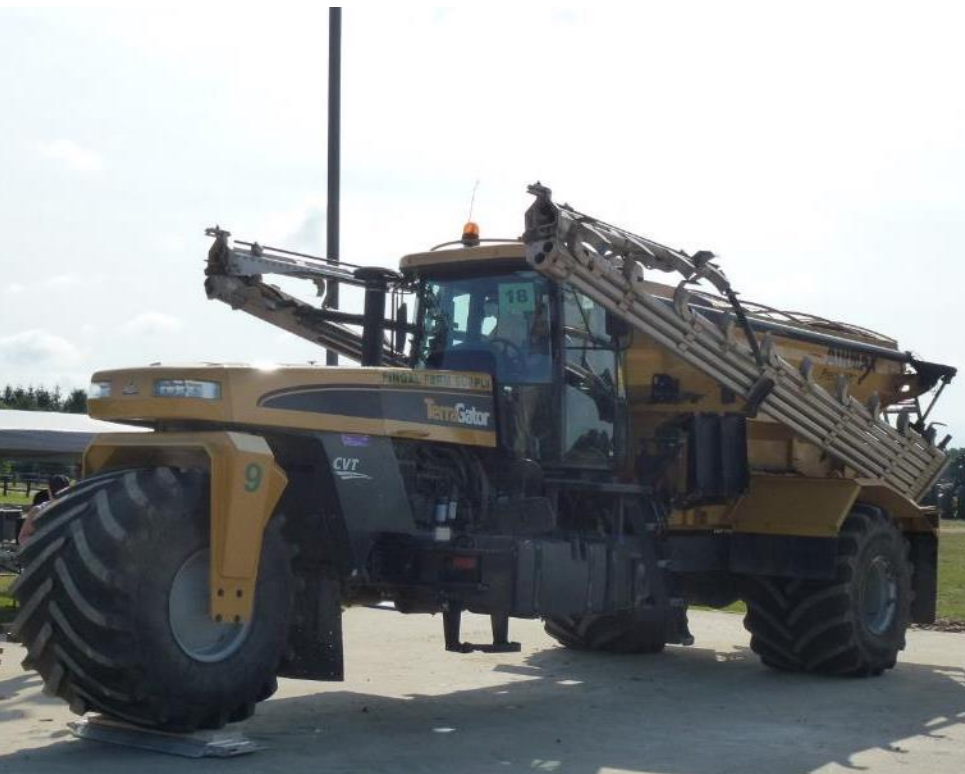
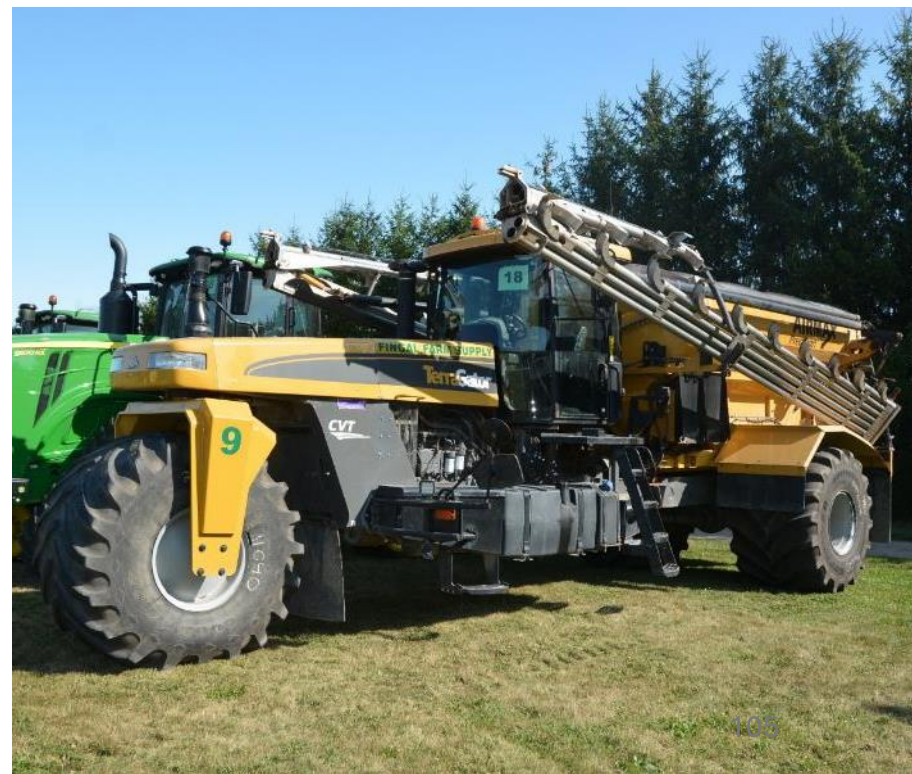
- This is a well configured unit although it was not fully loaded with product.
- The front tire was not tested.
- The stress detected is below theoretical threshold for both rear tires.
- Despite the high psi on the rear tires, the sheer tire volume based on tire size means the compaction threat is reduced in most situations.
