2019 Elgin SCIA Compaction Event

Shedden, Ontario

August 8th, 2019

Elgin SCIA Compaction Event

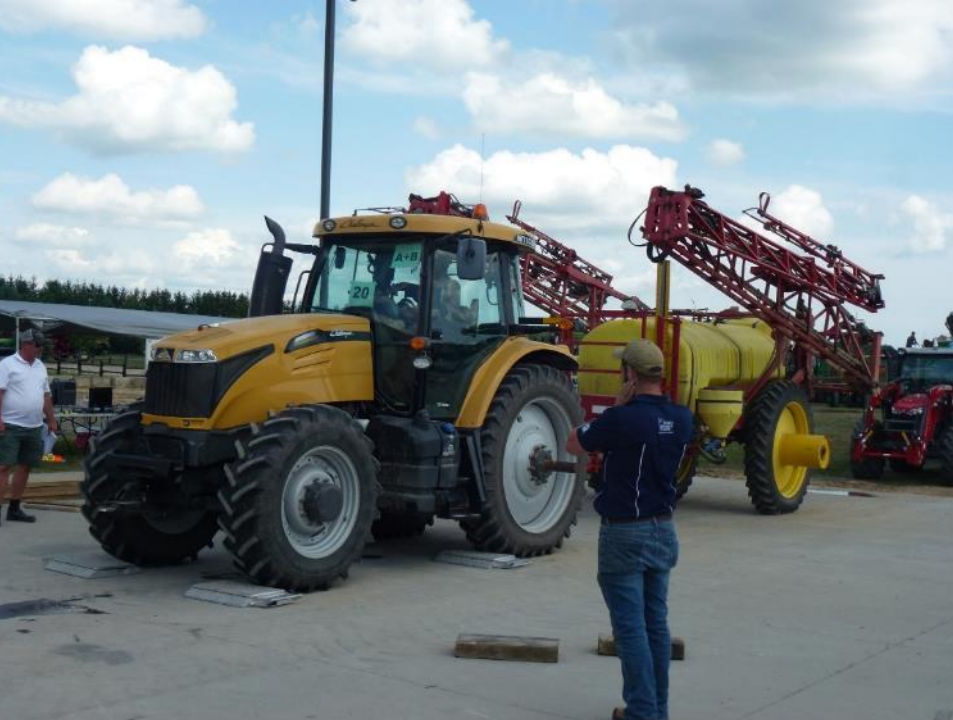
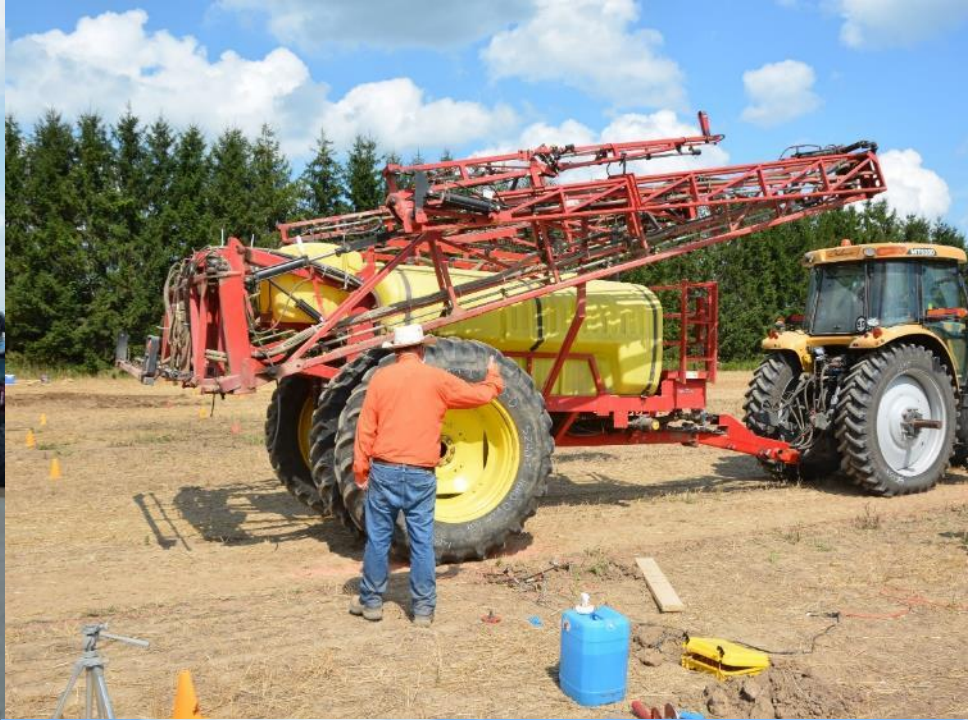
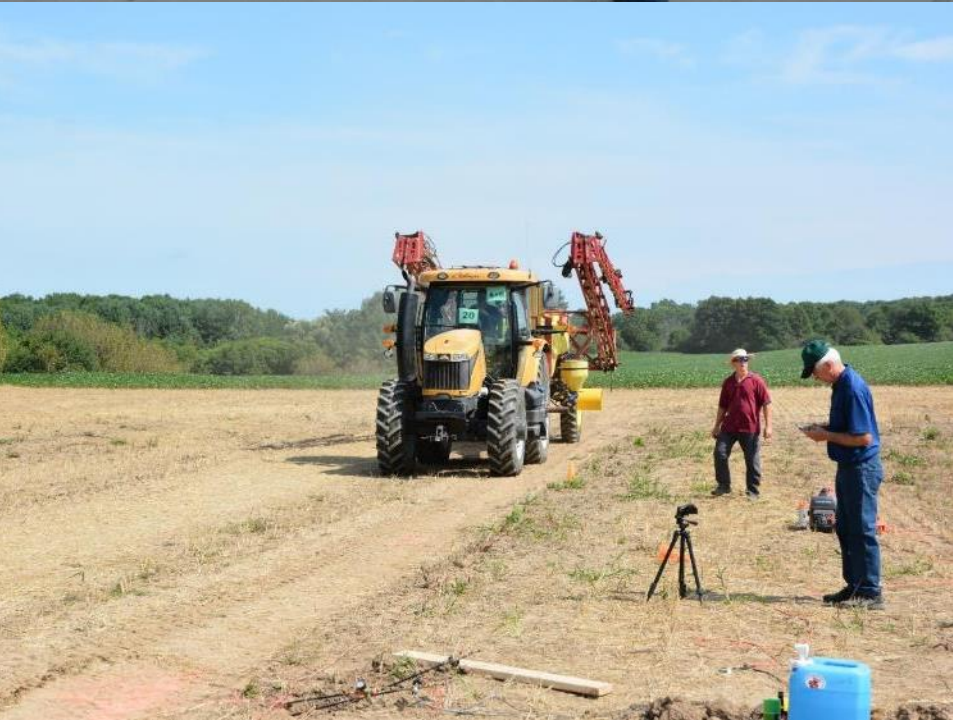
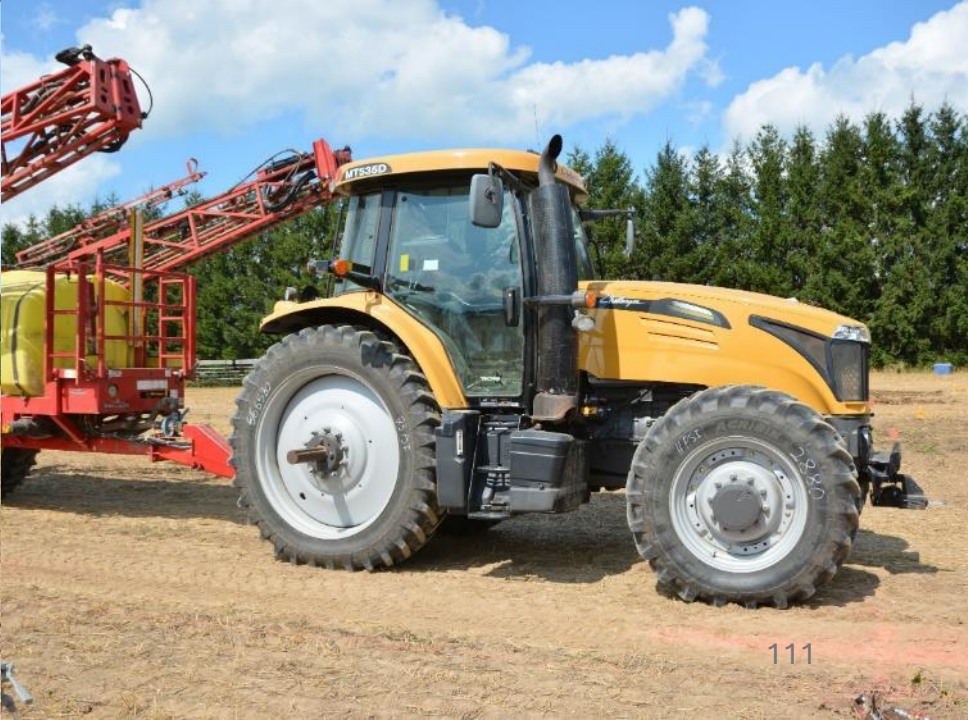
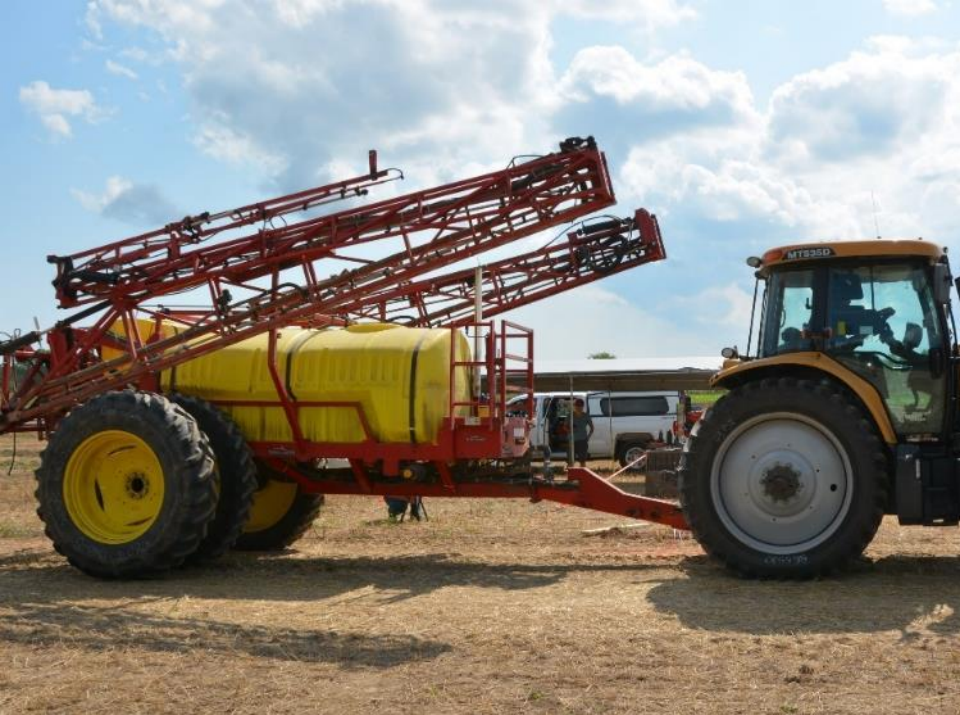
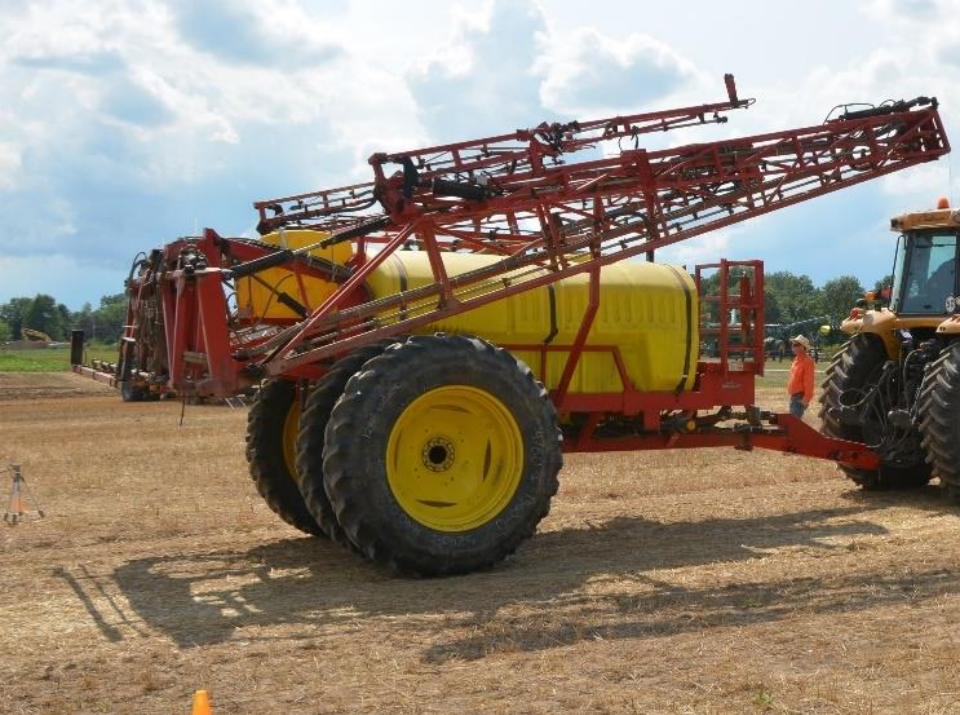
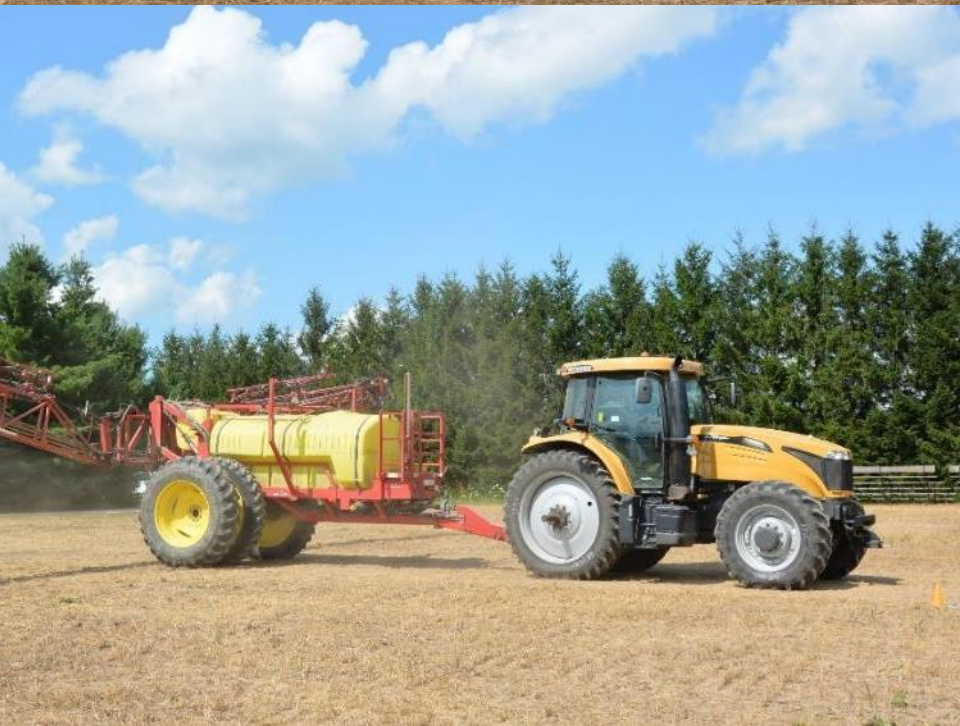
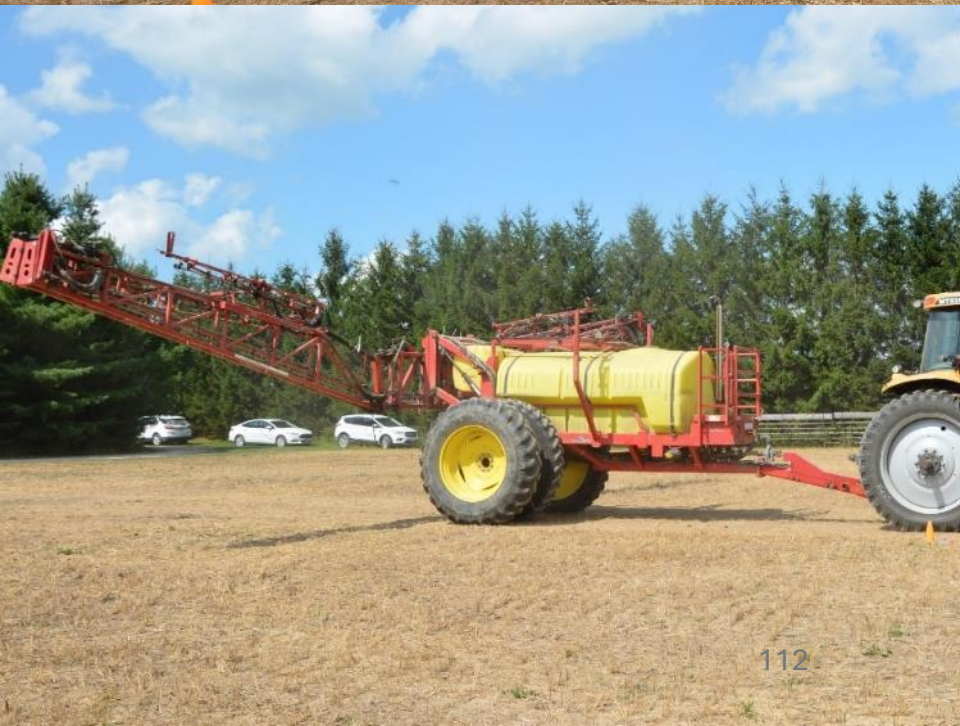
- This Unit shows how unbalanced duals can be misleading (29 vs 12 psi).
- The plots E20_A_3 show the high peak for the single tire but when compared to the outer dual in plots E20_B_3 the stress is substantially reduced. Notice that the weight being carried by the outer dual is very low compared to the inner dual. In subsequent events we determined the proper PSI setting for all tires and adjusted accordingly before sensing.
- Dual tires are only effective for reducing stress when they can share load equally. Inside dual would likely have measured high stress!
- There may be a stability advantage to having this dual.

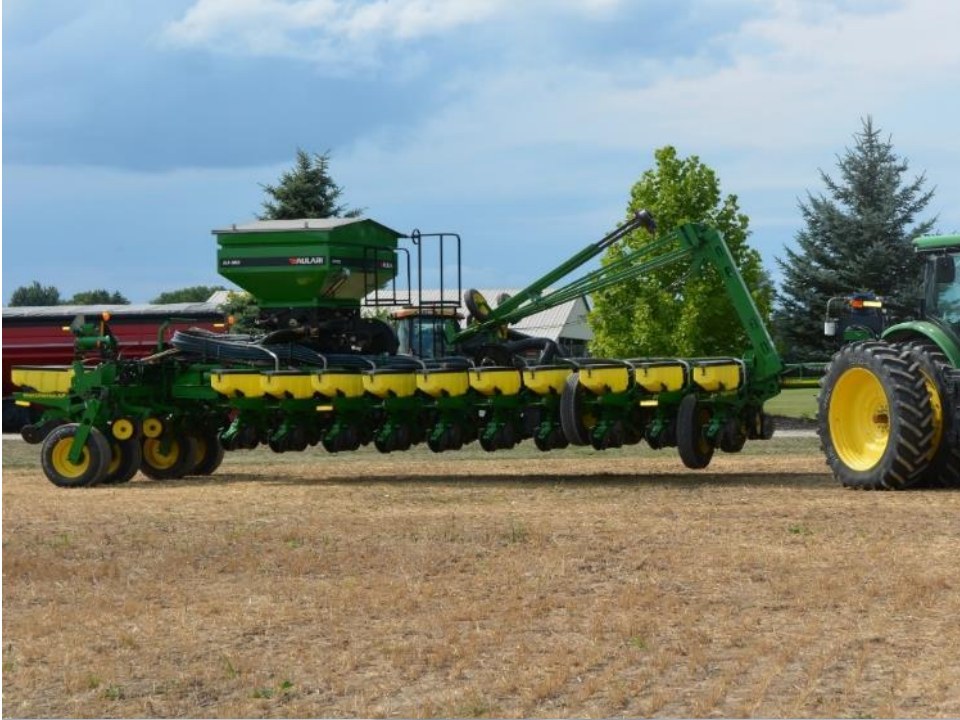
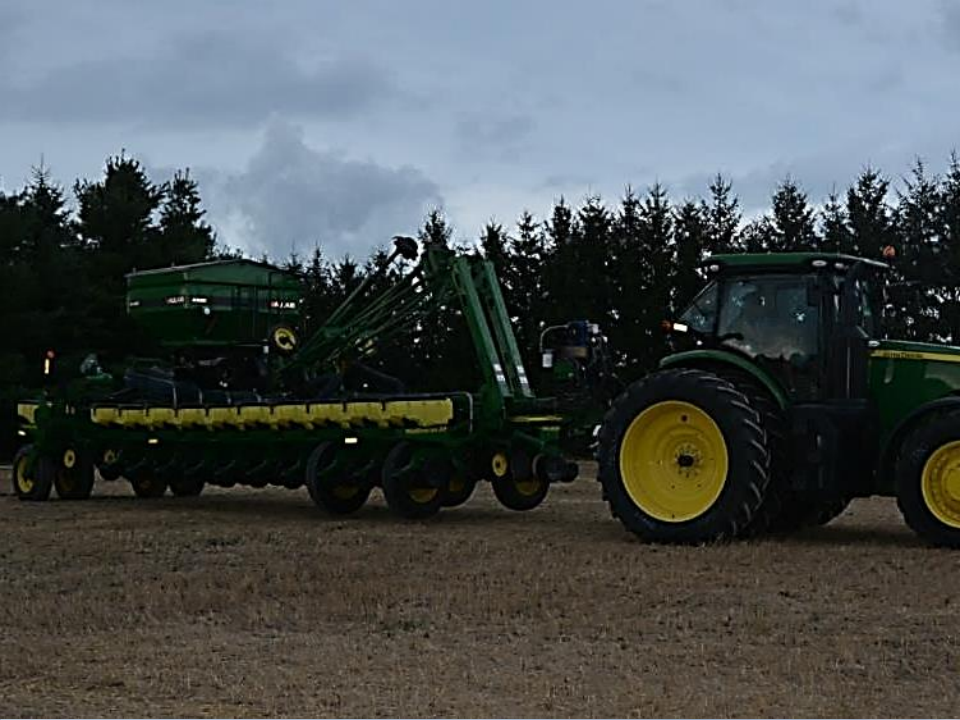
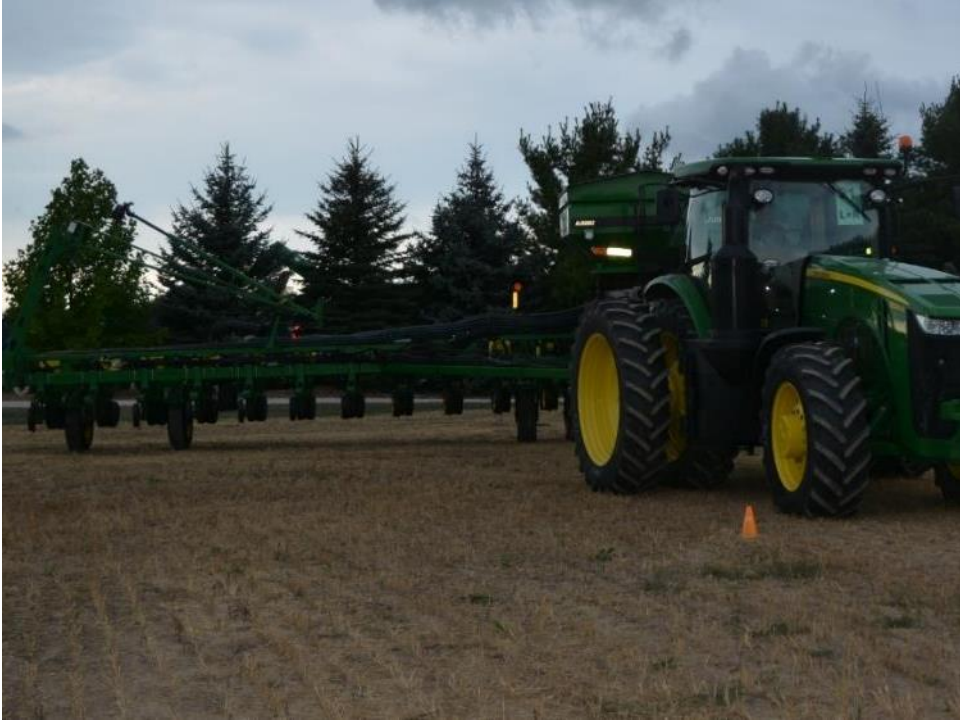
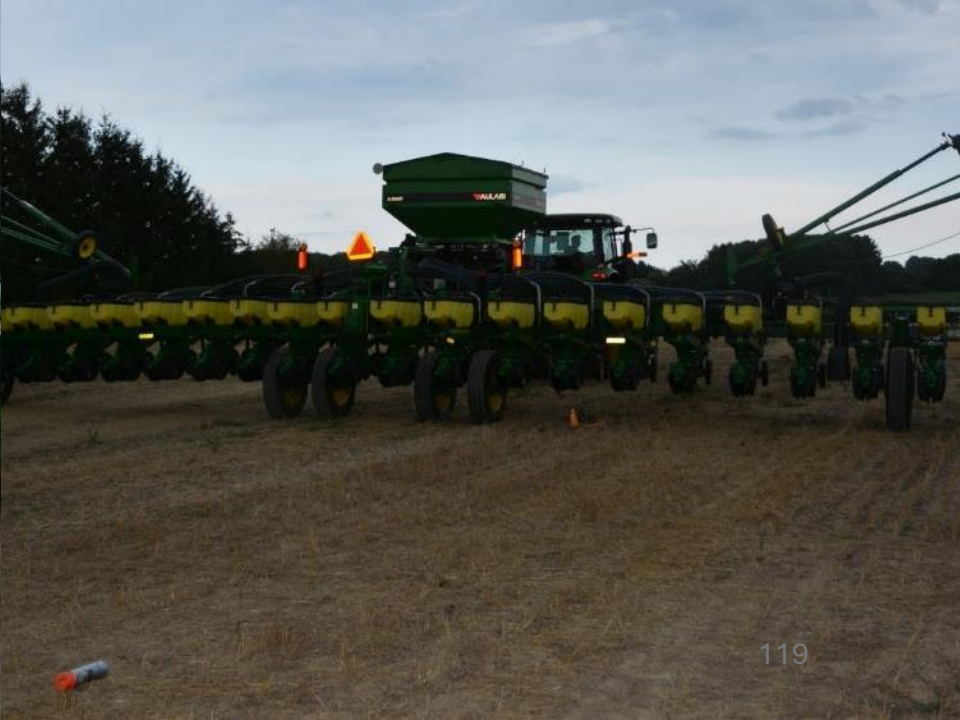
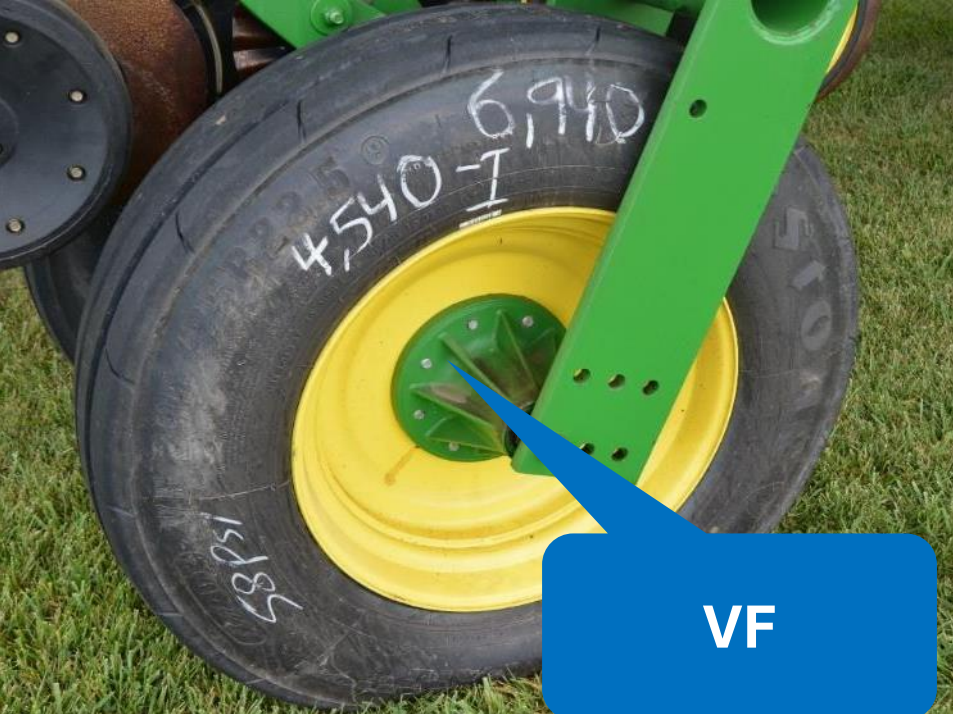
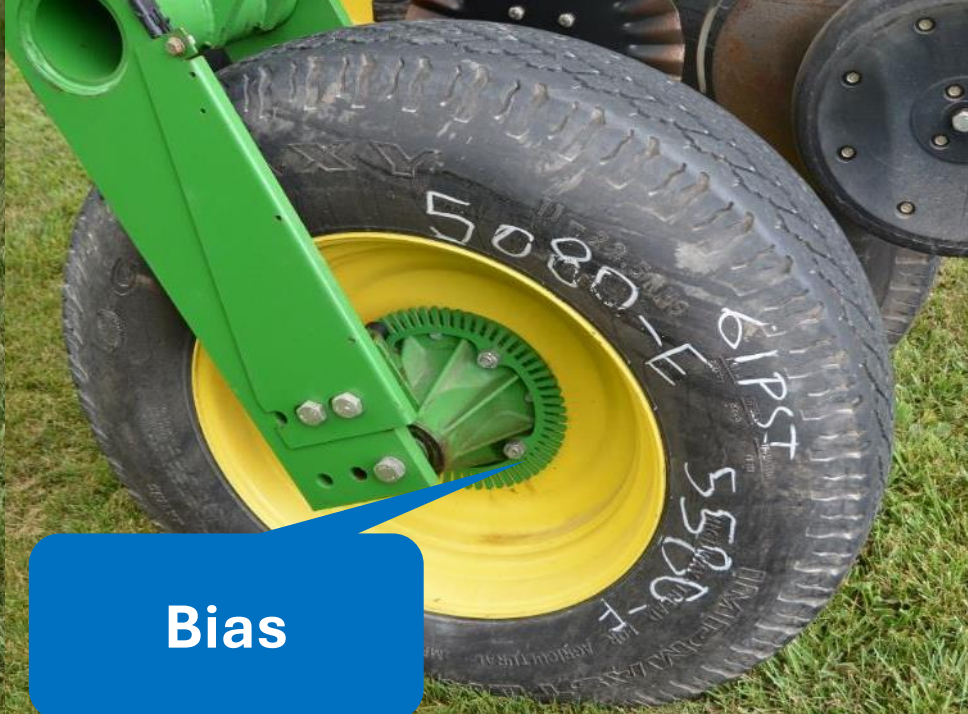
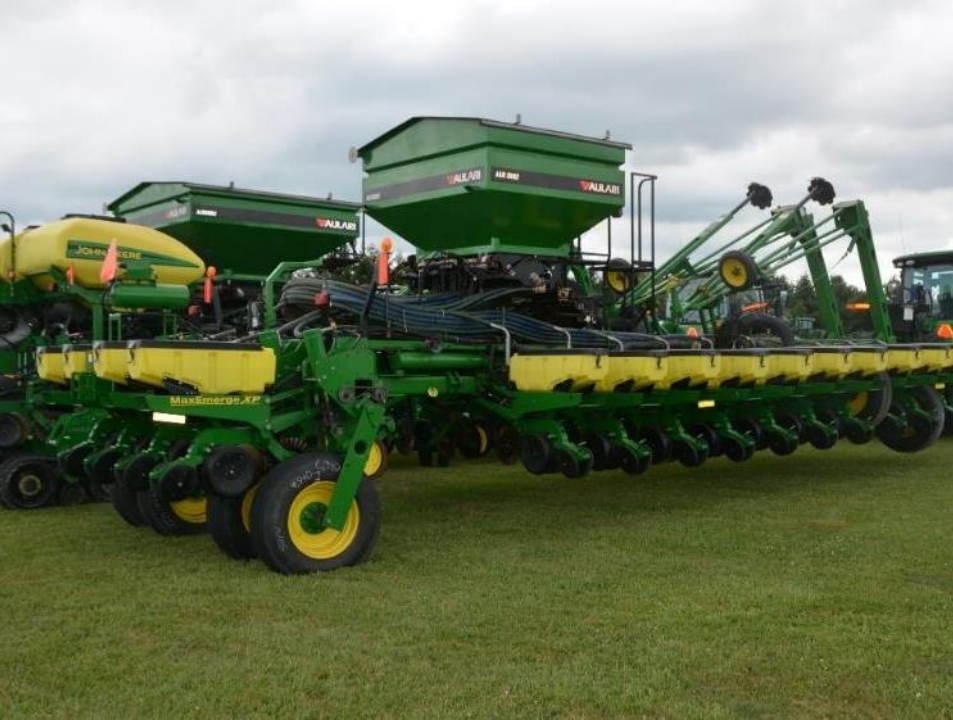
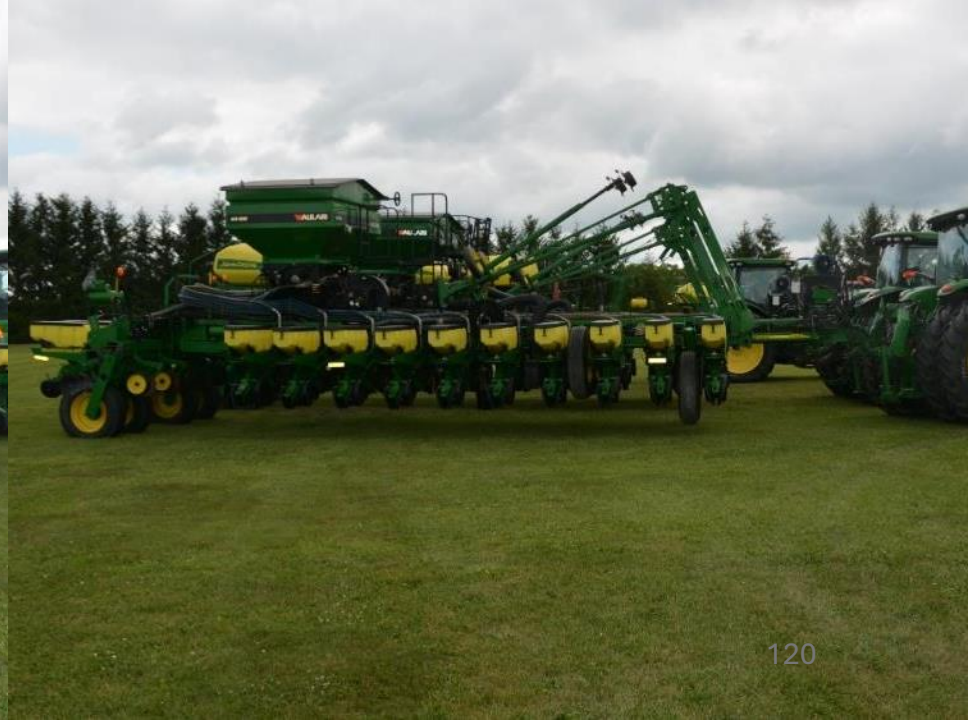
- Interestingly the plots look almost identical but should not be considered as such.
- Contrast to E22 with the tracked planter being 4000 lbs heavier and lower soil stress recorded.

- **DO NOT USE THESE RESULTS!** Presented only to show the problems associated with trying to test these types of implements in compaction events.

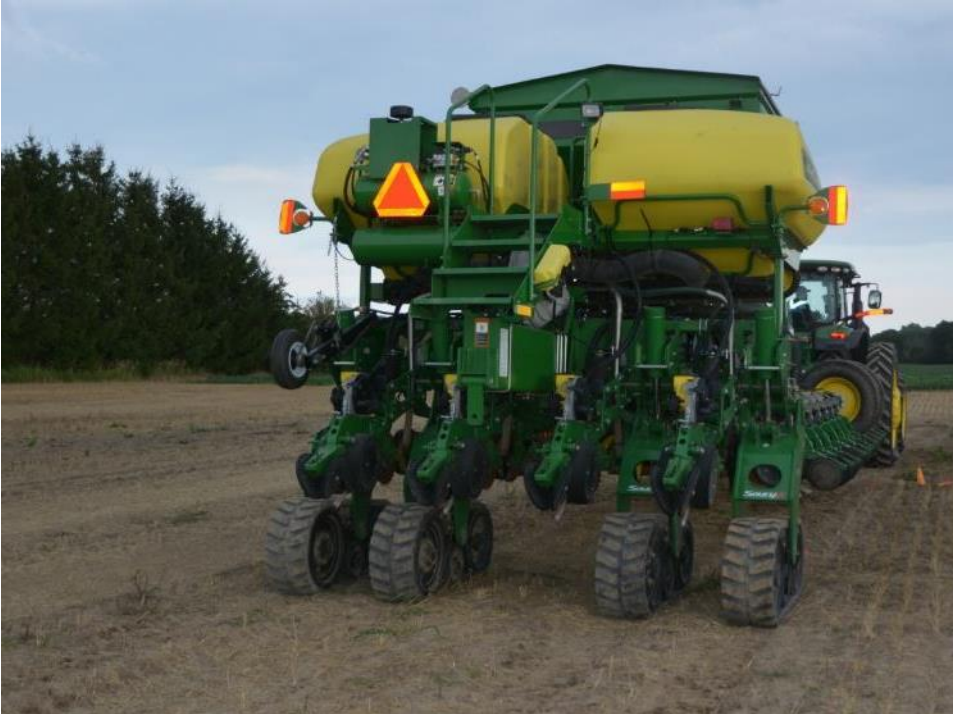
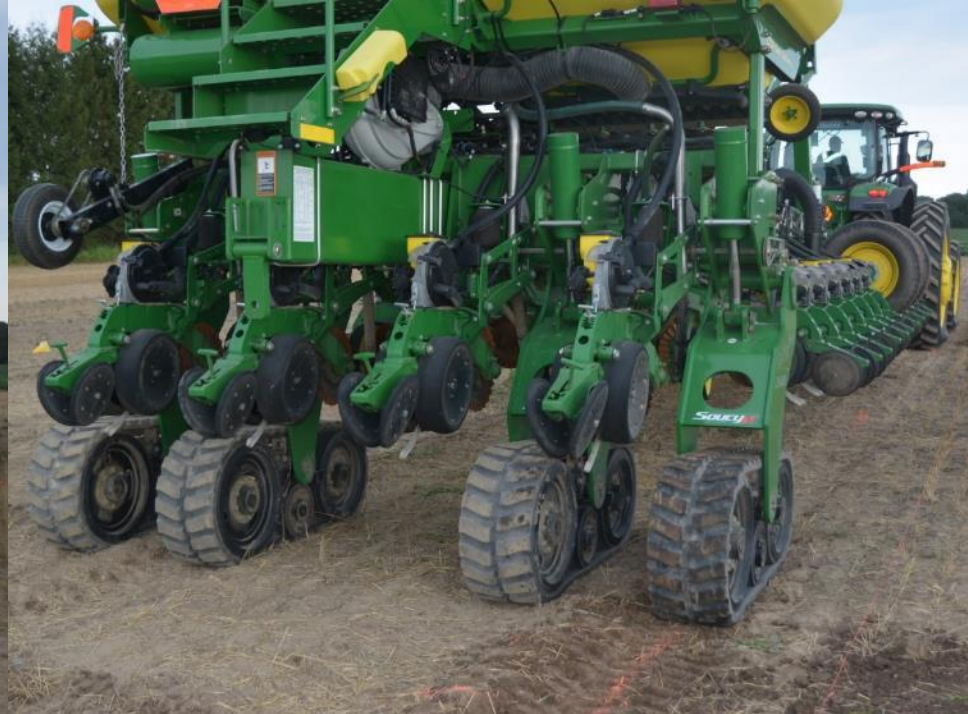
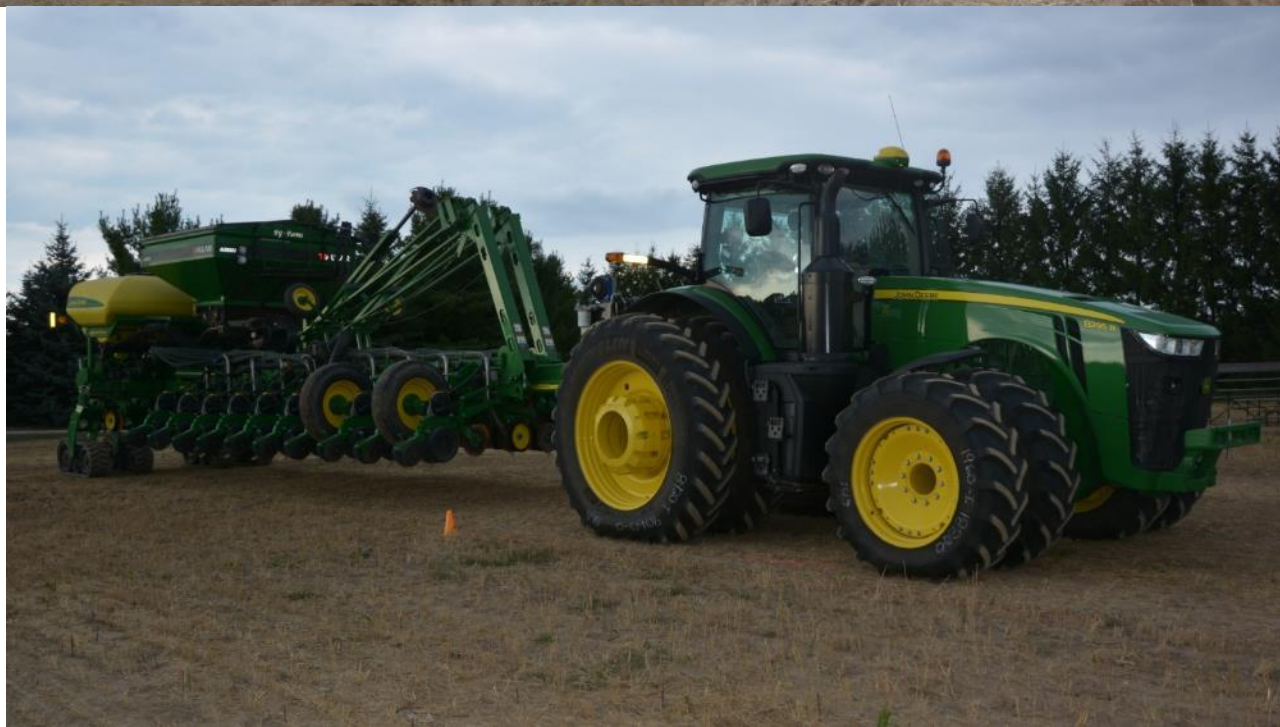
- This unit was NOT loaded to field full weight and so interpretation should account for that.
- This track unit was much better suited to this application compared to the tires that were tested on Unit E21+E23.
- From load carrying and soil compaction, the track system outperformed tires for this empty load.
- There remains a significant compaction threat with this type of implement setup because there is no place to add the amount of rubber needed to support these units loaded weight.
- In general, tires are overloaded on planters, so considering soil stress, safety, magnitude of weight, tracks may be the best option.

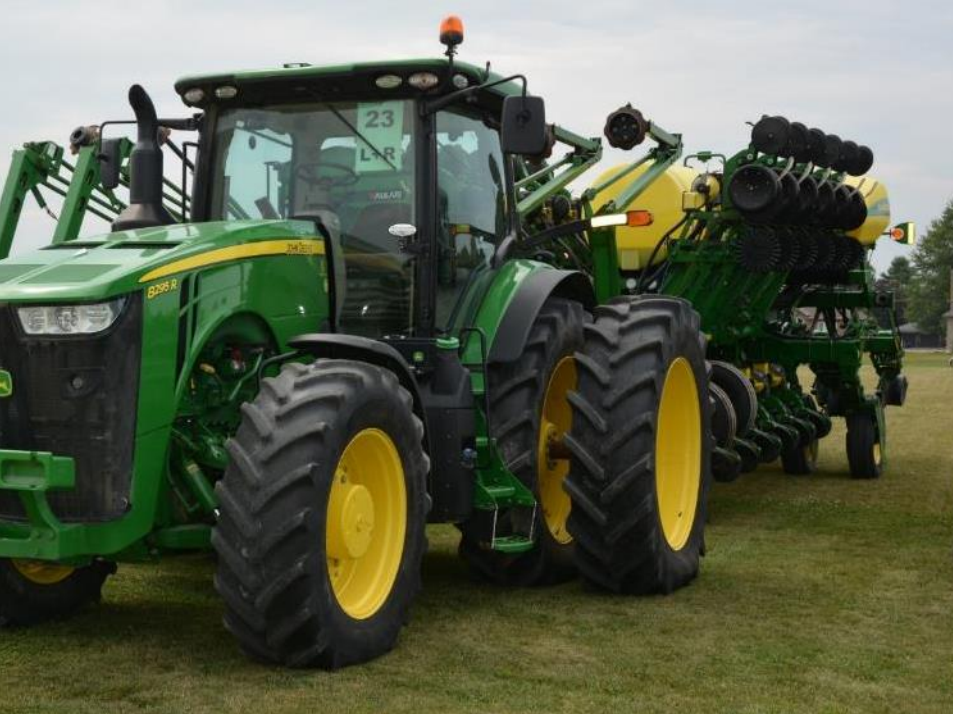
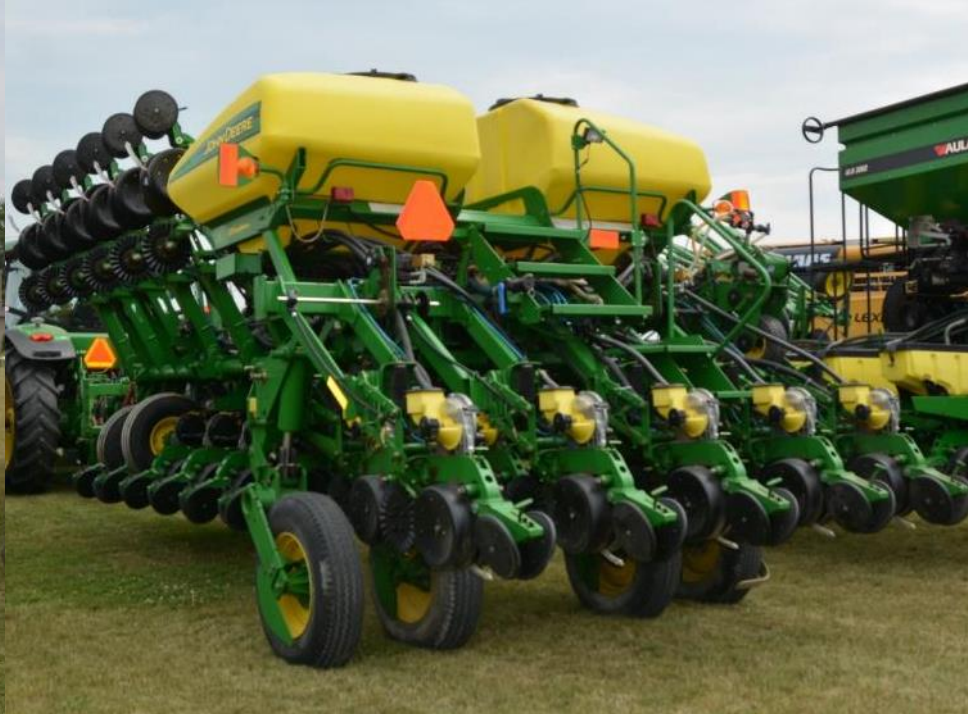
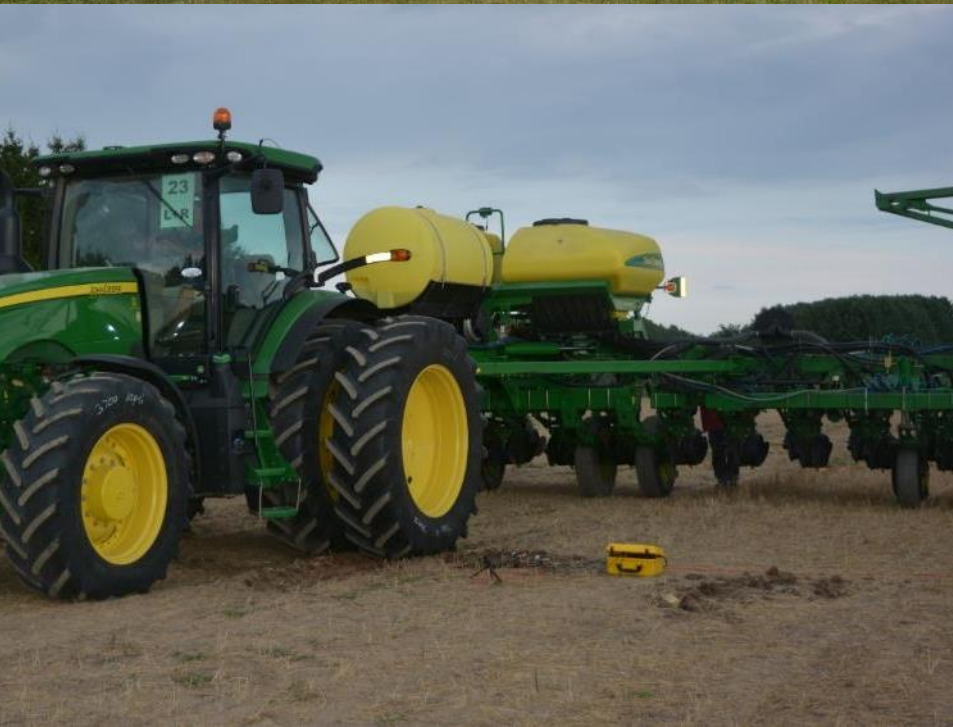
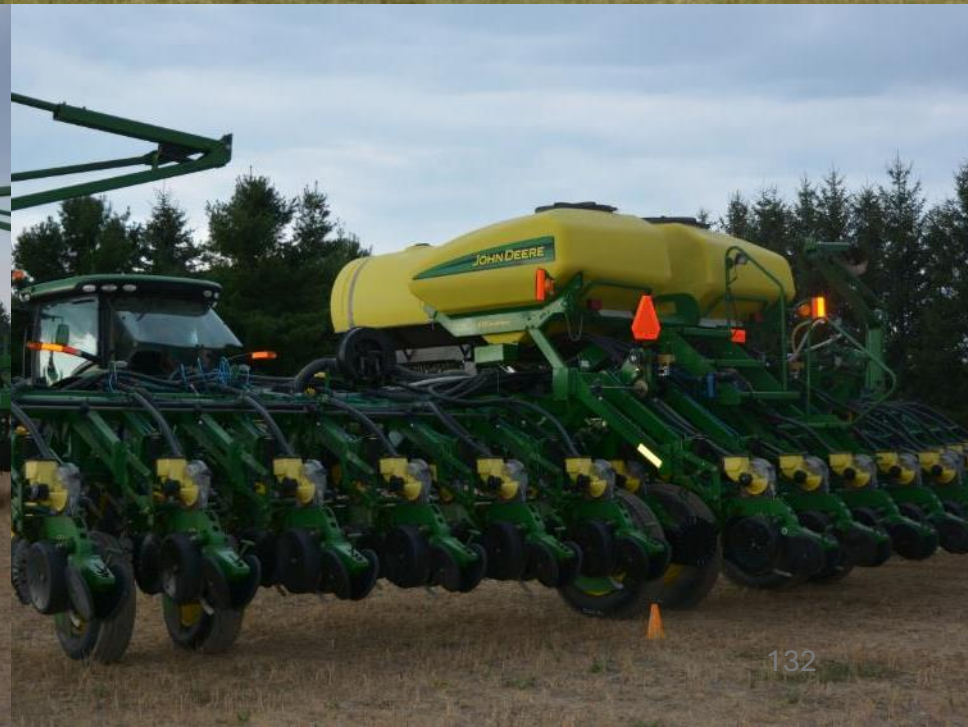
- Like with E21+22, we discourage using this data in making tire decisions for planters. The planters were not fully loaded and it was difficult to hit the sensors properly!
- This Unit again tested a bias and a VF radial tire on the center section of the planter
- Inflation pressure are similar in both tires. It may be the case that the bias ply tire was at the maximum inflation pressure and would not be suited to carry this load.
- Soil pressure is similar between the two tires. The slightly lower pressure for the bias tire (E23_L-unfolded_4) may be due to the tire being off center as these were very narrow tires.
- The first peak on both plots was the outer dual of the tractor, slightly off of the sensor.

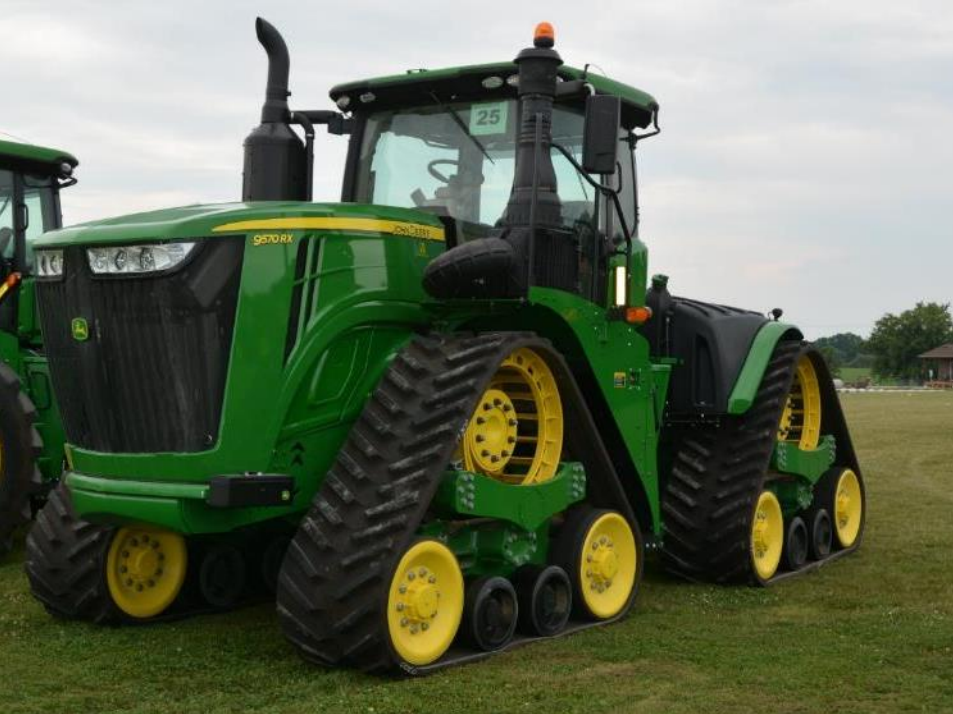
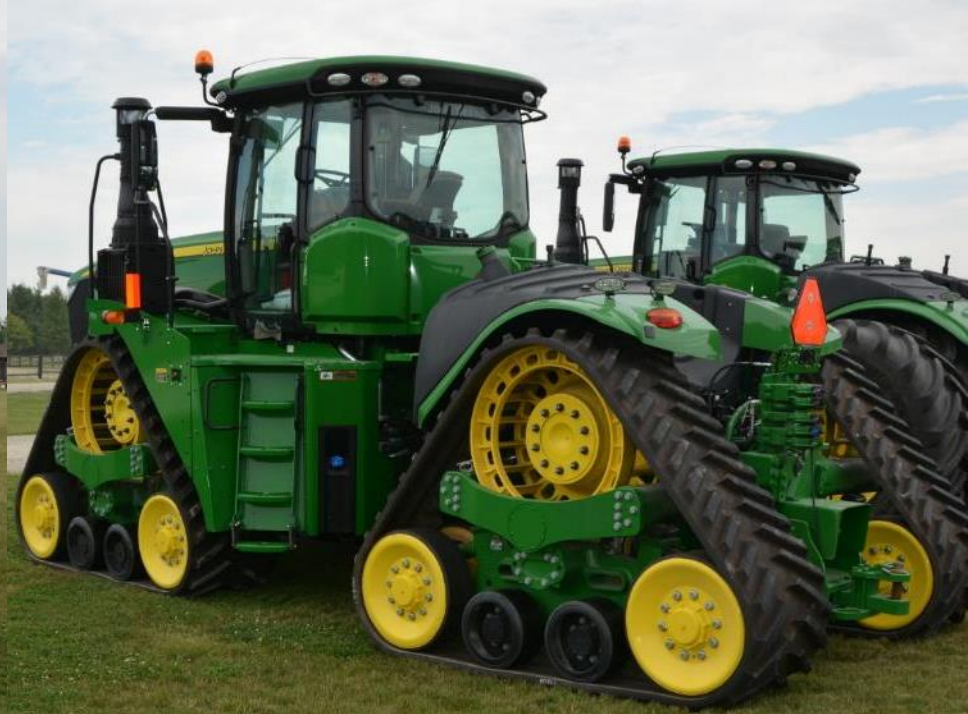
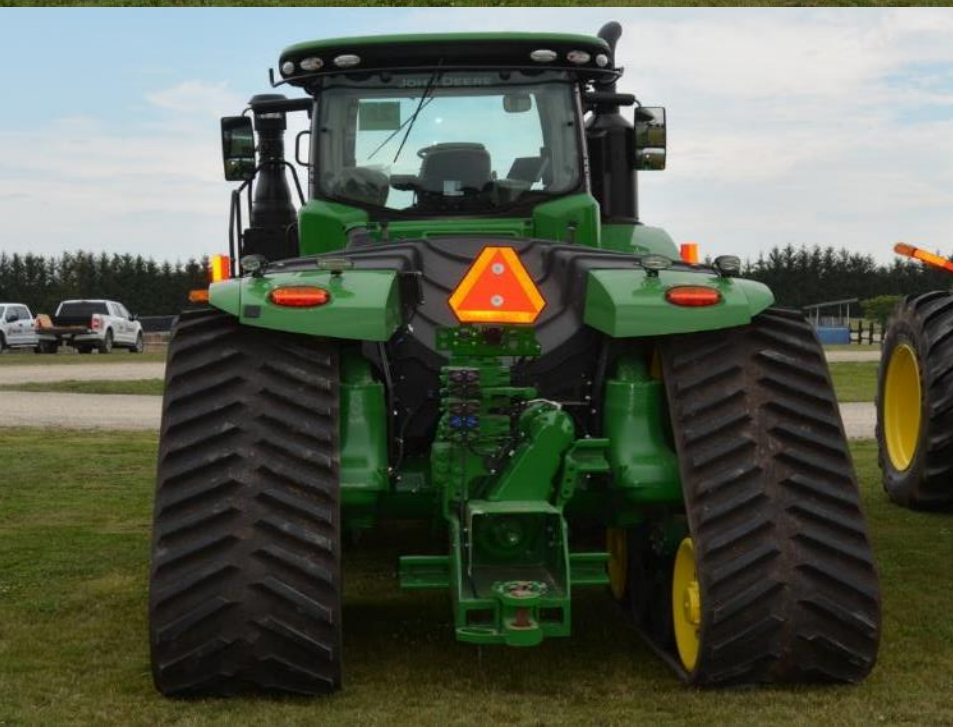
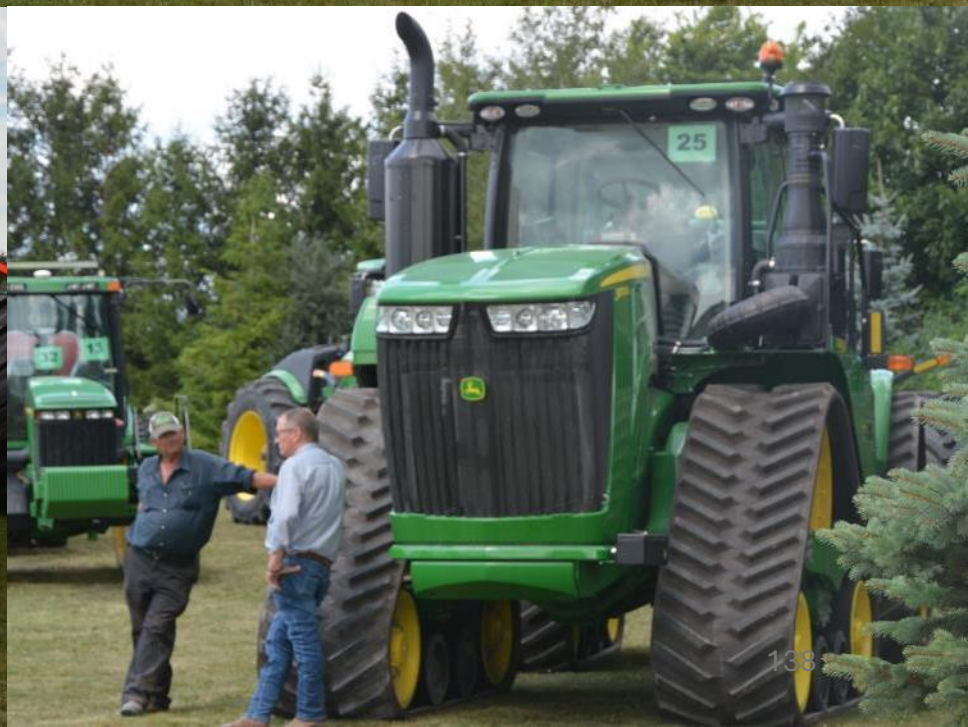
- This Unit again shows the varying pressure distribution across the face of a track.
- The pressure under the rollers in the track unit is higher than the pressure in the center of the track face.
- But the level of pressure transmitted to the sensors at all depths is good and would unlikely result in soil compaction occurring with this configuration.

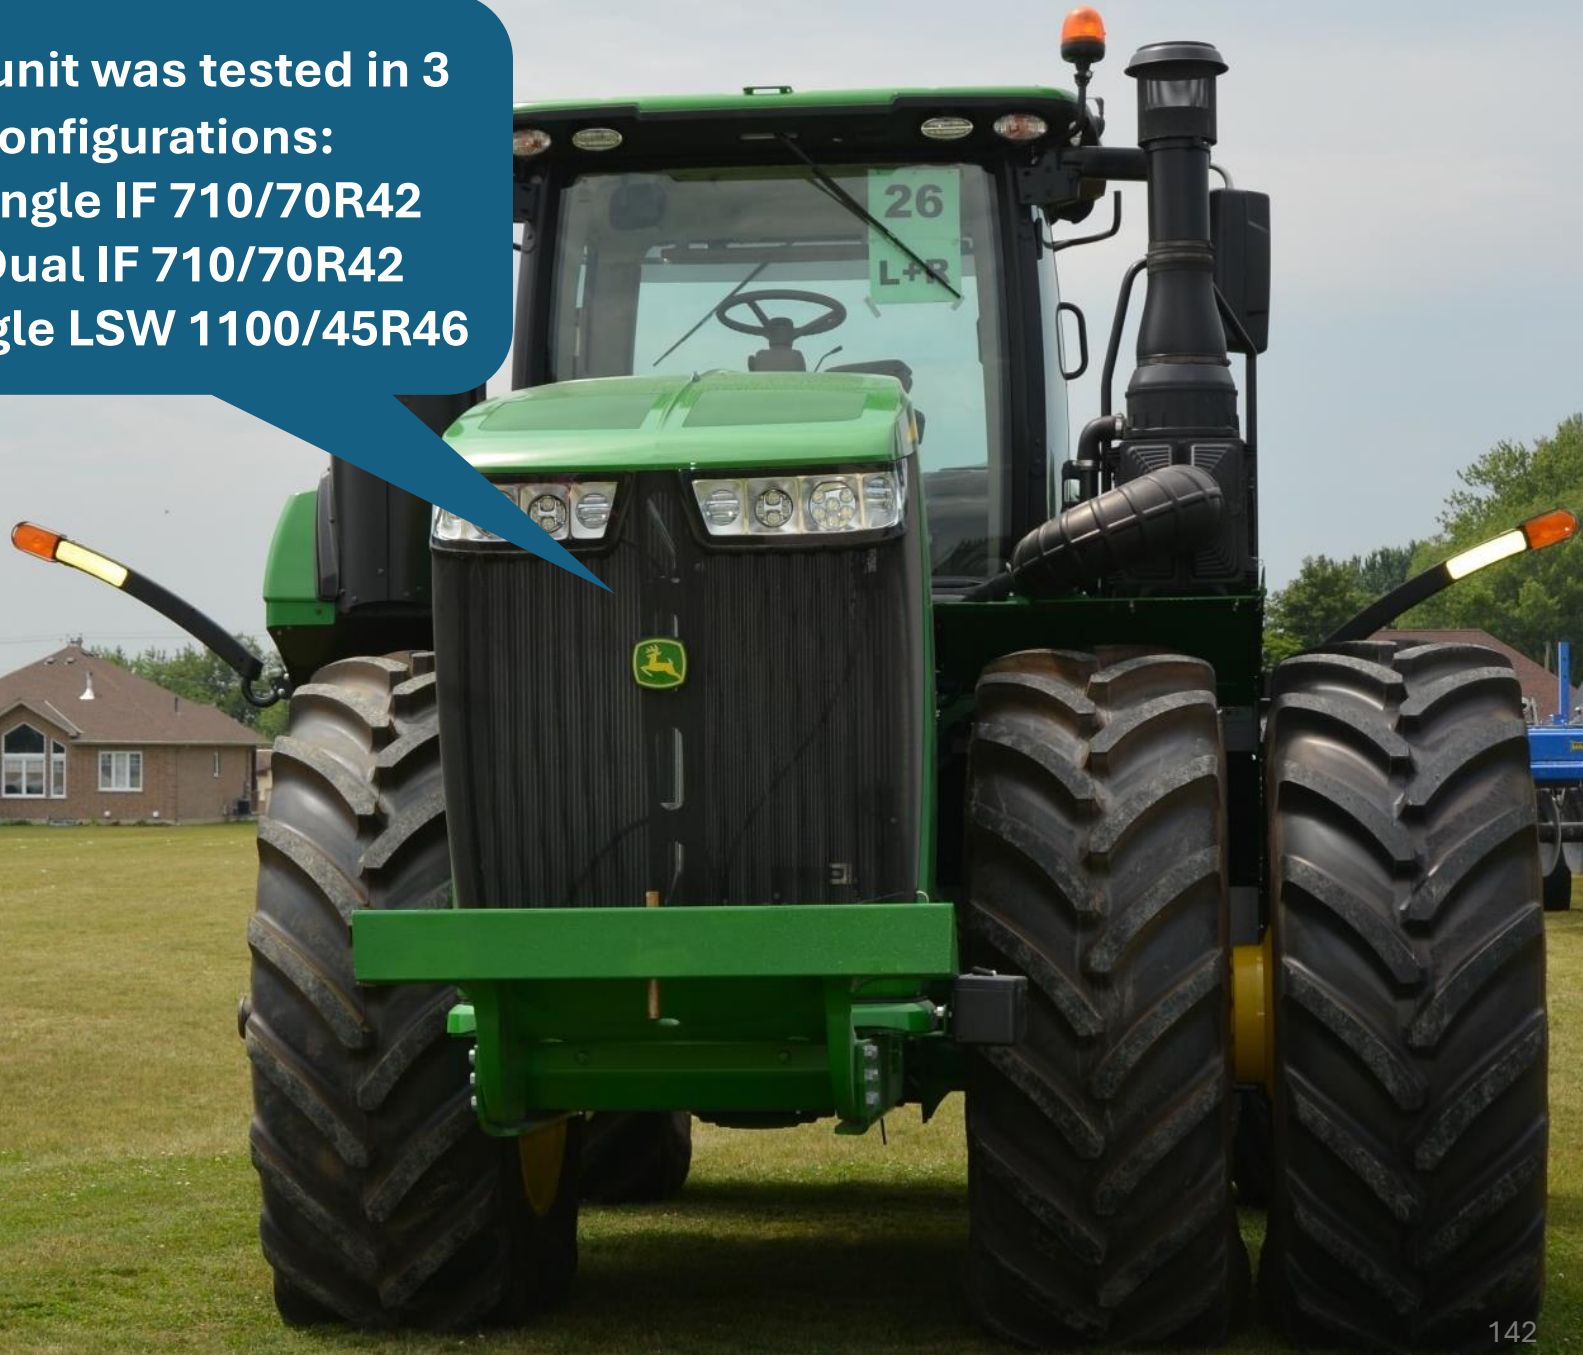
Exh: E26

This unit was tested in 3 configurations:

- 1. Single IF 710/70R42**
- 2. Dual IF 710/70R42**
- 3. Single LSW 1100/45R46**

- This unit compared IF710 dual tires to IF710 single and Low Sidewall (LSW) 1100 tires.
- The plots label with Tue and Tuesday did not have the LSW tire installed and only compares duals and singles.
- In that case the duals reduced the load on the soil compared to the single tire
- The plots label "Wed" show that the Duals and the LSW tire were similar in soil response.
- Under these conditions all 3 configurations showed they were under the theoretical threshold for causing soil compaction under the conditions tested.
