2019 Elgin SCIA Compaction Event

Shedden, Ontario

August 8th, 2019

Elgin SCIA Compaction Event

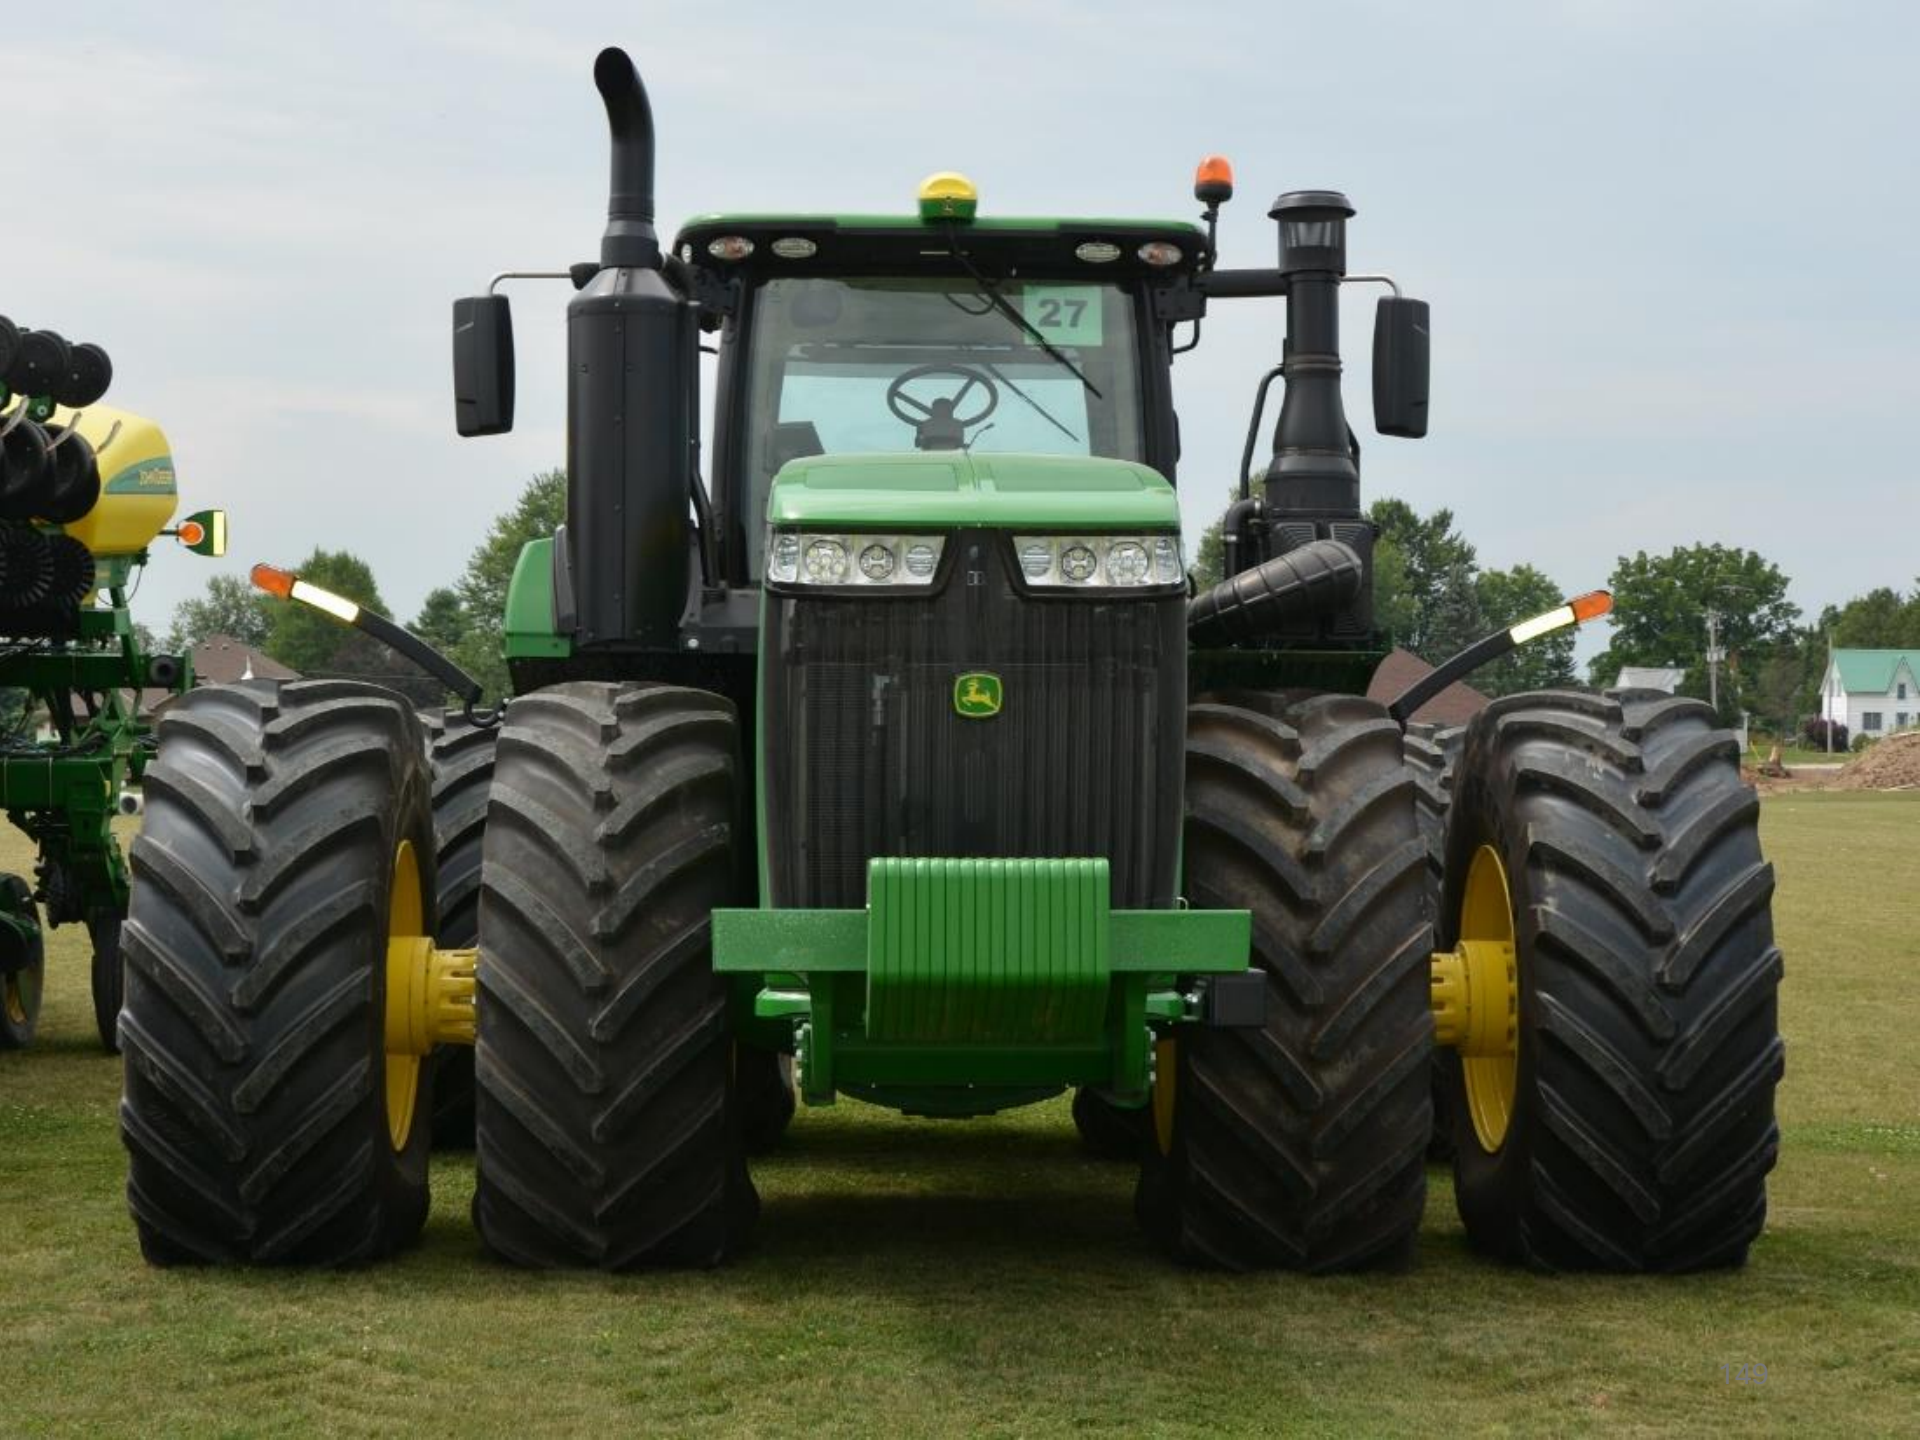
Exhibit: E27

**JD 9420 R Tractor w
IF 800/70R38 Duals**

- This Unit is a very nice demonstration of well balance duals on an articulated tractor
- This setup did not have much weight on the tractor and draft load from any equipment would increase the pressure on the rear tires.
- This is a great example of equipping a tractor with sufficient rubber contact area to reduce the threat of soil compaction under a wide range of conditions.

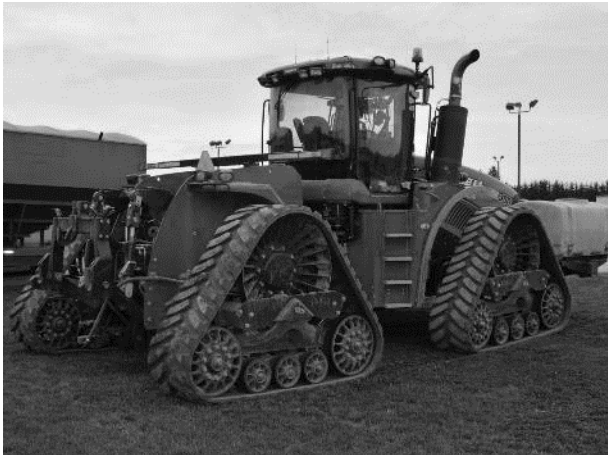
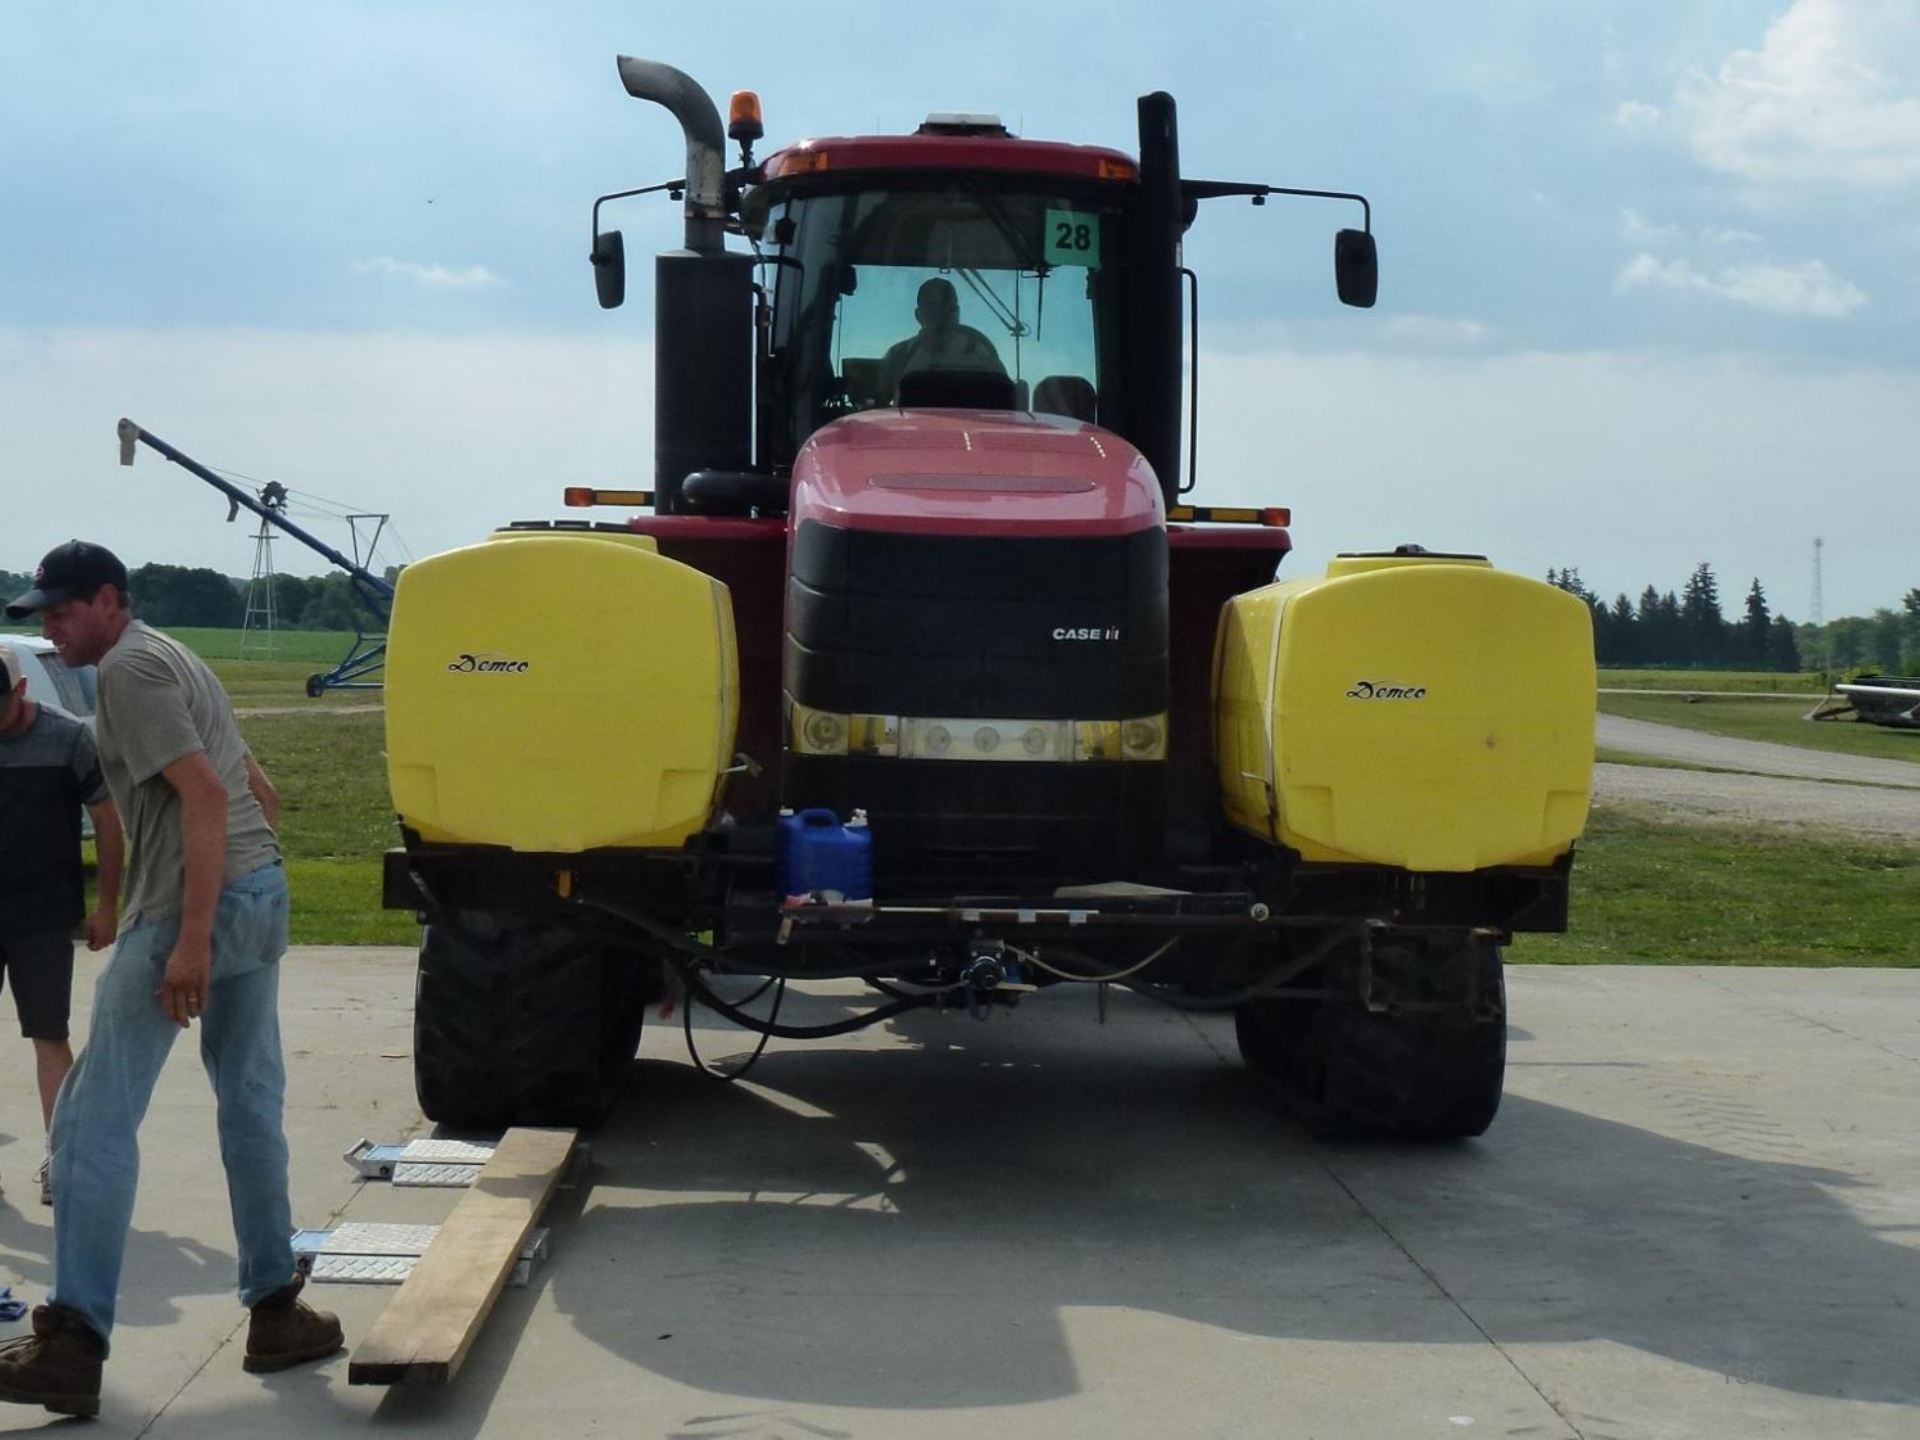
Exh: E28

**Tracked Articulated CaseIH
Quadtrac 350 Tractor w 24”
Track**

E= empty fertilizer tank
F= full fertilizer tank (water)

- This Unit again shows the relatively low pressure exerted on soil by articulated tractors with large tires or tracks.
- Note the difference between the two plots for this tractor is likely due to the change in soil properties between sensor installations.
- This demonstrates that the soil conditions can have a big impact on how the load is carried.
- However, in both cases the amount of stress transferred to the 3 sensors is relatively low.

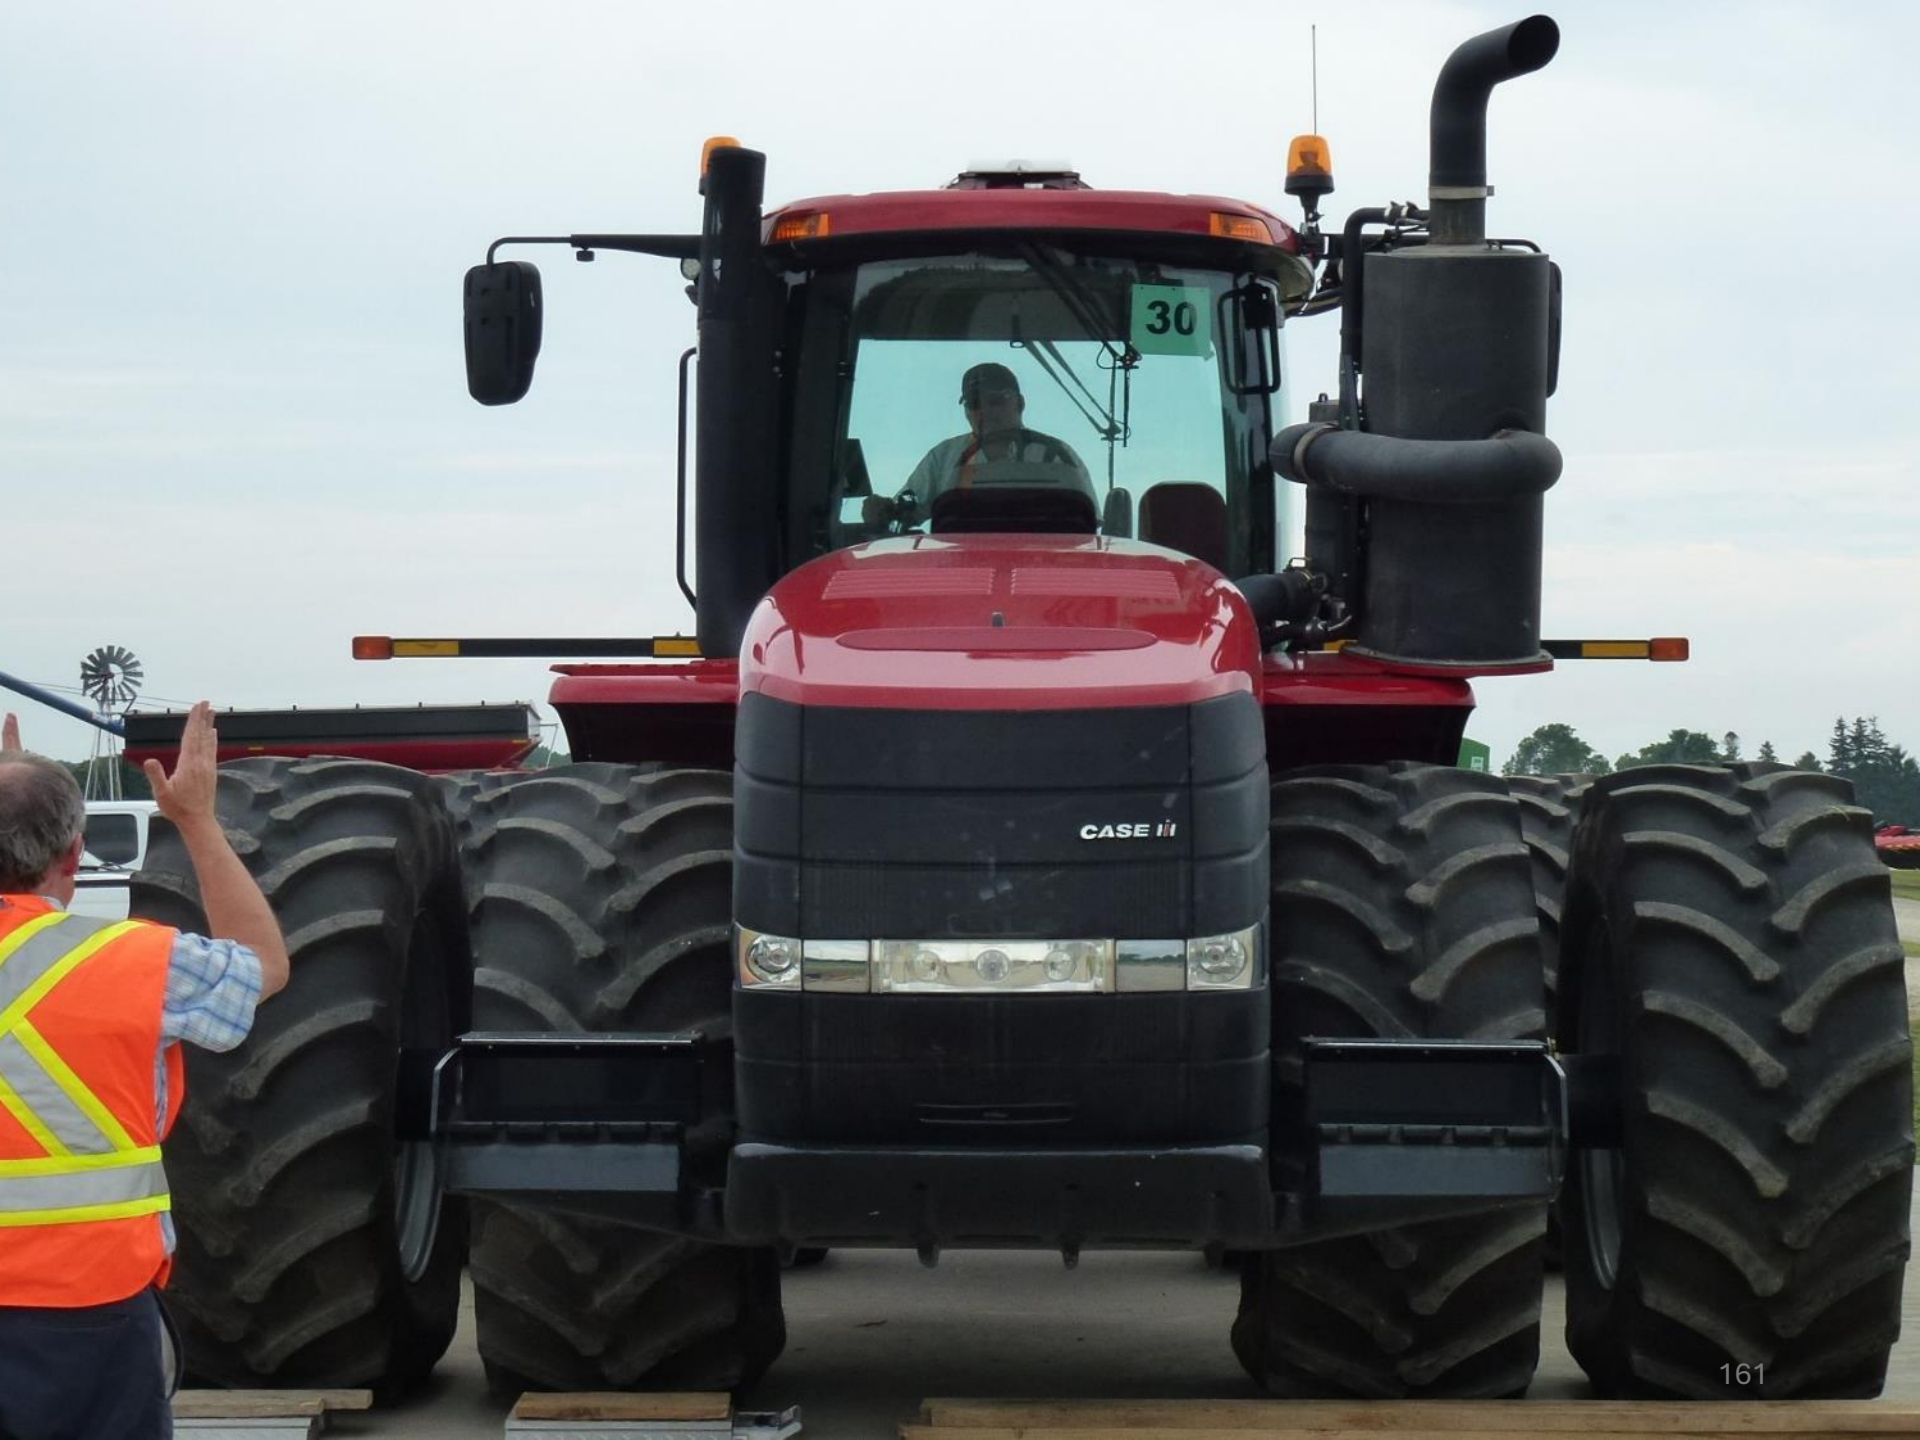
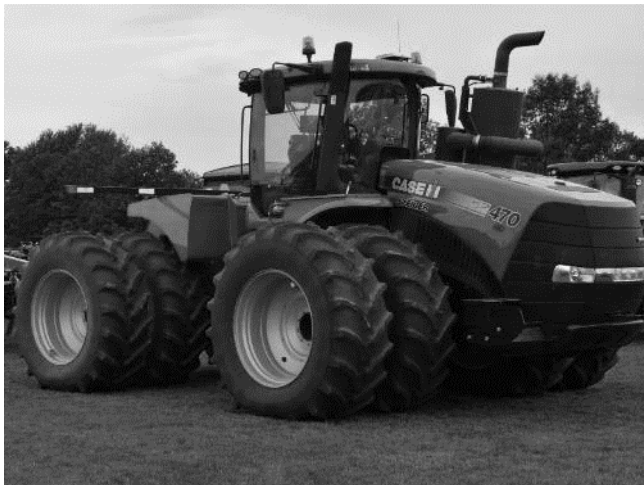
Exh: E30

**CaselH Steiger 470HD
710/70R42 Dualled
Articulated Tractor**

- This Unit was tested on sensor locations 2 and 4. Notice how the 12” and 20” stress was slightly higher for the location 4 (E30_w-disc_4).
- Also notice how the disc-ripper in the raised position was placing a much higher stress on the soil than the tractor.
- All tires tested on this unit were well below what would be a concern for soil compaction but the differences are interesting, especially the stress sent deep into the soil by the tillage unit wheels.

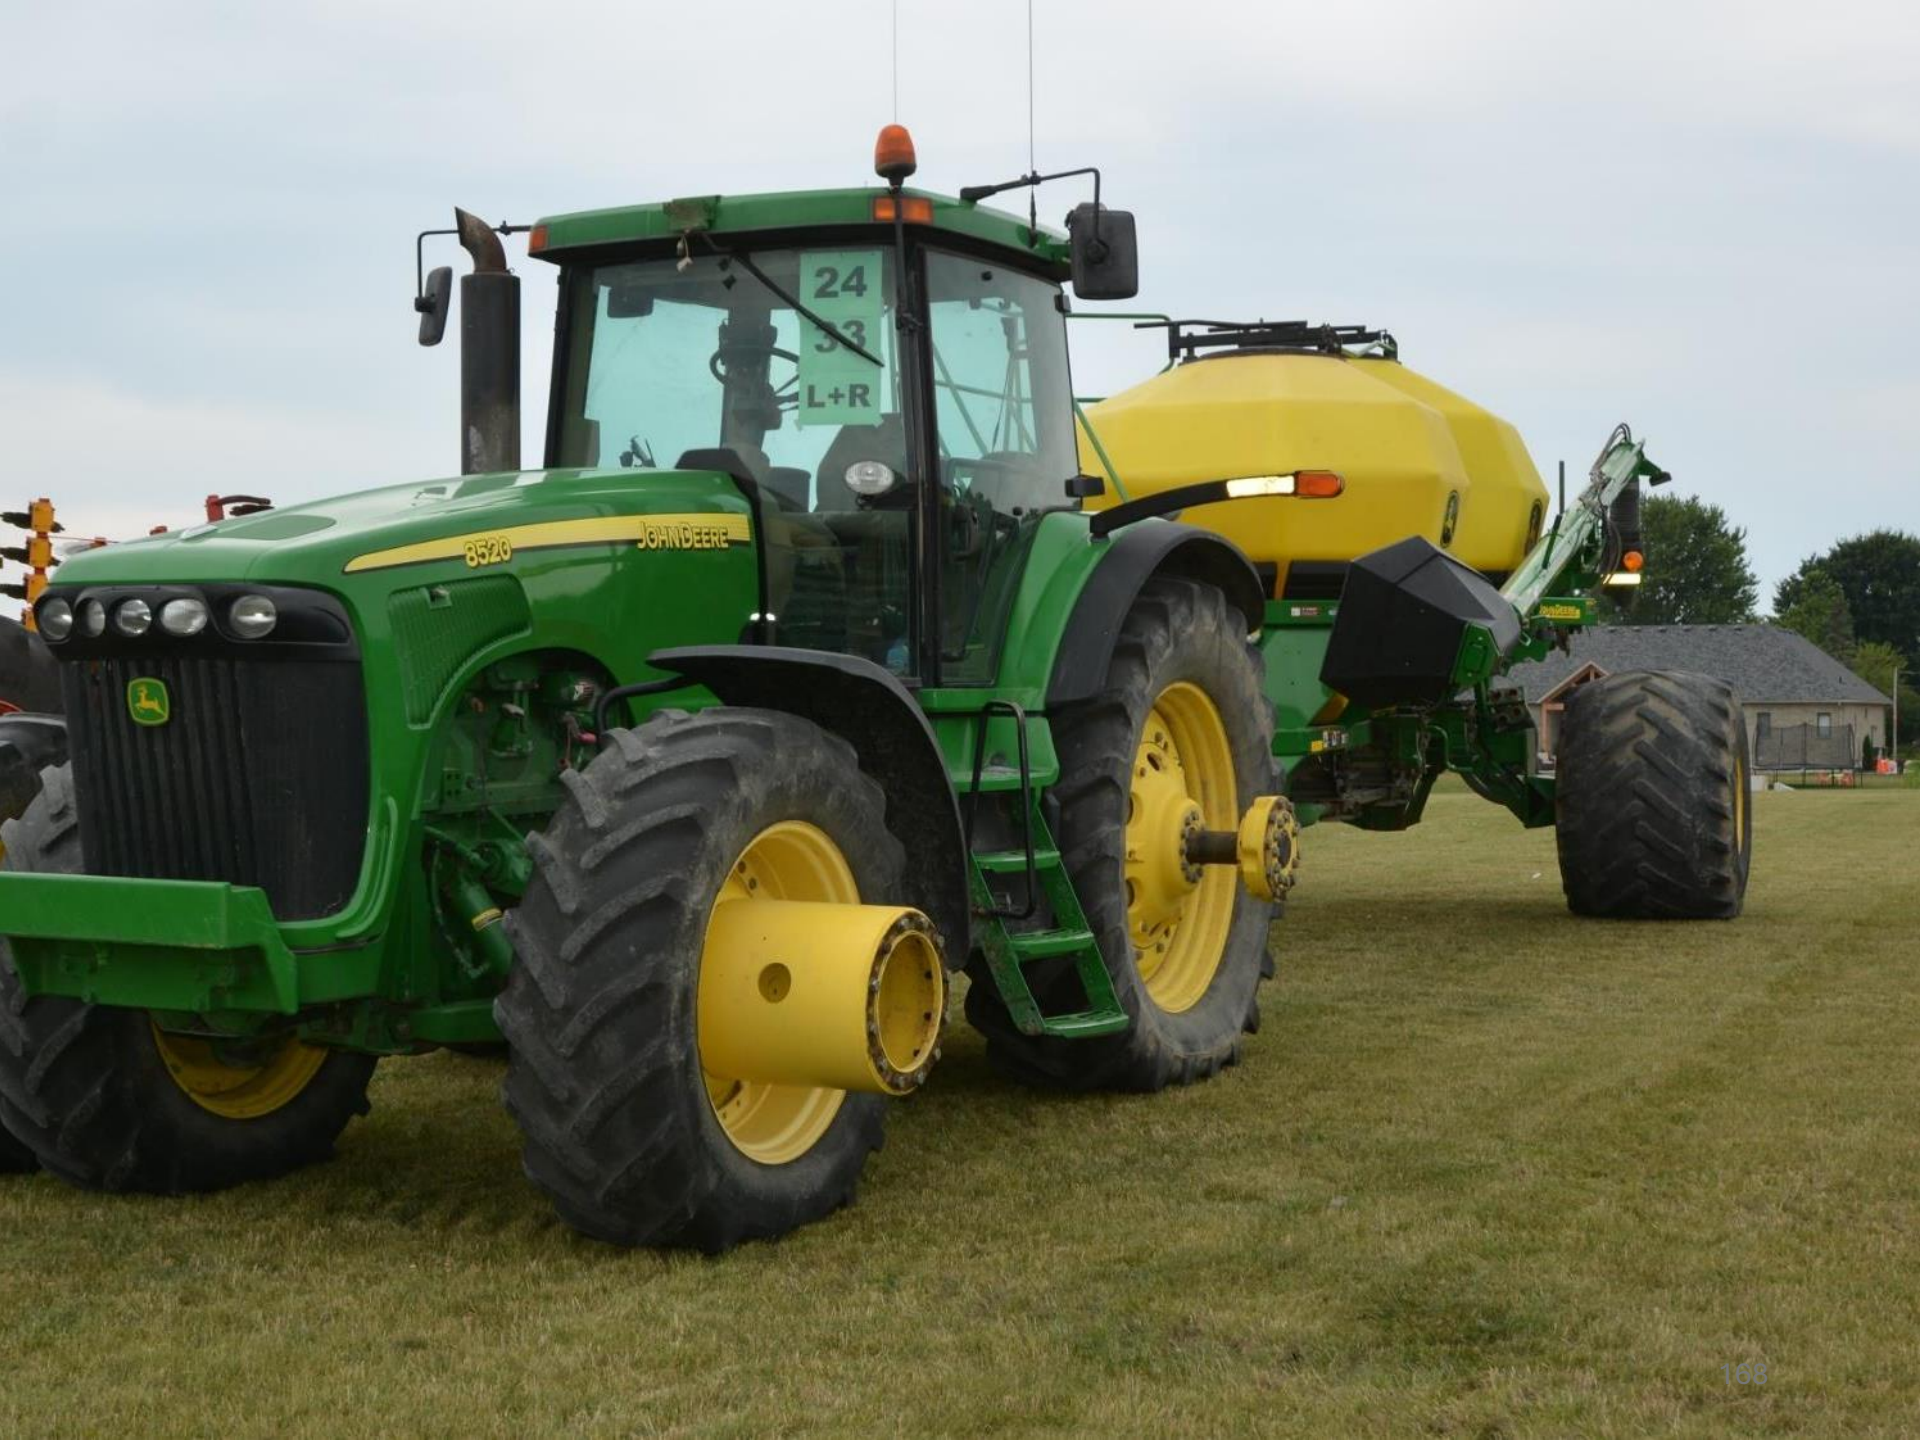
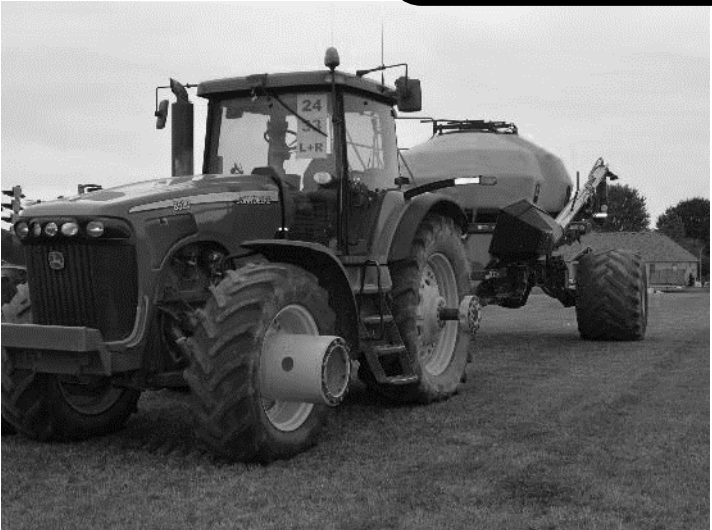
Exh: E33 + E24

**Pull Type JD1910 Dry
Fertilizer Aircart w 66x43-
25**

**+ JD8520 Row Crop Tractor
480/620 Single vs Duals**

Aircart tire centered over sensor on this chart only. The left chart shows the response of the tire partially engaging the sensor.

- Due to alignment the tractor was not able to drive over the sensors so only the cart tires were tested.
- The round profile of the face of this tires meant that the pressure response was non uniform across the face. This meant that the center of the tire applied more soil load (E24_R_3). In the other plot the tire was not exactly centered over the sensor and thus soil stress was lower since the sensor was unable to detect the full weight on the tire.

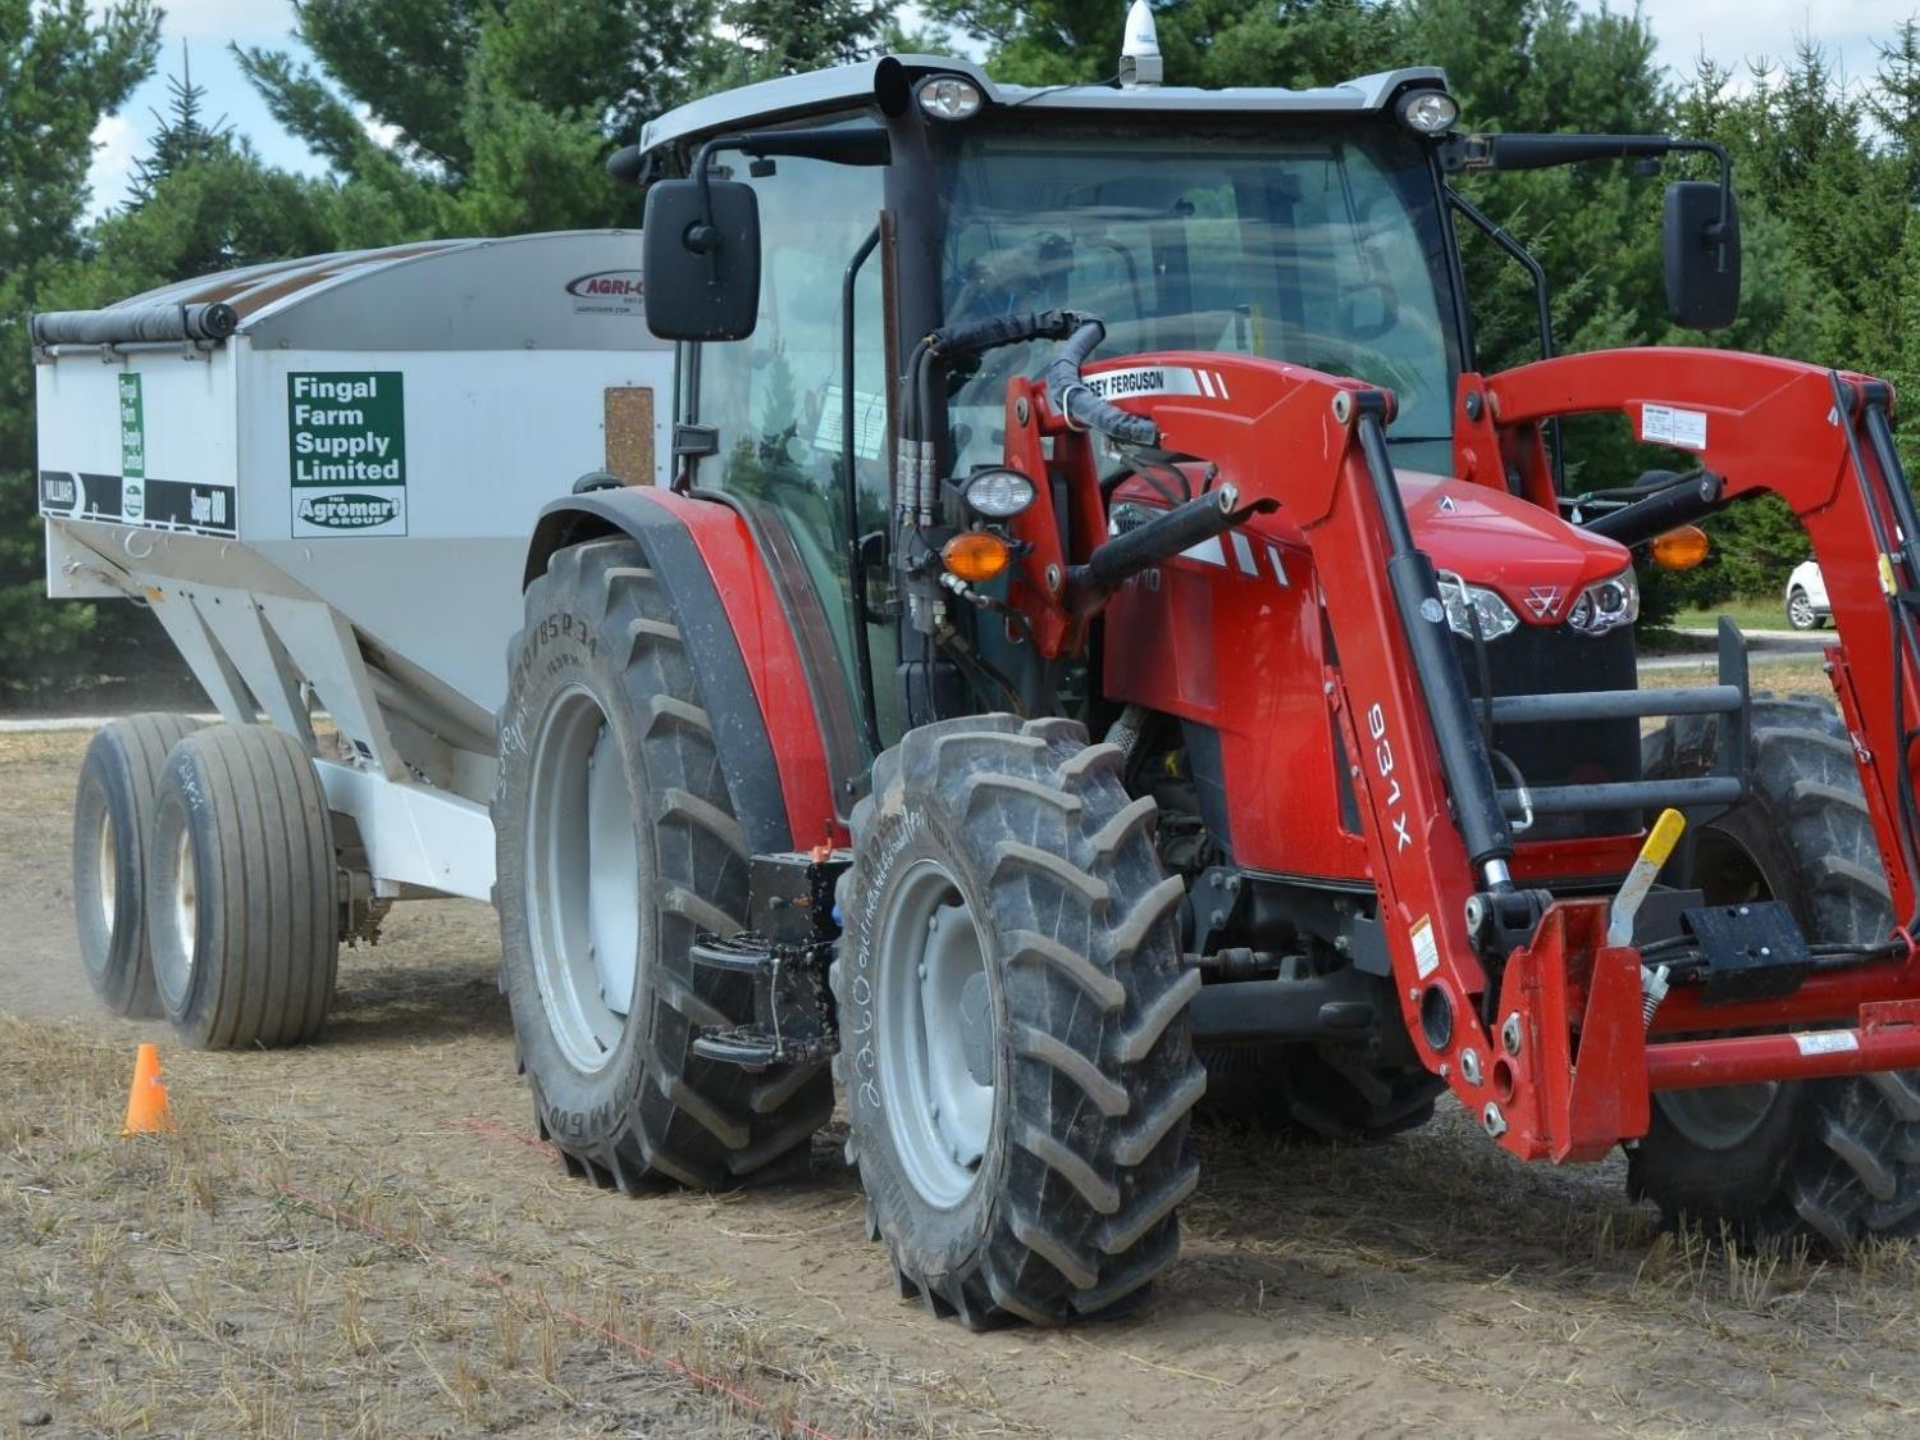
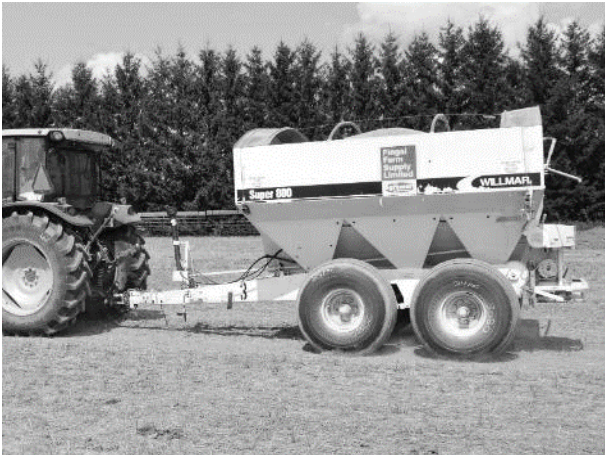
Exh: E35

**Pull Type Dry Fertilizer
Spinner Spreader w Tandem
19L-16.1Bias + MF 4710
Utility Row Crop Tractor**

The tractor response on the left chart is excluded because the alignment to centre the spreader off set the tractor tires. On the right chart, the response of the spreader is excluded as the target was the tractor.

- The response of the fertilizer spinner spreader is typical of an implement with moderate weight and high inflation bias tires. Response at the surface is much higher than it could be with a low inflation tire, but the moderate amount of weight does not generate much stress at the 20” depth.
- The response of the tractor (first two peaks on E35_R-tractor_3) show a low response as well. Low pressure tires and moderate weight.
- These types of spreaders often have overloaded bias tires which can be quite compacting.

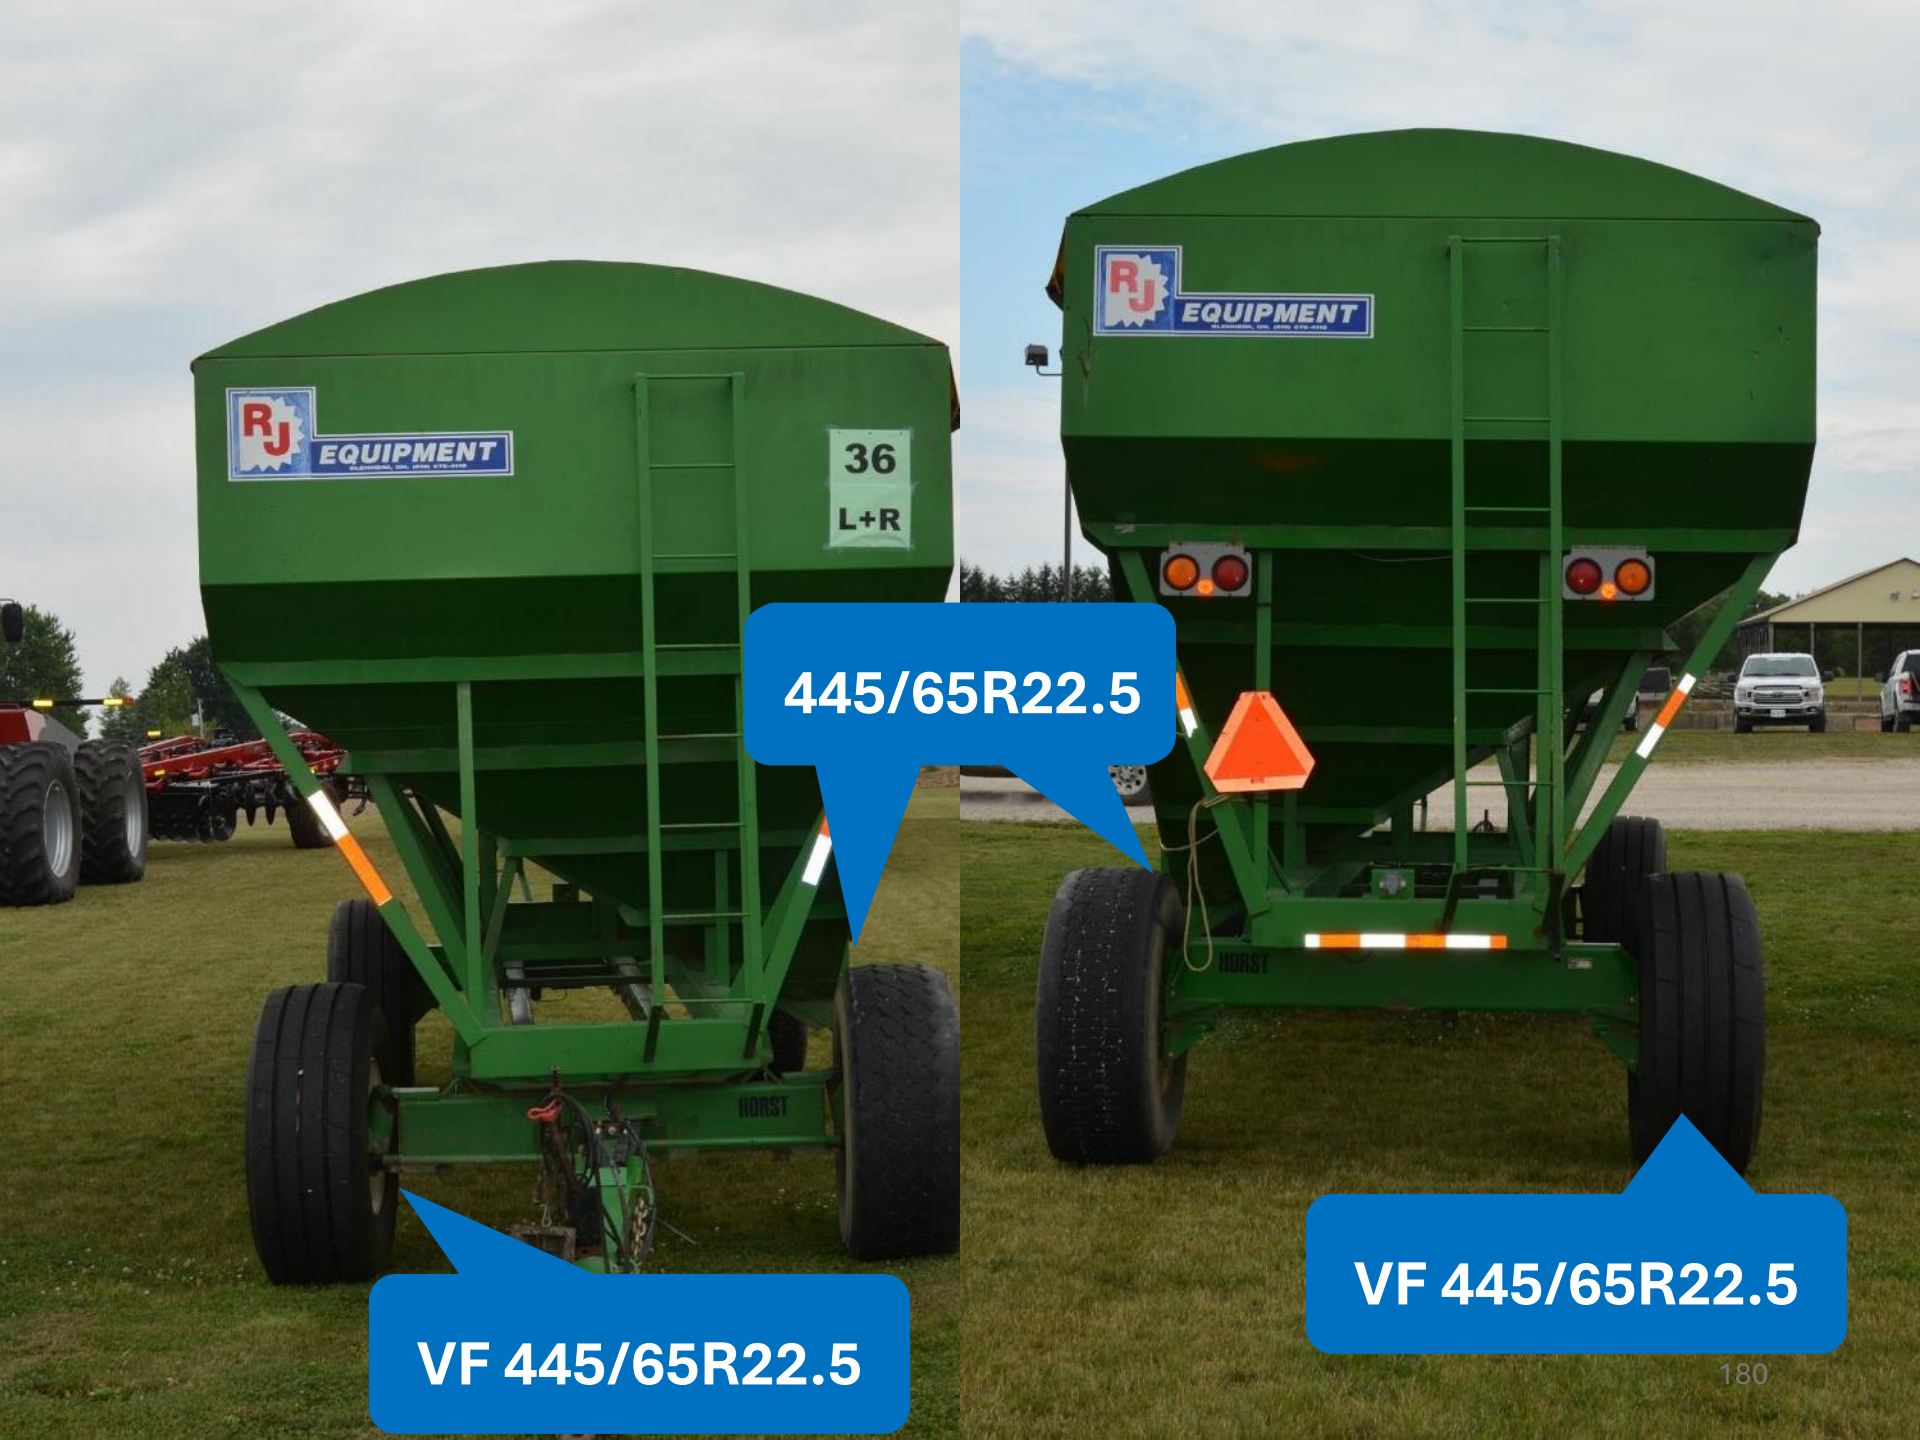
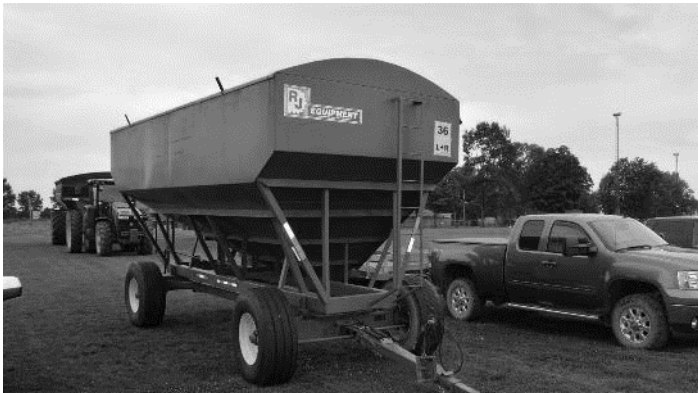
Exh: E36

**Standard Gravity Wagon w
445/65R22.5 Bias vs
VF445/65R22.5 Radial Tires**

- This shows a typical gravity wagon with a normal radial vs a VF tire.
- Gravity wagons are routinely configured with insufficient rubber on the ground for the weight they typically carry
- The final peak on the plot E36_R_4 would be expected to be higher. However the challenge of aligning both left wheels over the sensor meant that it did not measure under the center of the tread face.
- There was not a substantial difference between these two tires in this test due to the high inflation pressure of both types of tires.
- Under wetter conditions we would expect better response from the VF tire do to lower inflation PSI.

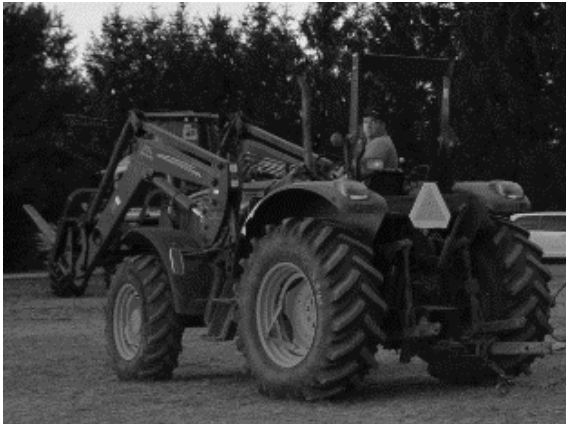
Loader: E=empty; L=Loaded (large round bales)

- This is a small loader tractor with and without a bale.
- The front right tire was slightly wider than the left side but there was not much of a decrease in soil stress with the wider tire.
- In both instances the bale added load to the front tire.

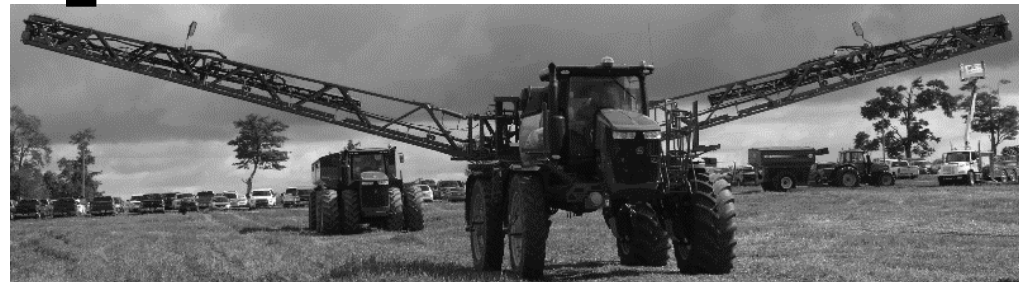
E39_LBW1-check_4 JD SPS High PSI Boom In - Birnam

Front – Radial 380/90R46
Rear – IF 380/90R46

- This sprayer was equipped with CTIS however it was not used to test different tire pressures.
- The plots show the balance between the left side and right side tires.
- The peaks on the plot show the balance of the machine with most of the weight on the rear tire (last peak on plot).
- The boom was in the folded position for this test, so it is expected that more weight would be transferred to the rear axle when the boom is unfolded.

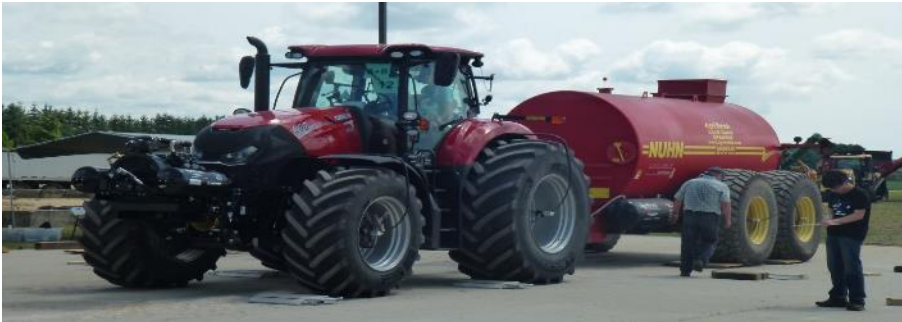
E40_LA_3

CIH+Nuhn Wide **High PSI** Agribrink/CC

- This Unit is another good example of the advantages of Central Tire Inflation (CTIS)
- On both the left and right sides the plots show a reduction in soil pressure when tire pressure was lowered.
- This particular tire on the right hand side is a very round tread face and generates a high soil stress in the center of the tread face. This tire created a deep rut over the sensors despite being a radial tire.

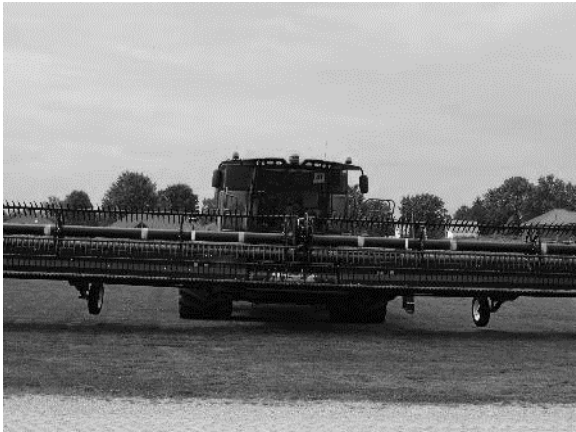
E41_2

Combine JD S680 1250 super single-Walters

- This combine with the large singles showed a relatively low soil pressure at 6” despite having a tire pressure that is well above 20 PSI.
- The large footprint of this tire helps the tire float.
- There is still a high pressure being developed at 12” and 20” due to the total weight of the combine but like with other combines in this event, the tires were good at protecting the soil from soil compaction given the current conditions on test day.

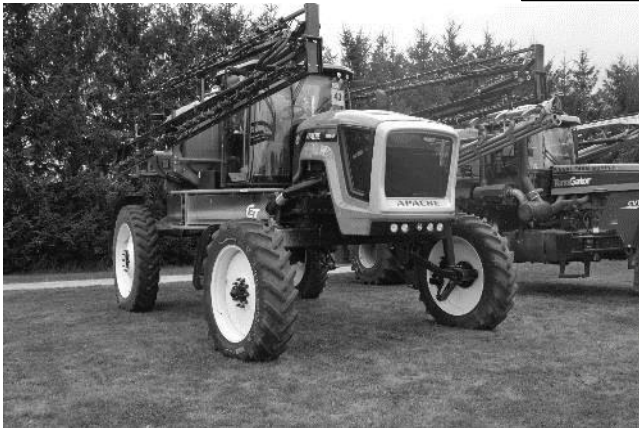
E43_boomout_4

Apache AS1240

- The machine is a self-propelled sprayer with different sized tires front and back.
- The response shows that the rear axle is much heavier than the front axle suggesting that load sharing could be improved.
- Viewing the 12” and 20” response curves it shows that the unit weight was being transferred deeper in the soil, almost to theoretical threshold because of less rubber contact area than with many SP sprayers. Using a wider set of tires or using during the dryer summer months would avoid any issues with this transfer of stress to depth.

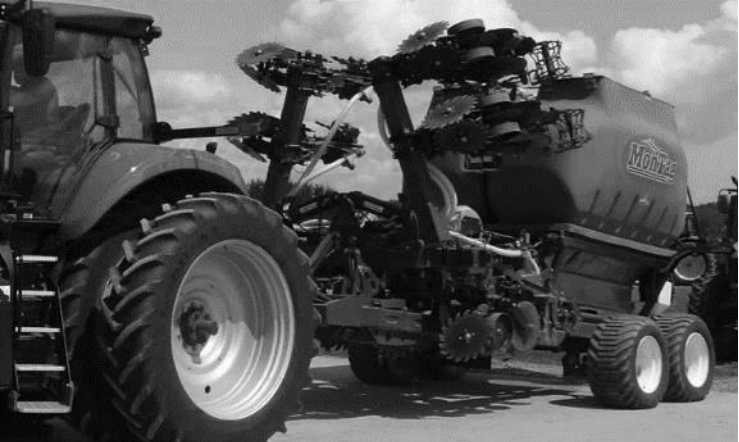
E44_L_3 Montag Fertilizer Cart

- This shows the response of the air cart (last two peaks on plot)
- The response is similar on both sides of the machine suggesting even weight distribution.
- The lower response on the left side was due to misalignment with the sensor.
- The tractor tires didn't line up to cross the sensors.
- Bias ply tires should be avoided as shown by the 6" and 12" sensors receiving over theoretical threshold stress! The total load weight wasn't enough to drive that stress to 20" but if the cart was fully loaded it might be different.

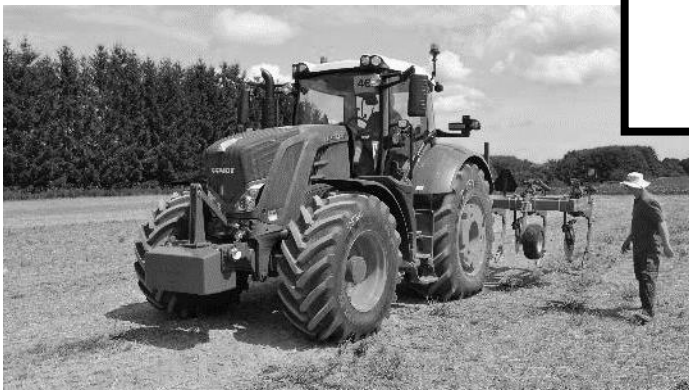
E46_A_3
Fendt 828

- The reduced tire pressure in the Field inflated tires (11 psi) on this machine reduces soil stress at the 6 inch depth (E46_B_3), the (E46_A_3) is the same tires inflated to 30psi for road travel by the onboard CTIS system.
- The data supports the advantages of employing CTIS to optimize tire pressures for road and field operations
- There is a slight reduction at the 12 inch depth
- There is no real noticeable reduction at the 20 inch depth because the total unit weight is not excessive.

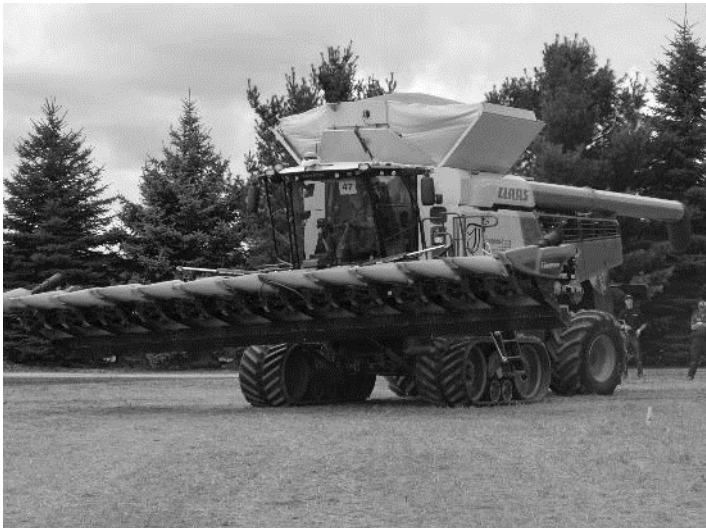
E47_ClaasClass10_4

Claas Class 10 Combine

- The tracks on this combine do a good job to limit pressure at 6 inches
- The excessive weight of this combine means that soil stress deeper in the profile will be high regardless of the amount of flotation from the tracks. Note the blue and red lines approaching the dotted blue line which is the theoretical threshold for these depths.
- The rear tire in this instance looks like it is not applying much load to the soil but notice that the heavy corn head is counterbalancing the rear axle but again the blue and red lines are approaching the threshold.

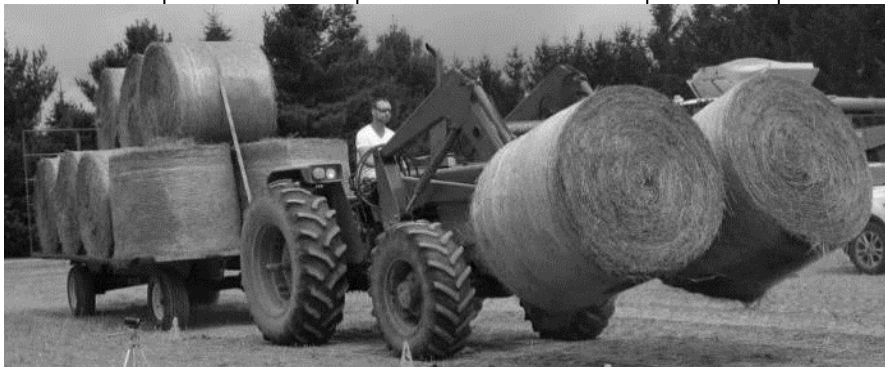
E48_wagonLeft_4
CIH 885 Tractor and Bale Wagon
